Master Landscape Plan

The Village of Key Biscayne

Working Paper I: *Inventory and Analysis of Existing Conditions*

January 20, 2009

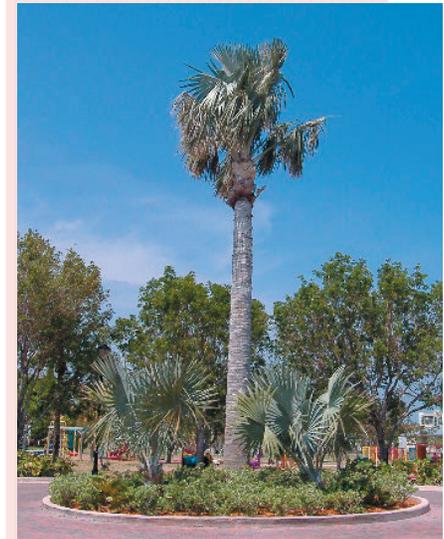
Bismarck Palms

Species	Condition	Comments
Cocoplum Hedge	Good	Heavy Shade
Variiegated Pittosporum	Good	Heavy Shade

These hedges are currently in good condition, but continual shade could lead to sparse and leggy growth habits.

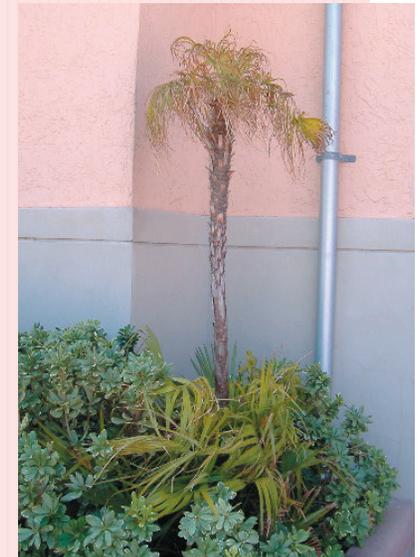
Paurotis Palm with
Nutritional Deficiencies

Species	Condition	Comments
Veitchia Palm	Fair	Nutritional Deficiencies
Macho Fern	Fair to Good	Dry/Need Pruning

Shell Ginger	Fair	Dry/Wind Damaged Improperly Pruned
Heliconia psittacorum	Fair	Susceptible to Nutritional Problems
