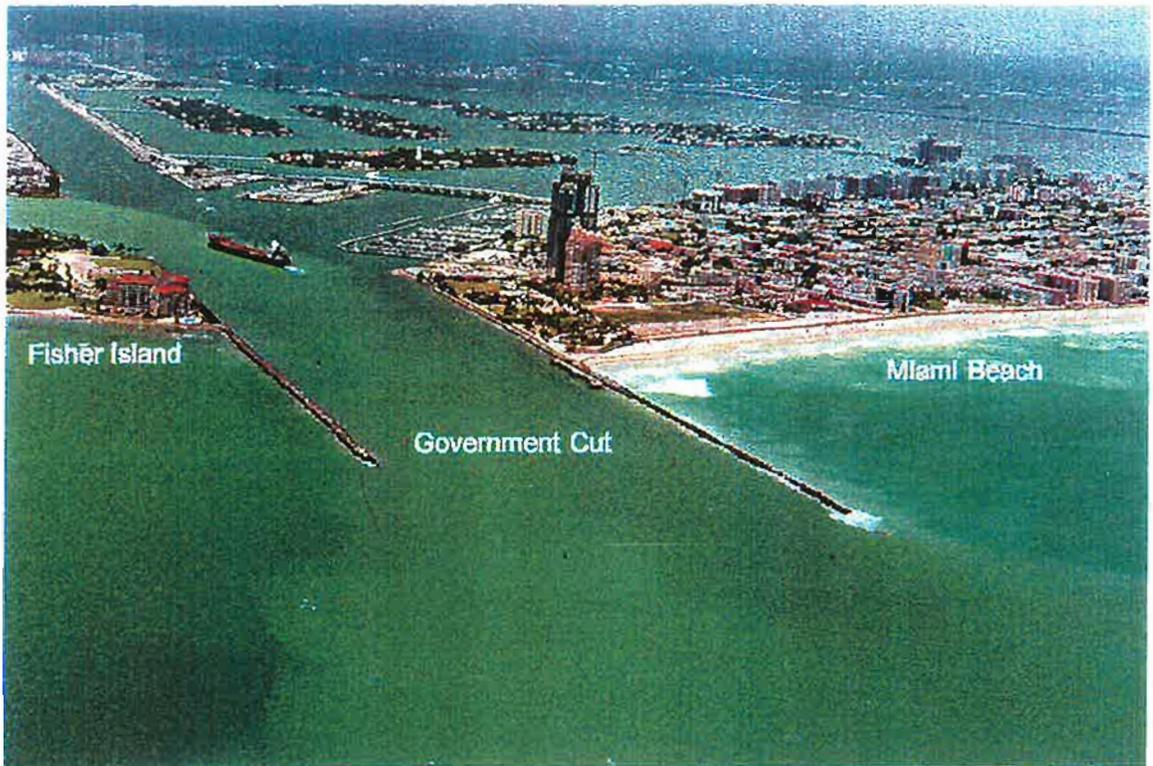
Photo A.1 - View looking westerly into Government Cut and north Biscayne Bay. The Cut separates Miami Beach and Fisher Island.

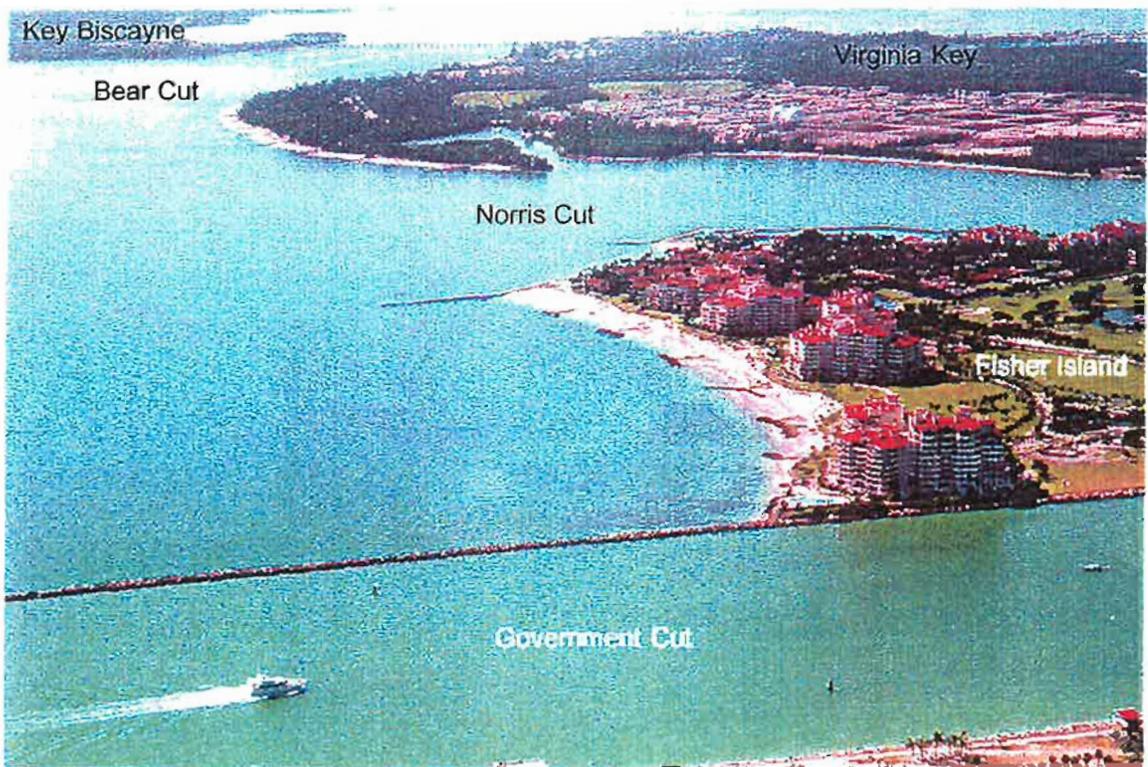
Photo A.2 - Another view of Government Cut looking south-southwesterly with Norris and Bear Cuts beyond separating Fisher Island, Virginia Key, and Key Biscayne.

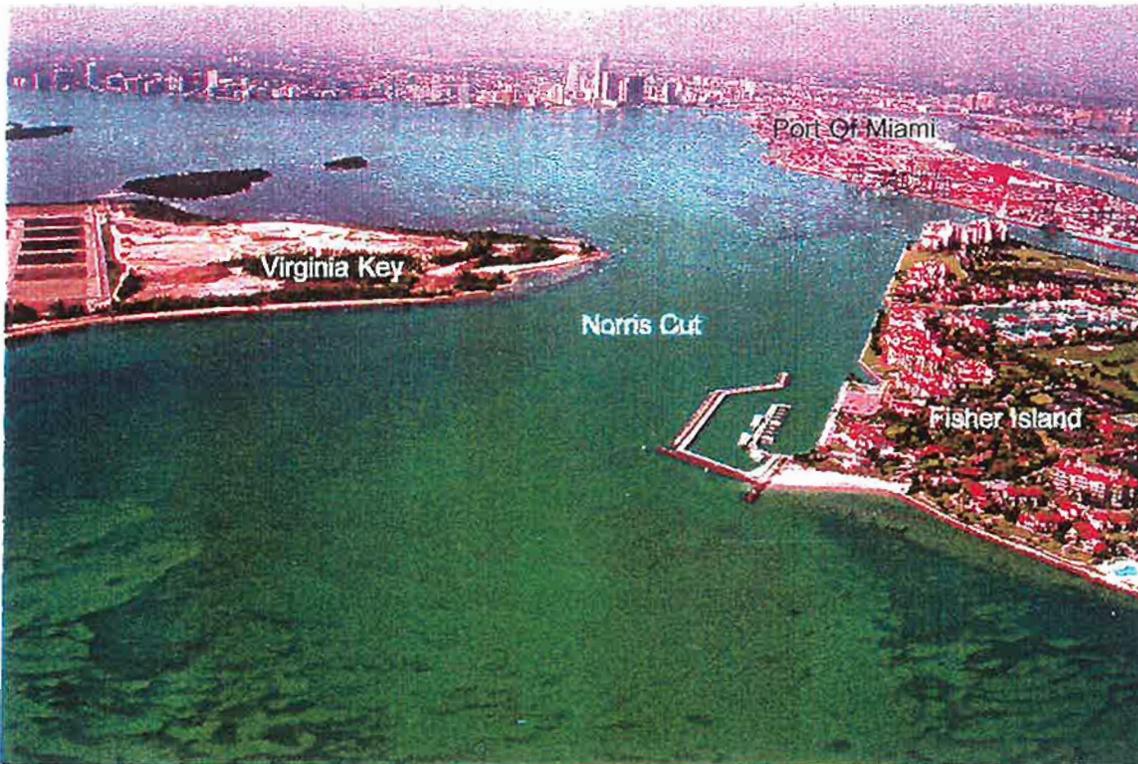
Photo A.3 - Westerly view across Norris Cut located between Virginia Key and Fisher Island. The Port of Miami is visible in the upper right.

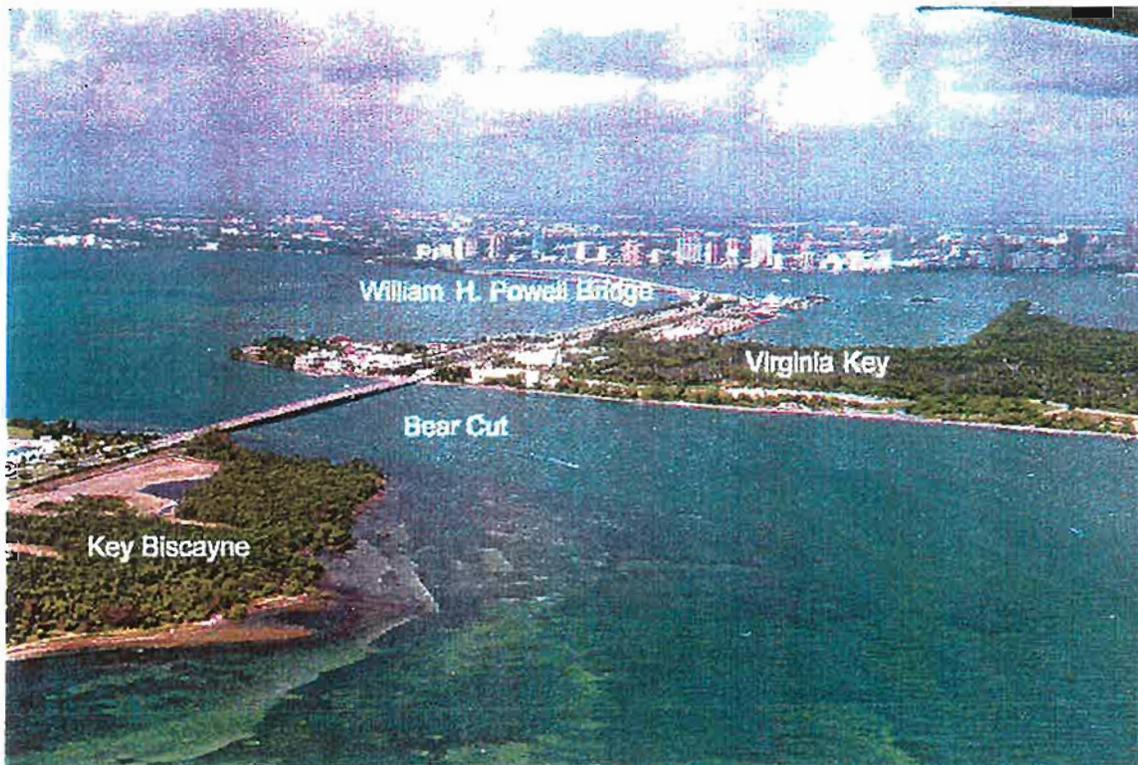
Photo A.4 - View of Bear Cut looking northwesterly across Virginia Key and the William H. Powell Bridge.

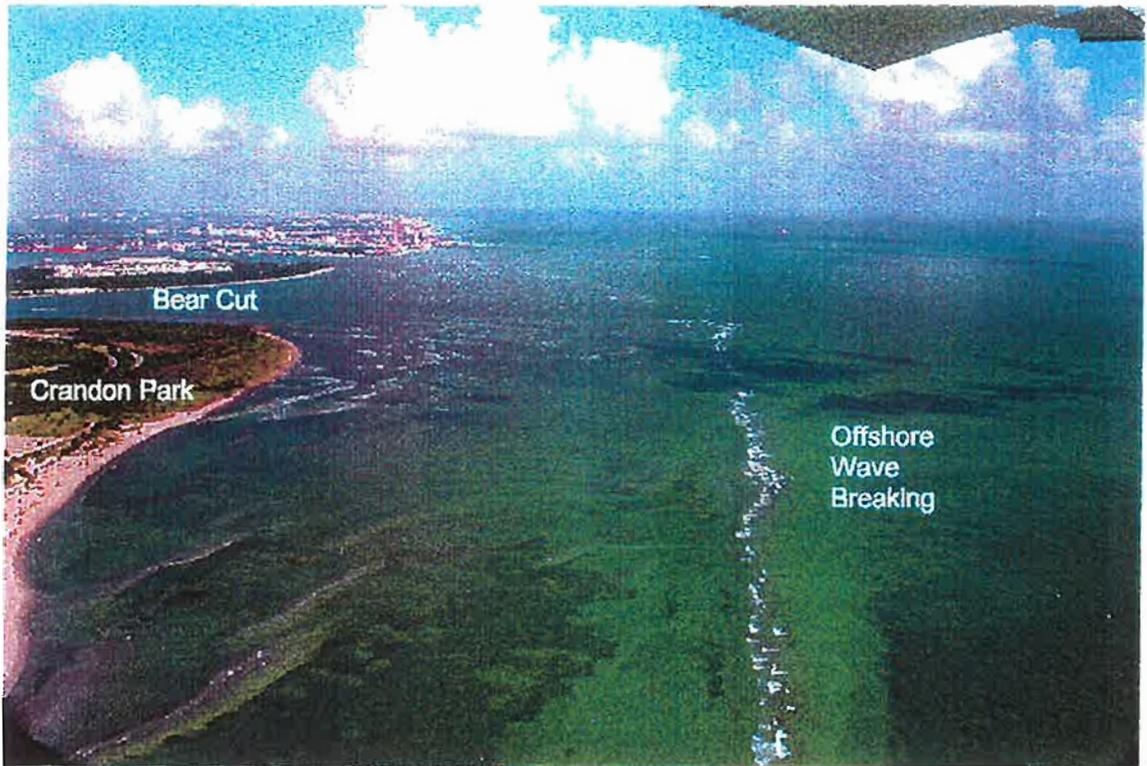
Photo A.5 - Northerly view offshore Crandon Park showing distinctive line of wave breaking along the north shoal area.

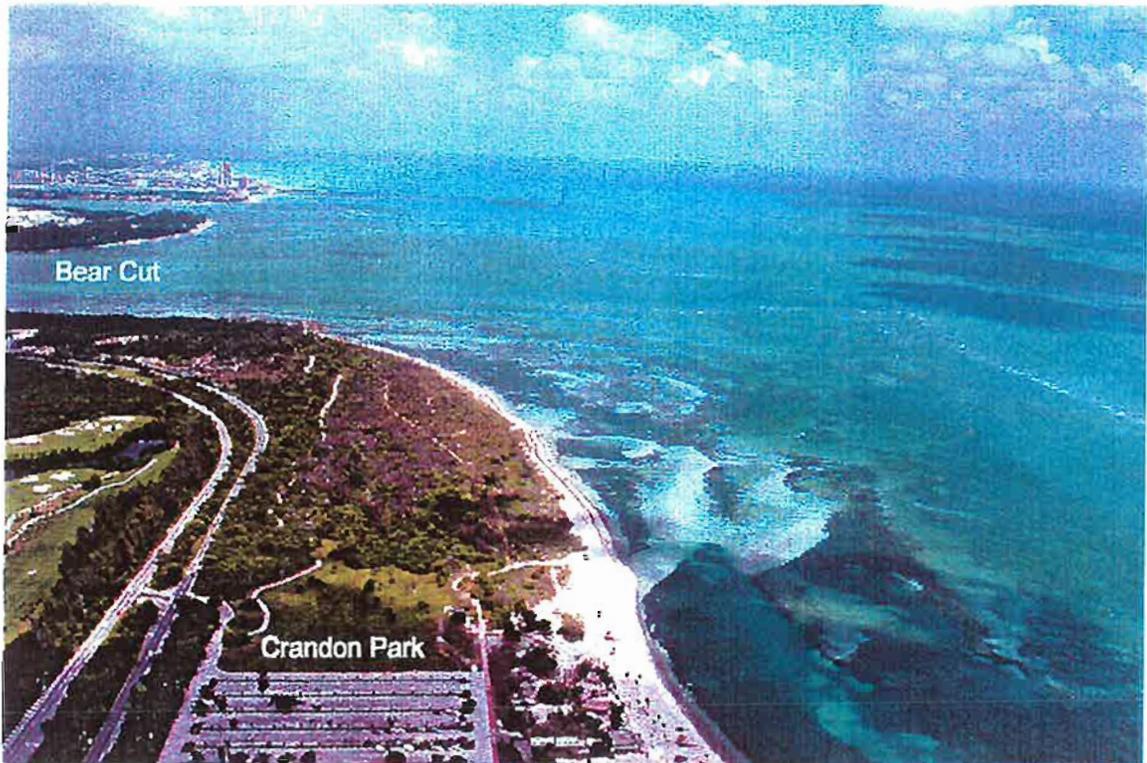
Photo A.6 - Northerly view towards Virginia Key, Fisher Island, and Miami Beach showing active littoral movement within the nearshore seagrass along north Crandon Park.

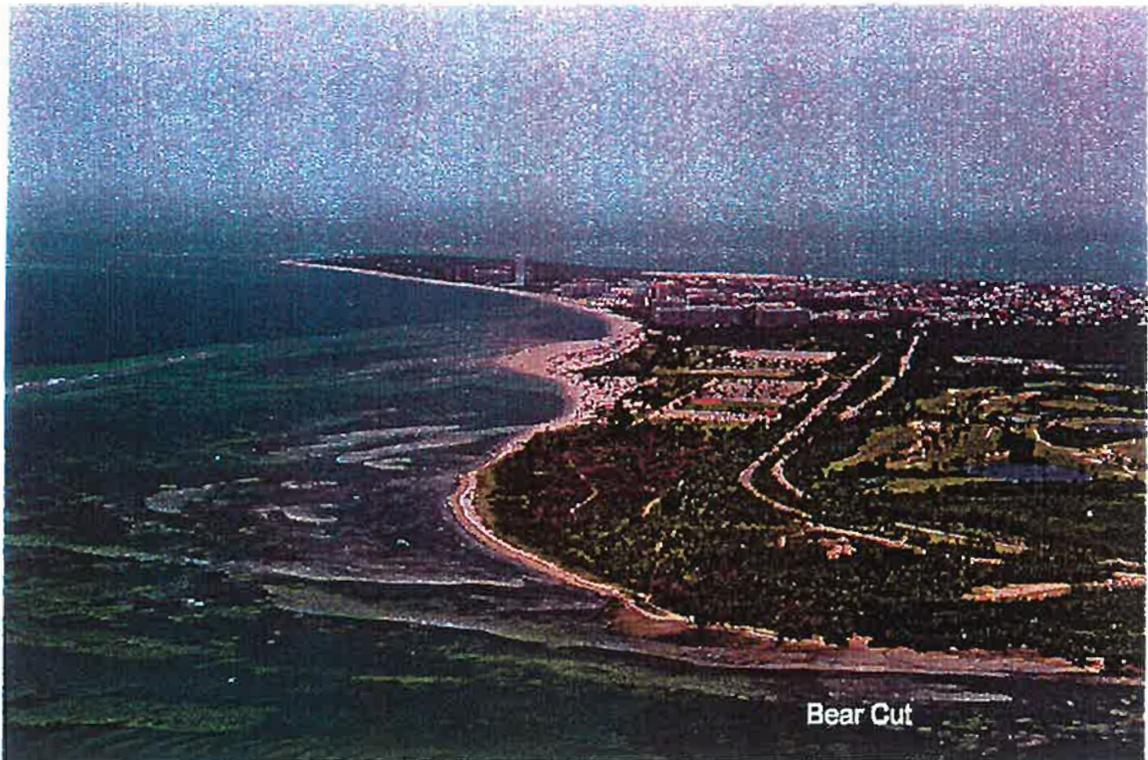
Photo A.7 - Southerly view showing extent of the Key Biscayne Atlantic shoreline. Bands of littoral sediment denote active sand movement within the vicinity of Bear Cut and the north ebb shoal area. Note distinct sand spit along Crandon Park.

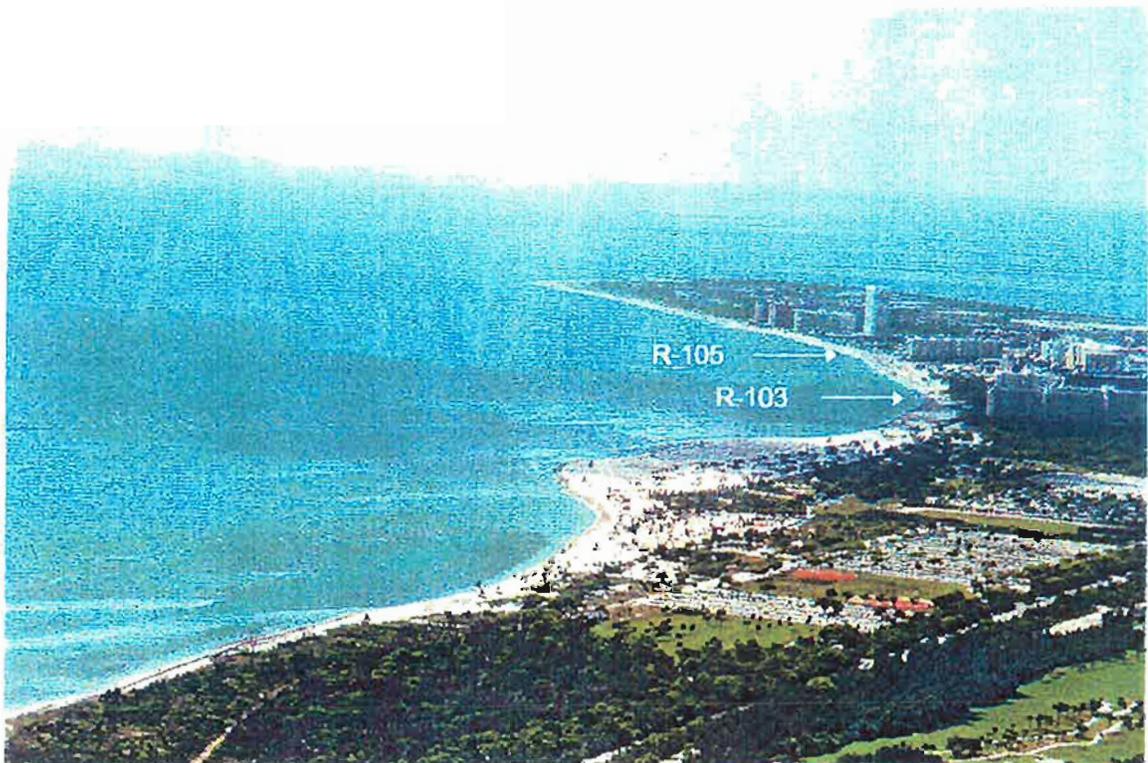
Photo A.8 - Southerly view across Crandon Park with the Village and Bill Baggs State Park beyond. Shoreline indentations are visible at R-103 and R-105 hot spots.

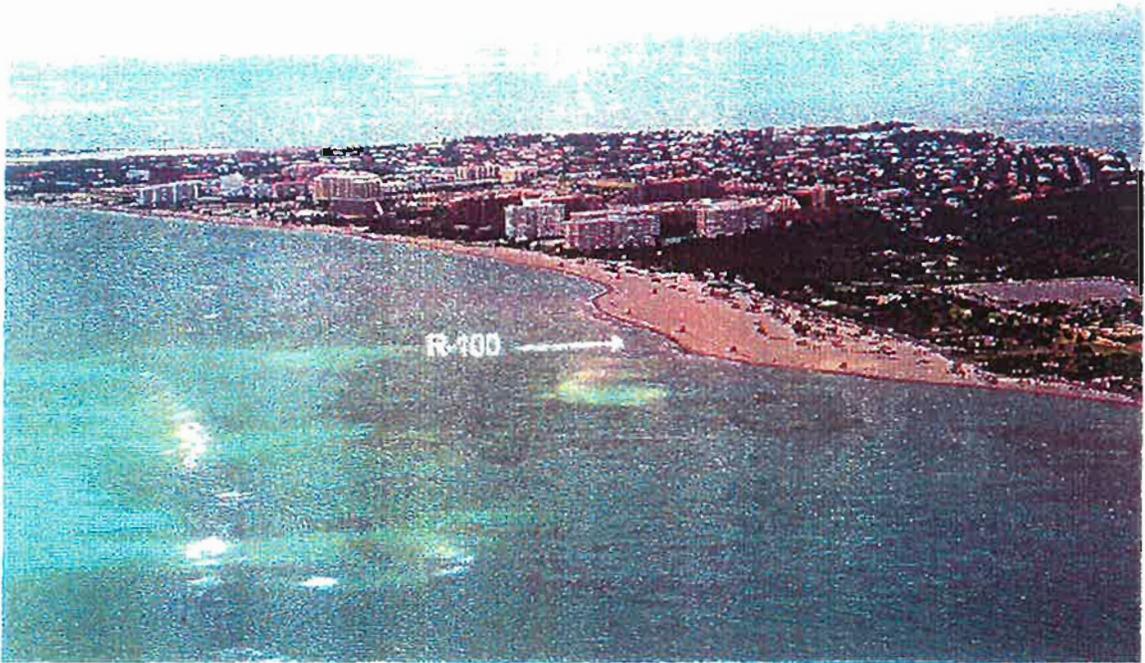
Photo A.9 - Southwesterly view further south along Key Biscayne showing extent of shoreline sand spit at Crandon Park near R-100.

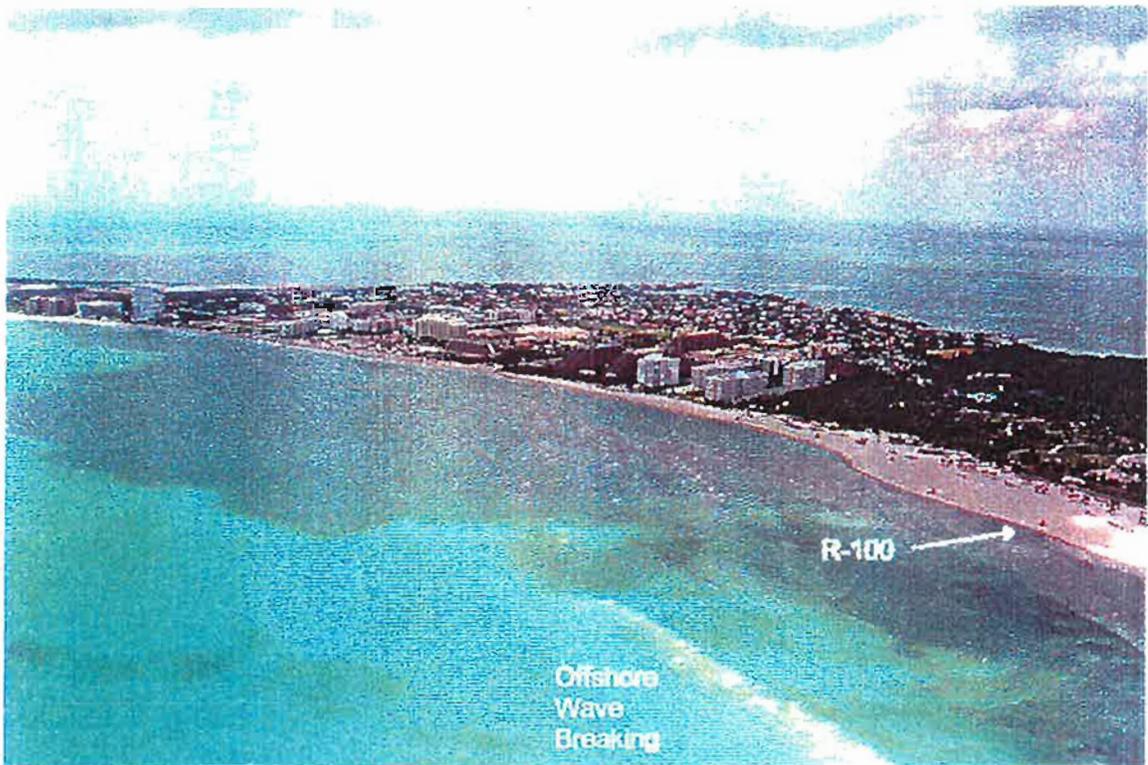
Photo A.10 - Another southwesterly view across south Crandon Park/north Village showing extensive shoreline spit near R-100 within the Park. Note wave breaking offshore along north shoal area.

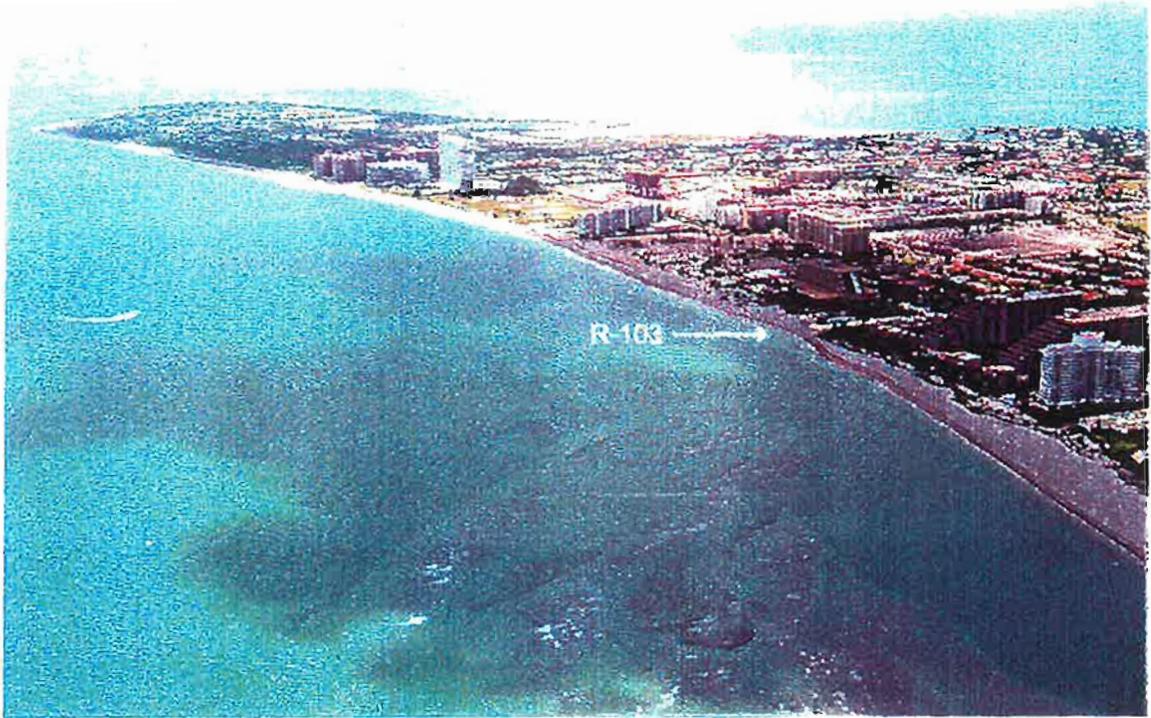
Photo A.11 - Southwesterly view across the Village showing R-103 hot spot transitioning to a wider shoreline towards Crandon park to the north.

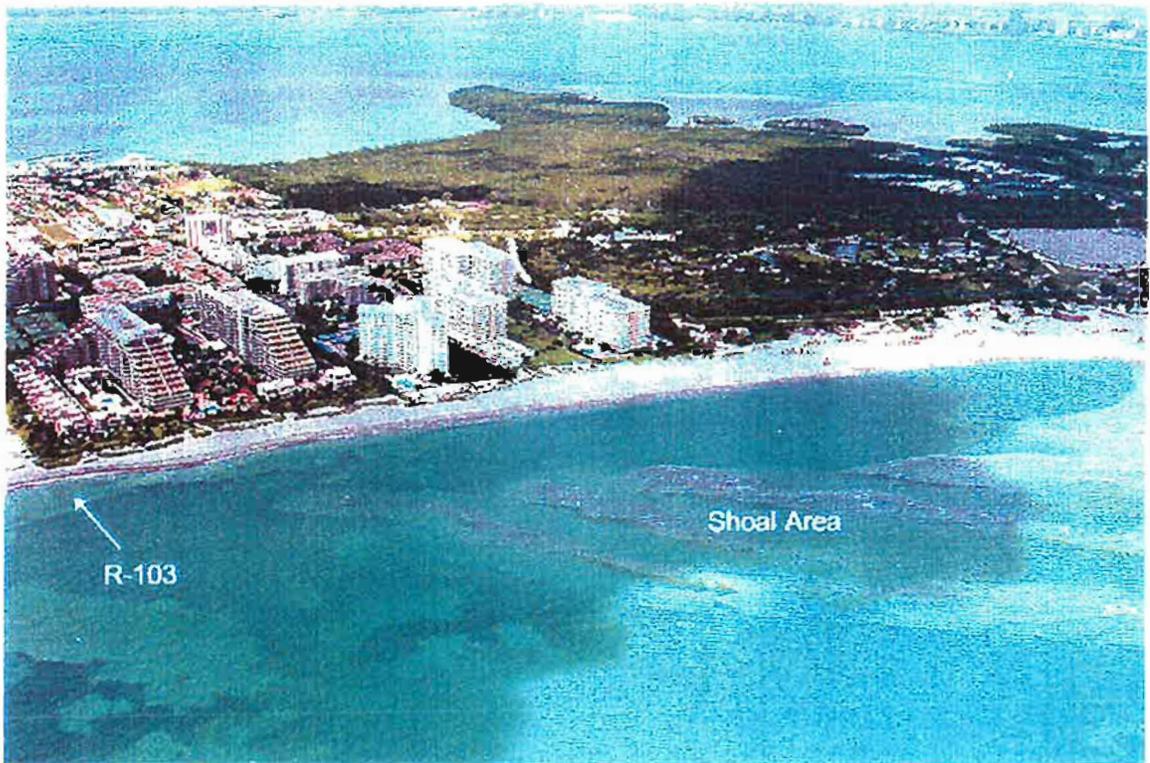
Photo A.12 - Westerly view across the north Village shoreline. R-103 hot spot is visible at far left with extensive shoal formations streaming from the north.

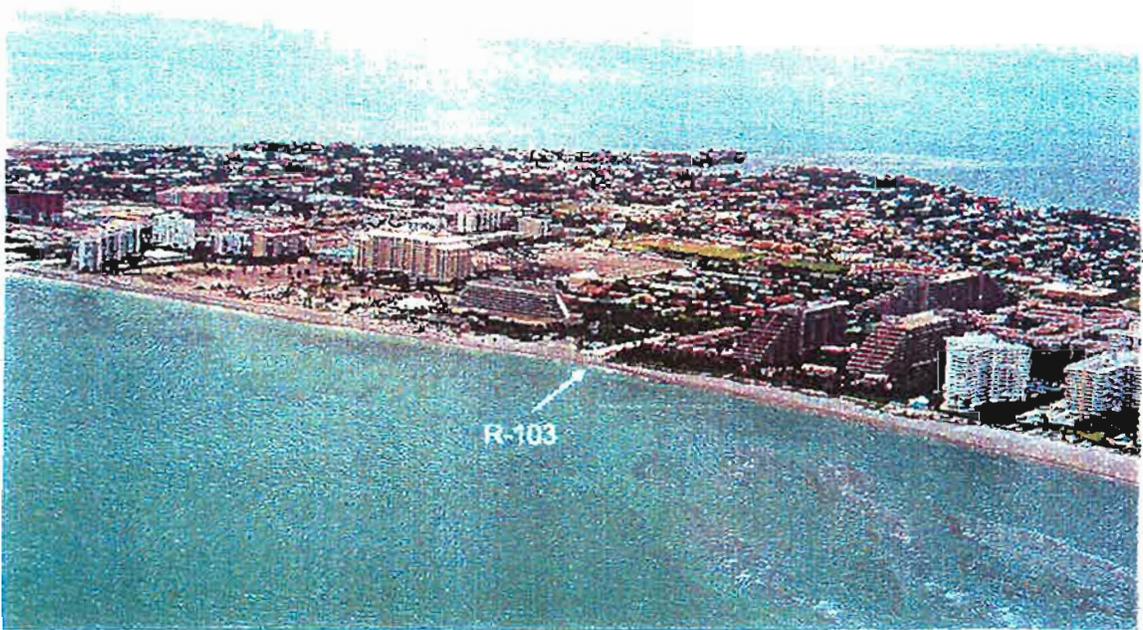
Photo A.13 - West-southwesterly view along Village shoreline. Erosional hot spot near R-103 is visible just south of the Key Colony Condos.

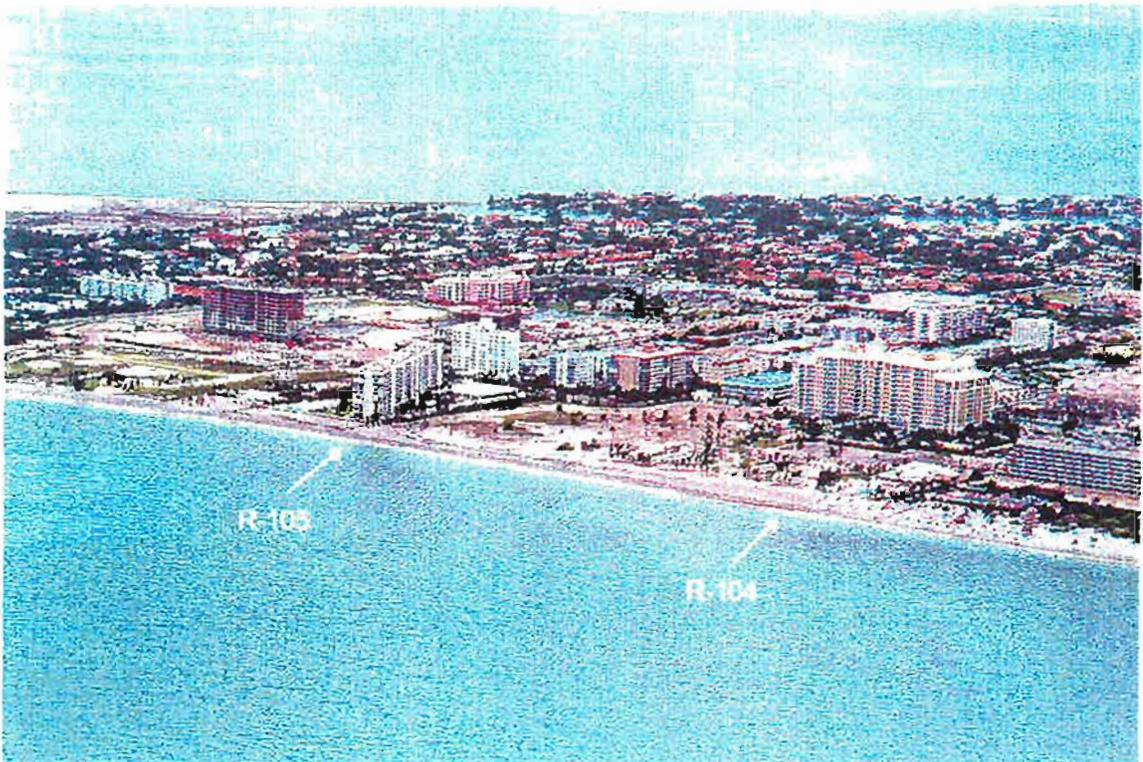
Photo A.14 - View further south looking west-southwesterly across the central Village shoreline showing slightly wider shoreline at R-104 and increased erosion near R-105.

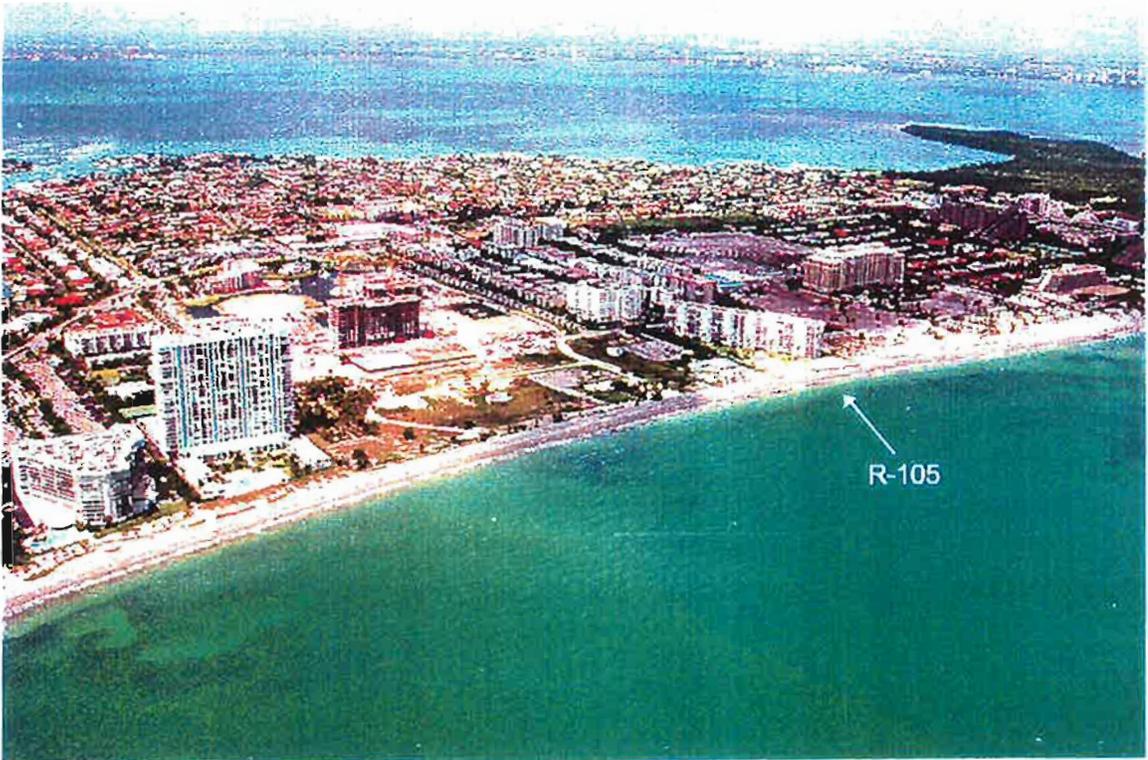
Photo A.15 - Northwesterly view further south along the Village shoreline showing visible cross-shore sand movement in the nearshore area and high erosion at R-105.

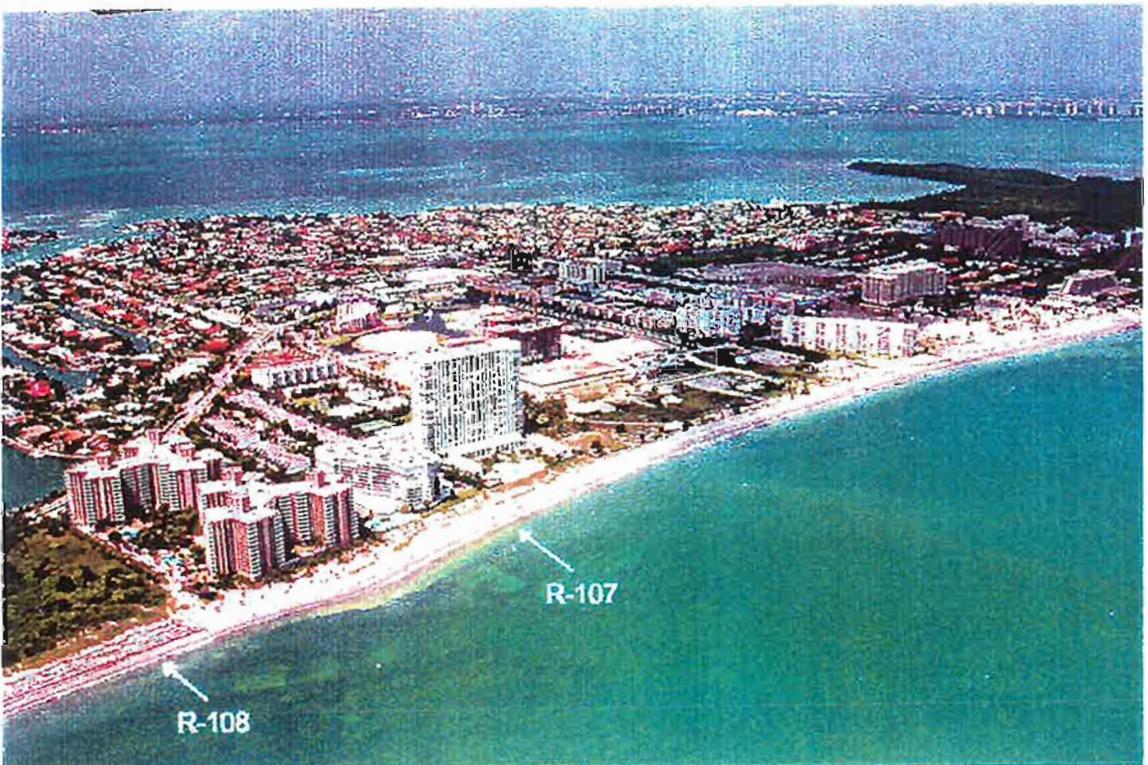
Photo A.16 - View looking northwesterly across the southern shoreline of the Village. Note small natural sand spit in front of the Towers of Key Biscayne between monuments R-107 and R-108.

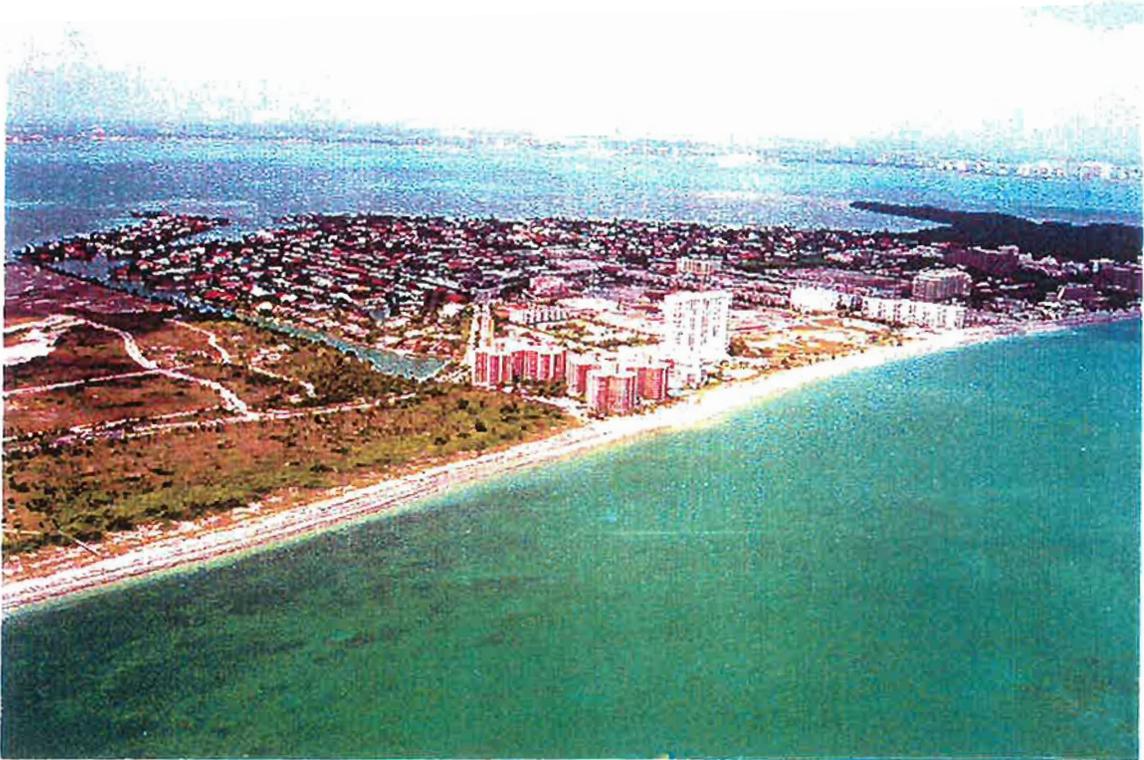
Photo A.17 - Northwestern view along the south shoreline showing northern Bill Baggs State Park, Village of Key Biscayne, and Biscayne Bay beyond.

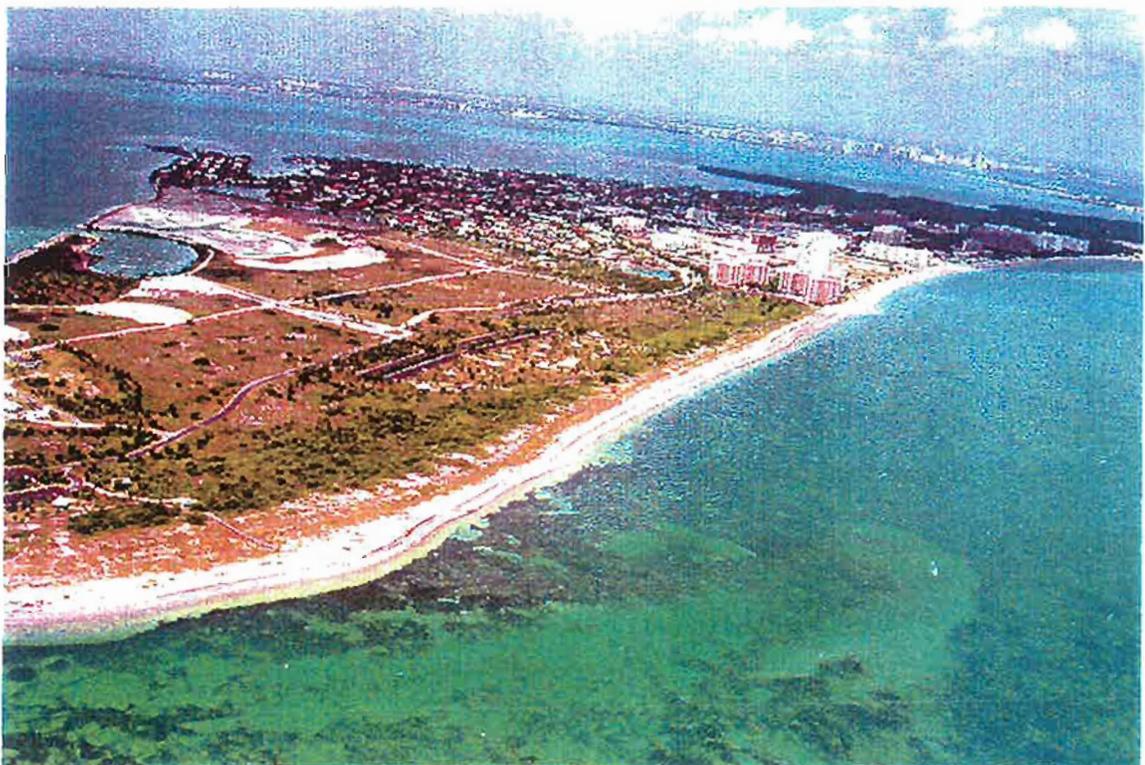
Photo A.18 - Northwestern view across undeveloped shoreline along Bill Baggs State Park. Note extensive seagrass beds in the nearshore.

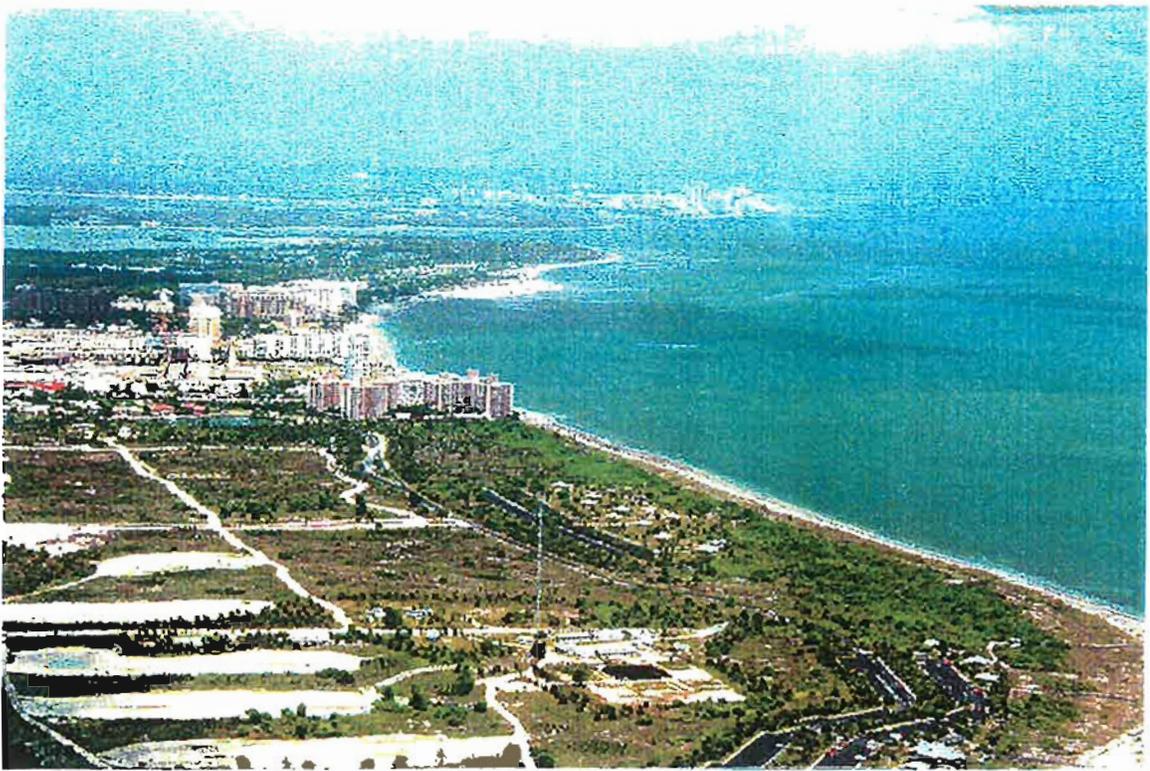
Photo A.19 - Northerly view with Bill Baggs State Park in the foreground, the Village of Key Biscayne and Crandon Park beyond.

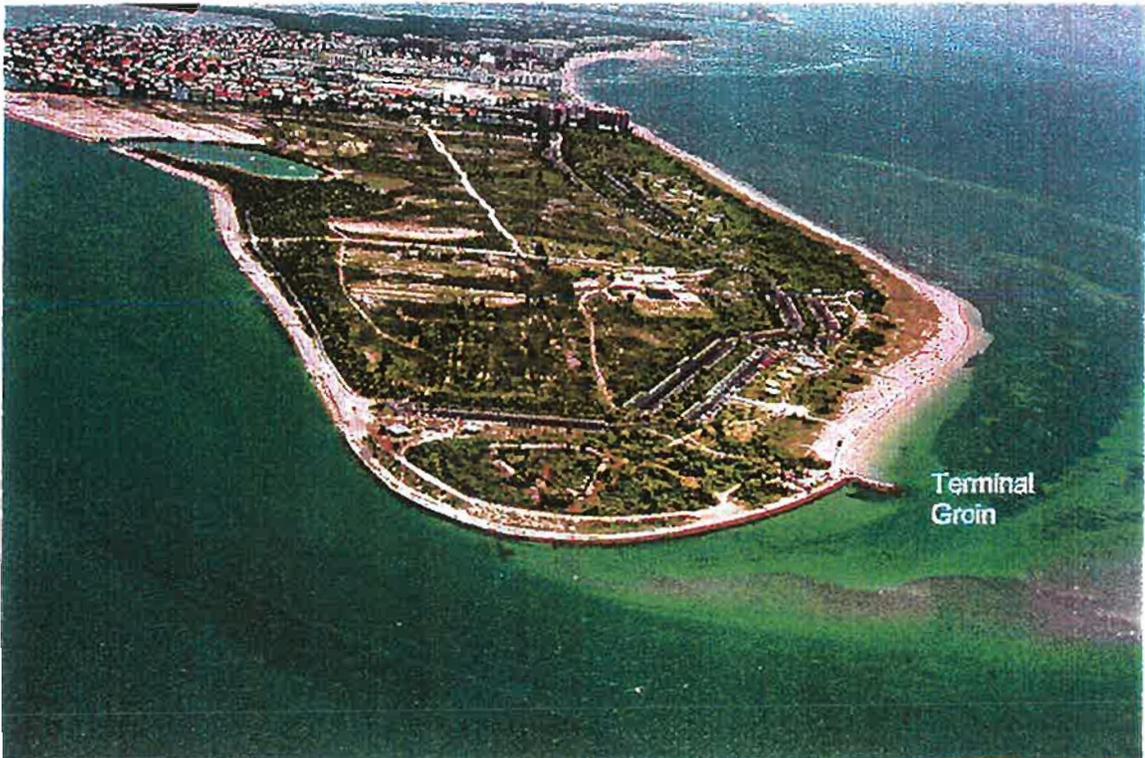
Photo A.20 - View looking northerly across the southern tip of Key Biscayne. Terminal groin near the lighthouse in Bill Baggs State Park marks the southern end of the Key Biscayne Atlantic shoreline.
