Master Landscape Plan

The Village of Key Biscayne

Working Paper I: *Inventory and Analysis of Existing Conditions*

January 20, 2009

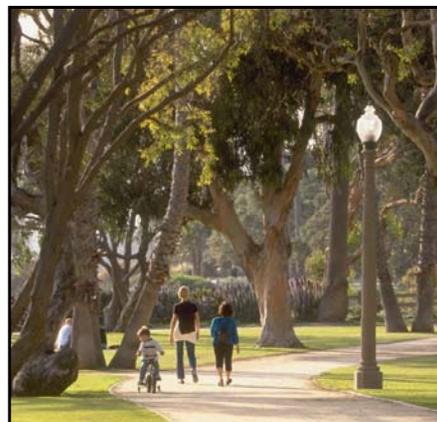
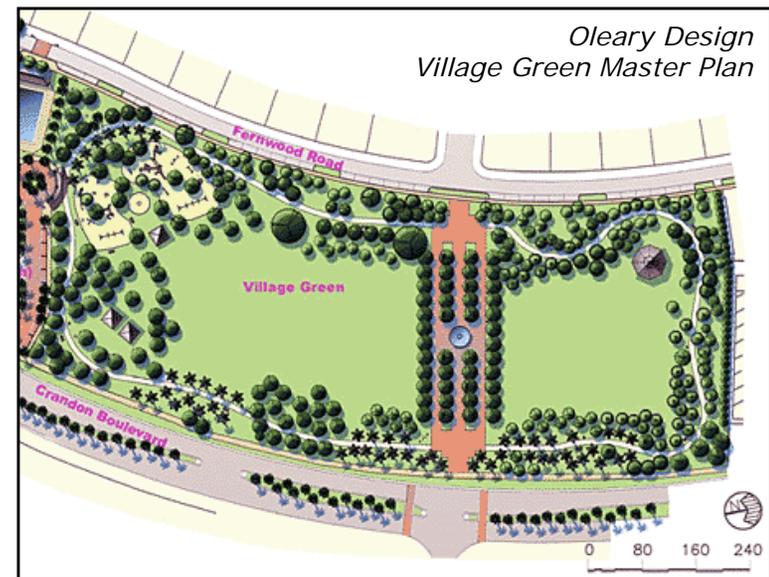
Village Green: Landscape Character & Condition

- Plant species and locations feel random—except for the Coconut and Kapok (Witness) trees, which have historical significance in this space.
- Vegetation does little to define space.
- Tree canopy coverage—in the non-recreation areas—is less than 30%.
- More shade is needed.
- Vegetative screening along the north boundary is minimal, resulting in views of adjacent buildings that interrupt the park setting..

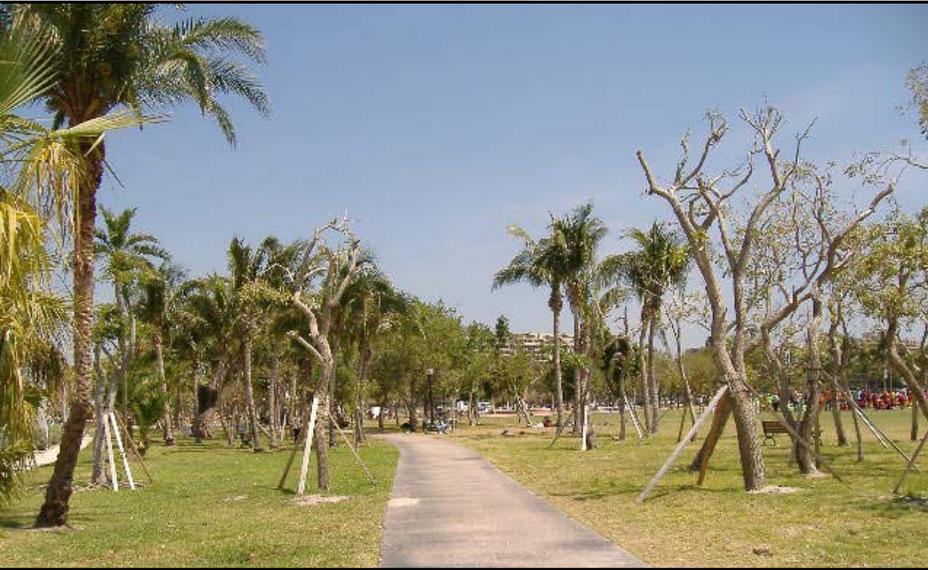
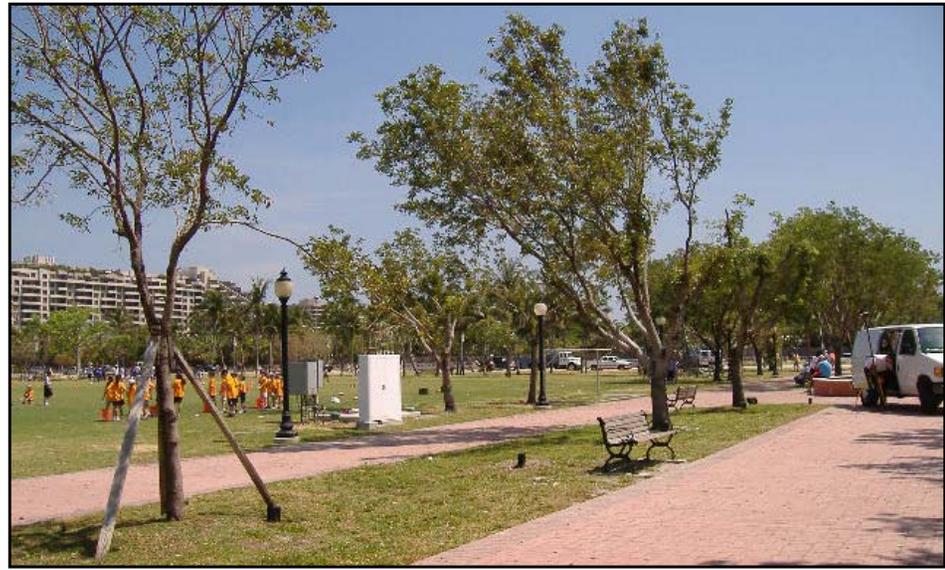
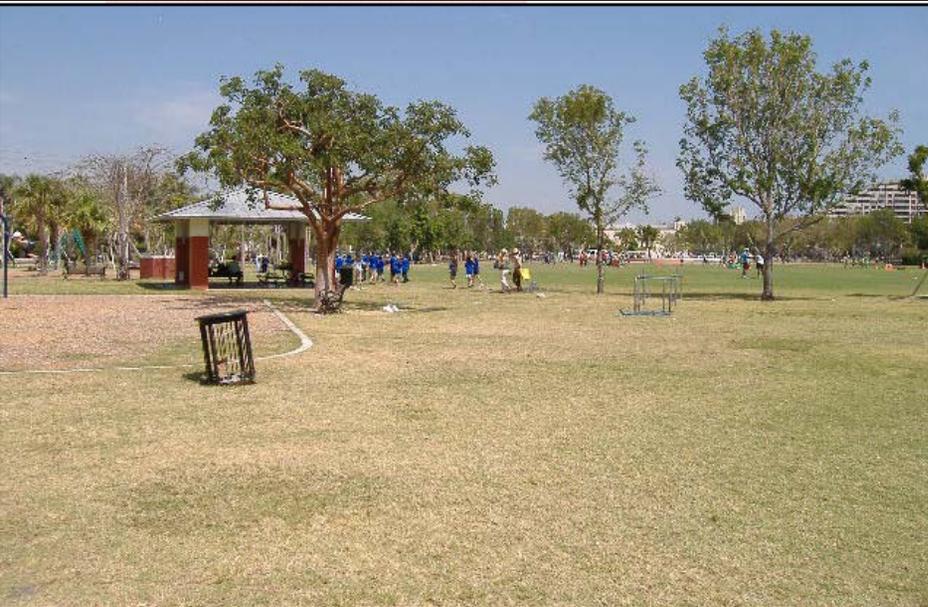
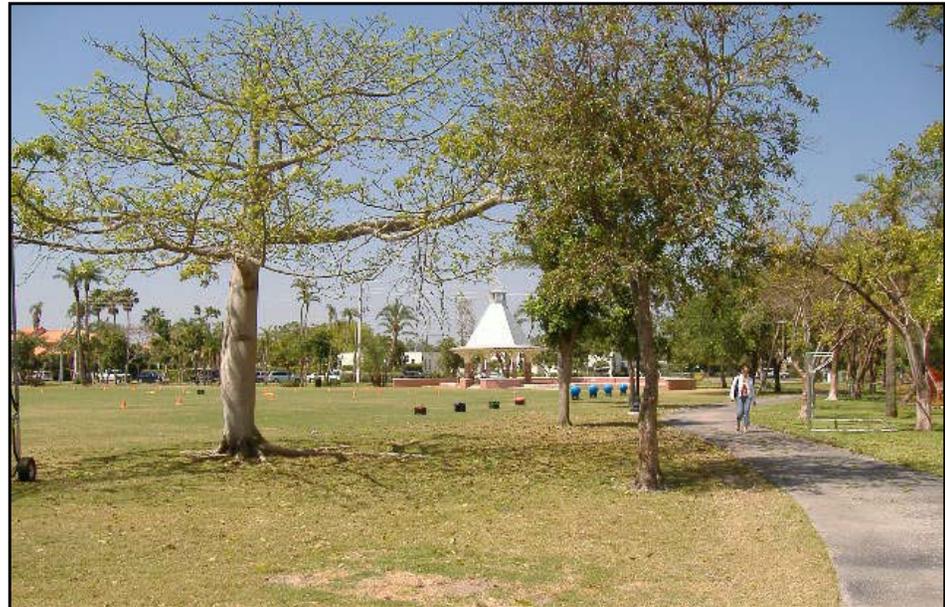
Village Green: Urban Design & Infrastructure

- Pedestrian circulation:
 - Pathway locations and widths are generally compatible with everyday park use.
 - Good access to desired locations
 - Generally good inter-connectivity
 - The Promenade is scaled for event use—when not in use the corridor feels un-inviting.
- The Stage area (north end of the park) gets minimal non-event use due to lack of site amenities, such as seating.
- Overhead power lines run along the west boundary of Village Green, resulting in visual clutter and poor street tree growth in several locations.
- Utility boxes are visible (un-screened) along edges of Village Green and Promenade.
- Storage of soccer goals at north end of park creates visual clutter and contributes to tree damage.
- Stormwater drainage problems were not evident during site reconnaissance.

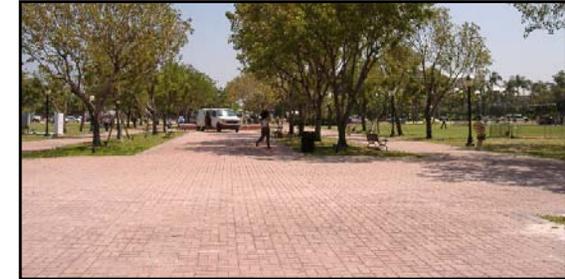
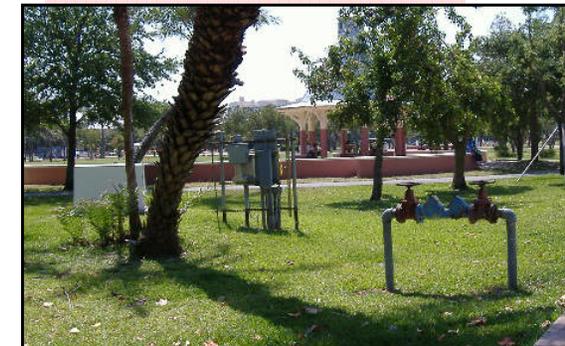
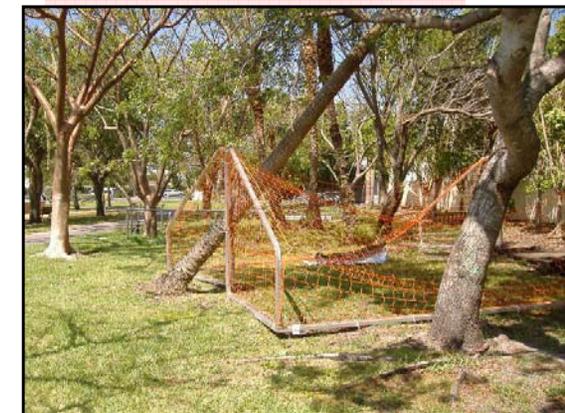
Village Green: Amenities

- Pathways are predominantly Asphalt, with surface-color variations resulting from repairs.
- Coral colored concrete unit pavers are used at entry points and throughout the Promenade.

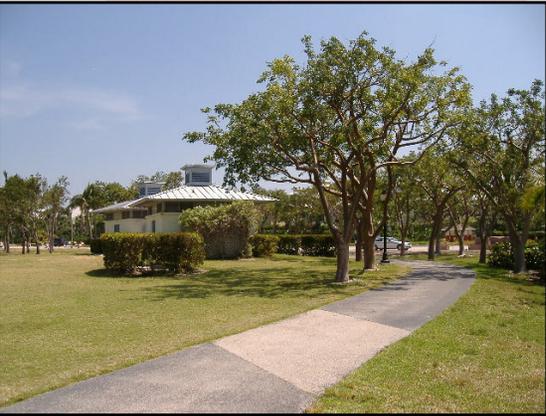
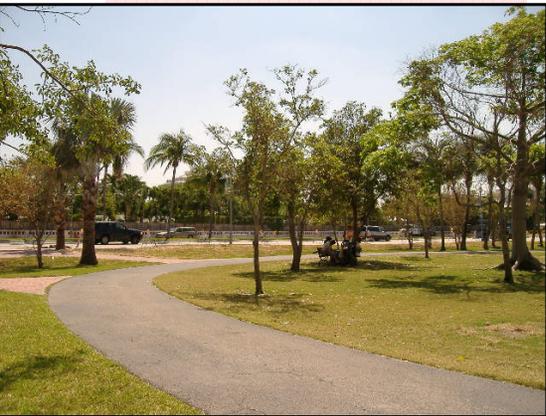
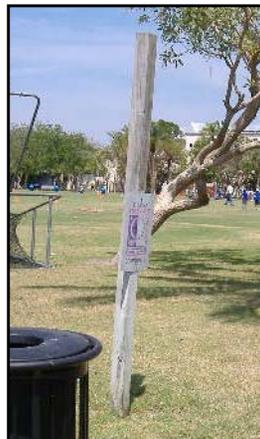
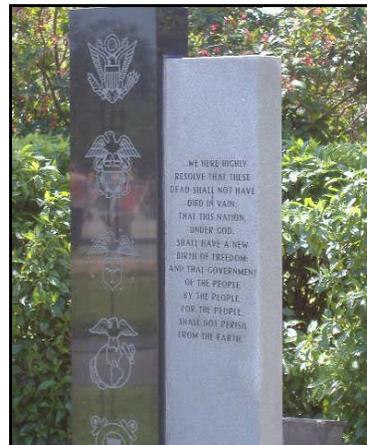
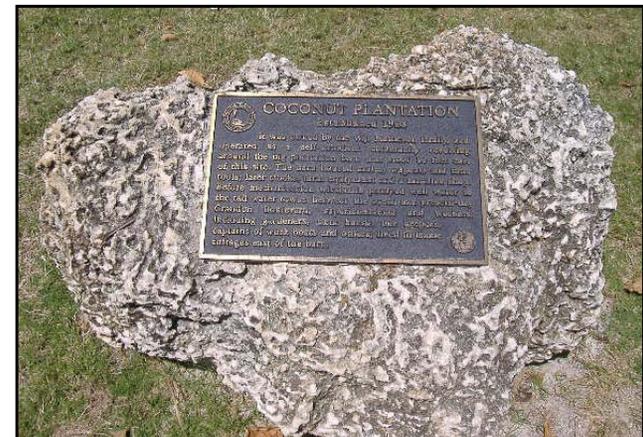
- Granite War Memorial; historic markers—Bronze plaques on “natural” limestone boulder bases; and wooden posts with metal instructional signs.
- Absence of entrance or wayfinding signs that identify the park as the “Village Green” or “Tree Farm Park.”

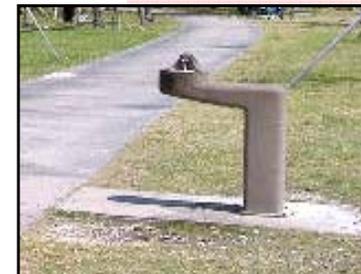
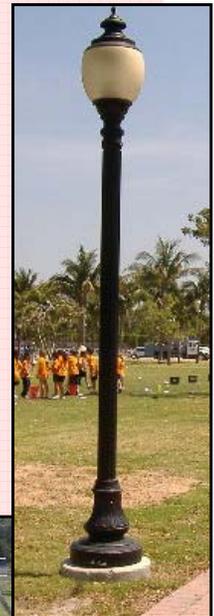
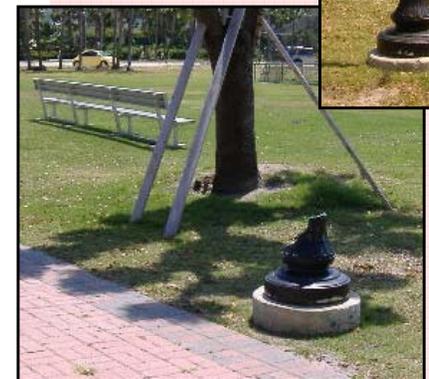
- Village standard furnishings are used in the Village Green:
 - Benches: Victor Stanley C-10 model, wood with black painted metal.
 - Trash Receptacles: Landscape Forms Scarborough Litter Receptacle in black.
 - Light Fixtures: Lumec Traditional Globe Series L23/L50 Luminaire mounted on 9-foot Spring Hill Capistrano cast aluminum post, painted black.
 - Drinking Fountains: Concrete cantilever
- Extant non-standard fixtures/furnishings:
 - Temporary aluminum one-level bleacher seating near athletic field area
 - Flagpoles at war memorial near Crandon Blvd.
- Inadequate seating opportunities along perimeter pathways.
- Significant site furnishings damage evident during reconnaissance.
- Approximately 30% of extant lighting not functioning.
- The illuminated fountain animates the park at night.

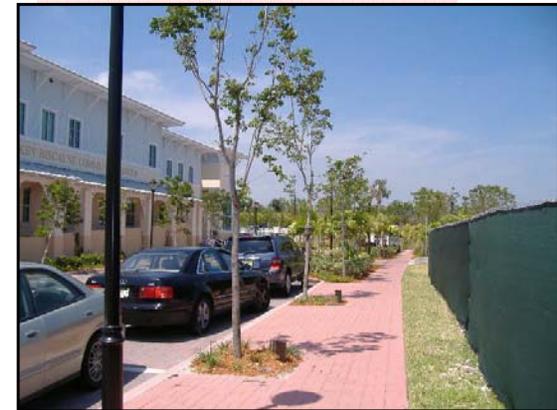
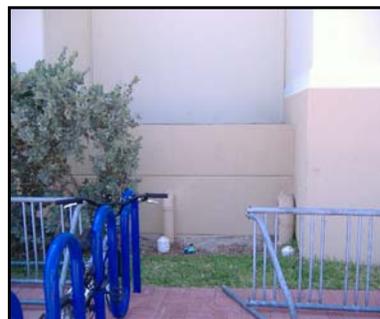
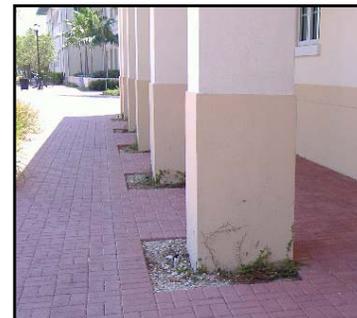
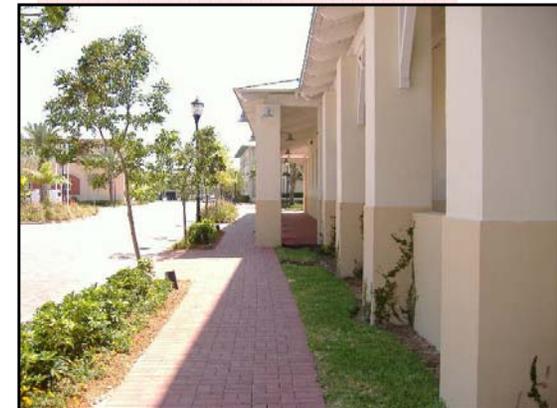
- The key elements of the Civic Center are the Village Hall, Fire Station, Community Center, oval/fountain area, surrounding streets, and surface parking lots.
- The Civic Center is new construction—all completed within the last 10 years.
 - Plants are immature due to new construction.
 - Inconsistent plant species between civic buildings.
 - Some species are not adapting to sites—harsh conditions, improper irrigation, etc.
 - The east side of the Community Center building and adjacent bike rack areas are sparsely planted and/or lack foundation plantings.

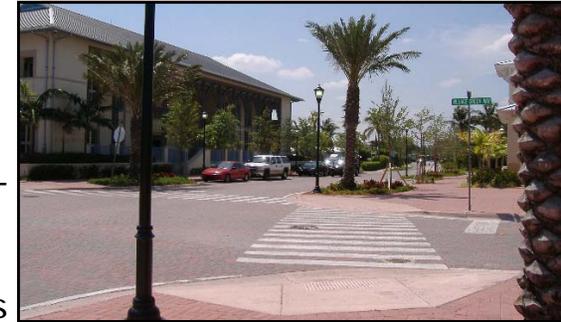
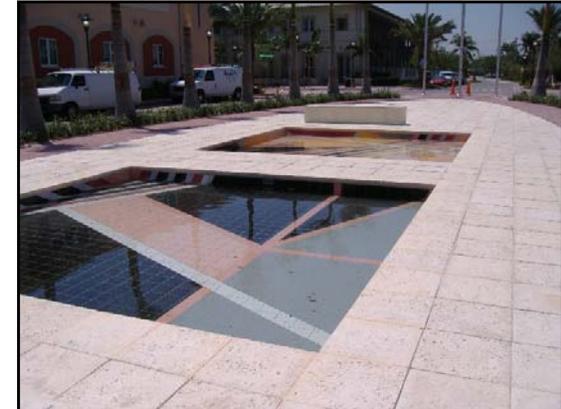
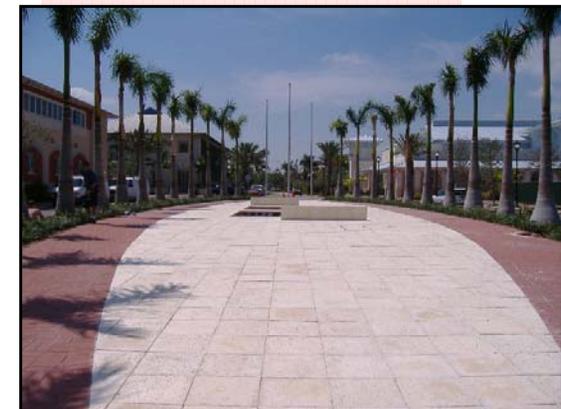
- Pedestrian and vehicular circulation work well. Visibility is good at critical vehicular/pedestrian conflict zones (intersections/crosswalks).
- The scale and pattern of the streetscape elements create a pedestrian-friendly environment.
- The scale and configuration of the McIntyre Street oval space suggests it was designed as an event space. Empty of people, it appears arid.
- The fountain/artwork is a destination lacking the human-scale amenities that encourage visitors on non-event days.
- Seating within the Civic Center area is minimal, with the only benches observed within the McIntyre Street oval.
- East/west overhead utility lines exist in parts of the civic center.
- No stormwater drainage problems observed.

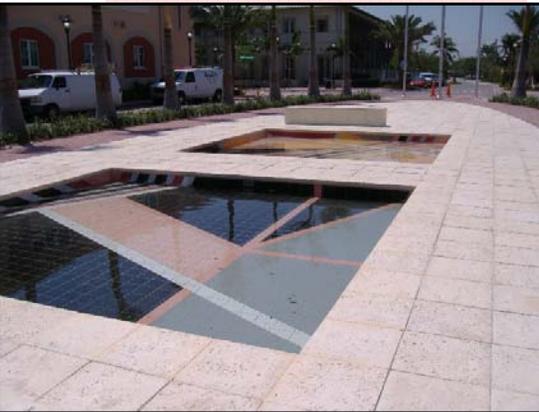
- Pavement:
 - All surfaces are new and in good condition.
 - Coral-colored concrete and concrete unit pavers, and burgundy/black cobblestone are the primary materials used as paving hardscape.
 - Some of the side streets and the Village Hall parking lot are asphalt.
- Art/Fountain:
 - The tile surfaces are in good condition, but the unique pattern/color tiles could be a long-term maintenance/repair issue.
 - The art fountains do not have standard drains and filters, which will be a maintenance and water-quality issue.

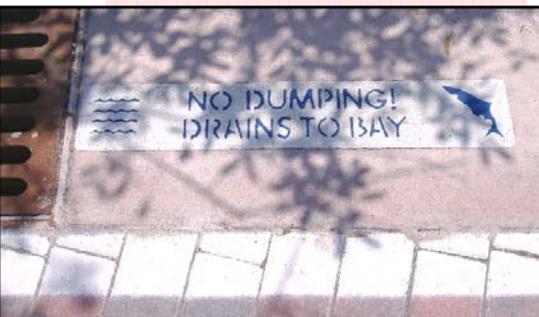
- Signage throughout the civic center is minimal. Street signs are standard metal with u-frame posts.
- ***Decorative wayfinding signage was not observed.*** The Village Civic Center is not identified by gateway signage.
- All storm drain inlets are labeled to help educate and prevent dumping.

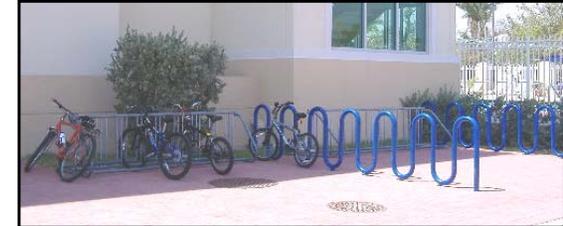
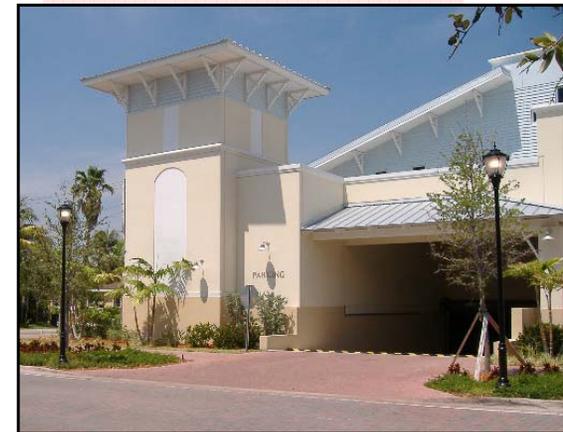
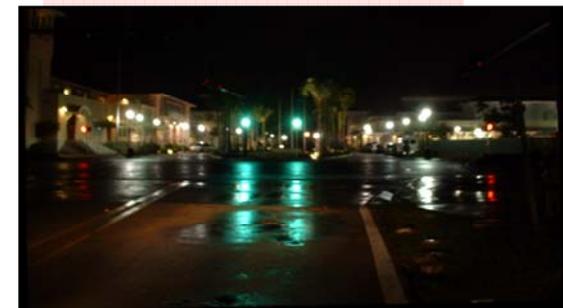
- Blue powder-coated bike racks and exposed aluminum bike racks are mismatched near community center.
 - Blue bike racks are Village standard TimberForm CycLoops original painted blue.
- **No benches were observed, except for the built-in stone benches in the oval/fountain area.**
- **No litter receptacles were observed.**
- Matching decorative, pedestrian scale light fixtures line the streets throughout the civic center. Light fixtures used are the Village standard.
- Light levels at night are very high. The Civic Center is the most noticeable area of the Village at nighttime. Noticeable light-trespass from the Civic Center to neighboring properties was evidenced during site reconnaissance.
- **All streetlights were observed illuminated at 1:00 in the afternoon.**

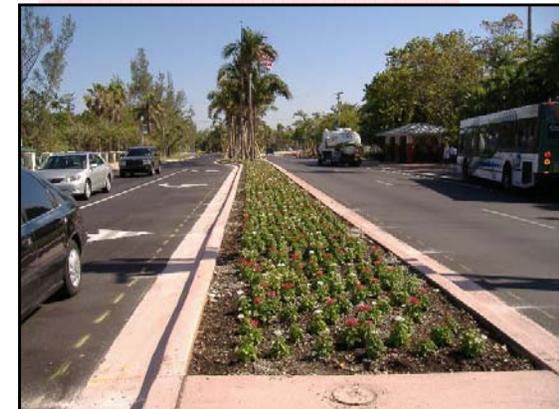
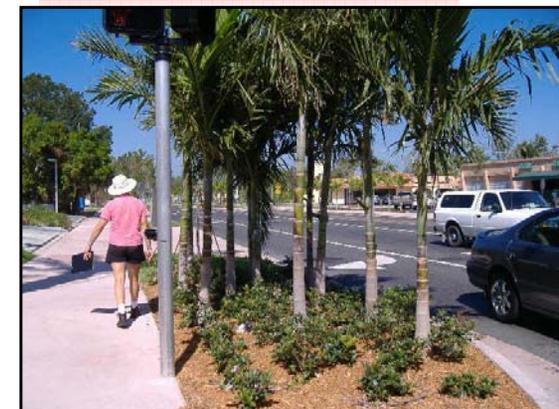
- Large annual planting beds require seasonal replacement and frequent irrigation, fertilization, and maintenance.
- Clusters of palms and shrubs at intersections may create visibility issues at critical pedestrian/vehicle conflict zones.
- Live Oak street trees planted along improved Crandon Boulevard should supply much needed tree canopy when they mature.
- Augmentation of existing coconut palm plantings successfully enhances the island aesthetic, and provides an attractive reference to the island's history.

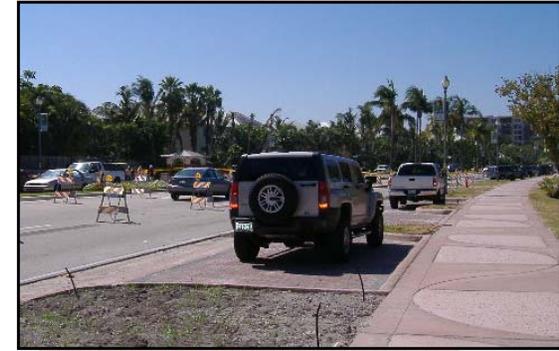
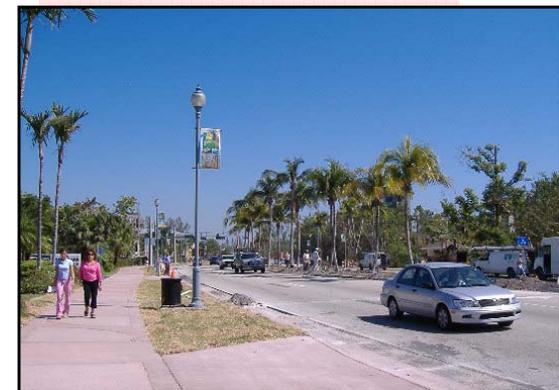
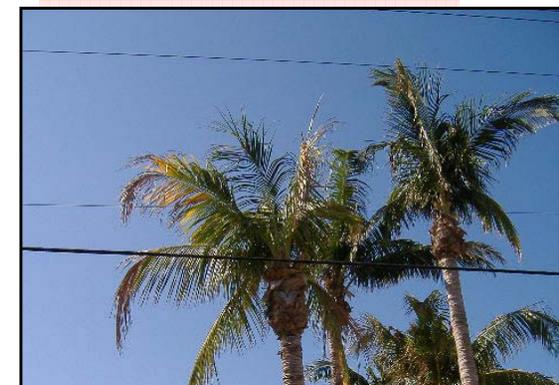
- The scale of vehicular and pedestrian circulation is improved, with better pedestrian crossings, continuous sidewalks, and enhanced traffic calming devices such as textured crosswalks and reduced corner radii.
- New on-street parking is located adjacent to the Village Green. The parking spaces are extra wide, which establishes a distinct clear-zone from on-going traffic. However, on site visits we did see confused parking patterns—combined angled and parallel parking within similar sections of the Boulevard.
- Stormwater drainage functions properly. However, Crandon Boulevard stormwater is piped directly to discharge points at Pines Canal and Canal Hacienda—any litter or pollutant runoff eventually reaches Biscayne Bay.
- Overhead utility lines cross and/or parallel Crandon Boulevard in several locations. In some cases the lines conflict with trees.

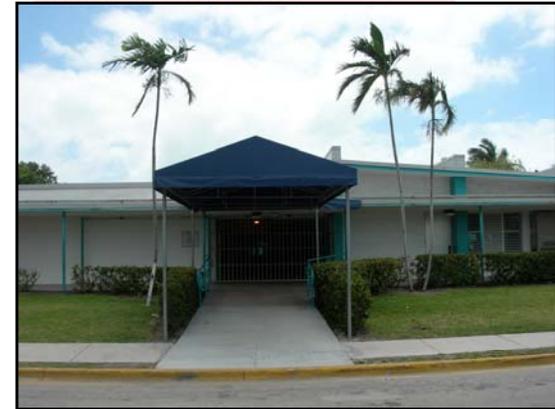
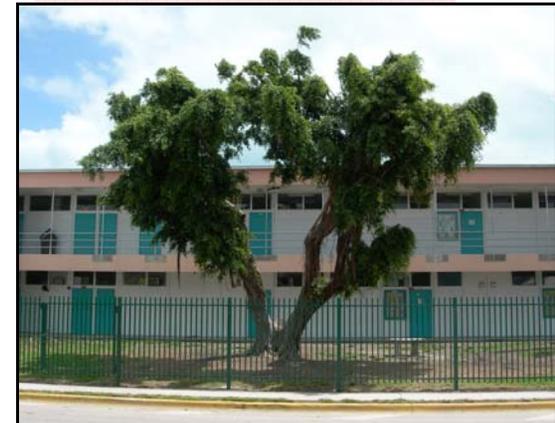
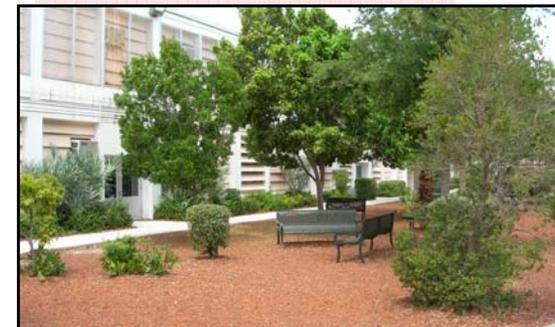
- Additions to the school over time have resulted in a fragmented, inconsistent landscape throughout the school property.
- The landscape is suffering from inappropriate maintenance and some poor plant selections. Some plantings are old and leggy, others are pruned into unnatural shapes, and some are newly planted.
- Shade trees are sparse, damaged, or missing throughout the school property.
- Uncontrolled foot traffic has reduced many sod or mulch areas to bare soil. Circulation improvements are needed to help reduce creation of "cow paths."
- The courtyards are the most inviting outdoor spaces due to shaded seating. However, plantings are sparse and unnaturally pruned.

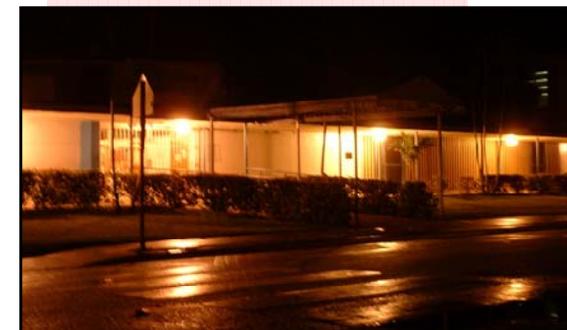
- Benches and tables are not consistent, or consistent with Village standard furnishings.
- Bike racks are Village standard model, but bare aluminum finish rather than blue.
- Fences are in good condition and are painted a consistent dark green throughout.
- Nighttime lighting levels are high. Light trespass was observed from neighboring properties.

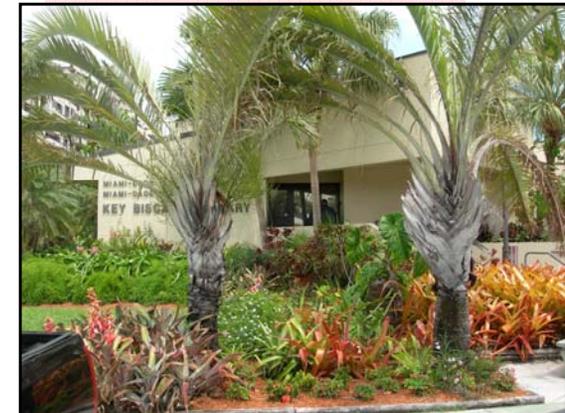
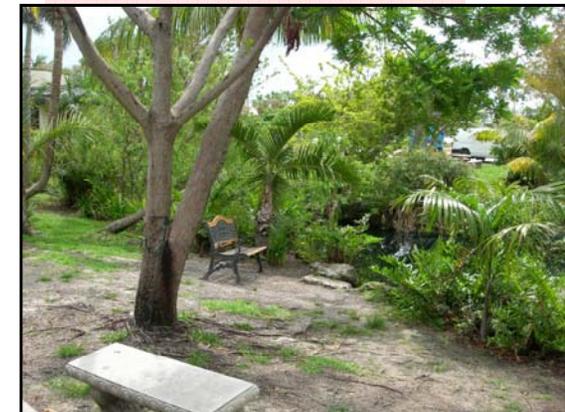
- Community groups have volunteered their time and resources to enhance the library landscape.
- The library landscape has a tropical, botanical garden aesthetic, with a wide variety of plant species and a naturalistic pond.
- The maintenance requirements for the current plantings are much higher than other Village-maintained landscapes.
- In some areas, foot traffic and/or erosion has worn away turfgrass, exposing bare soil and tree roots.

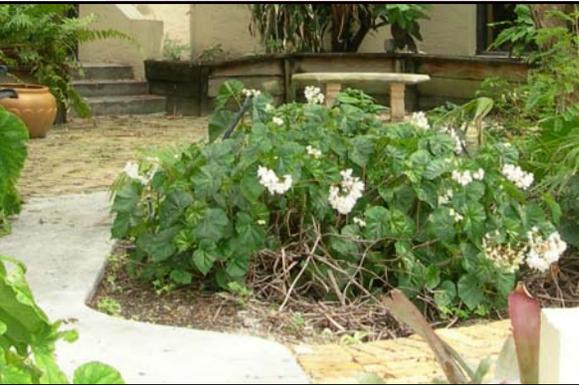
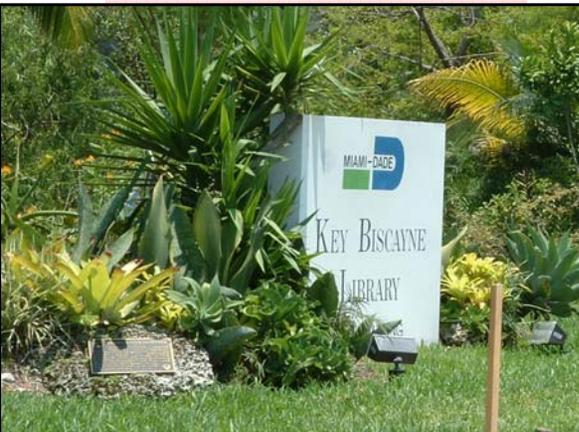
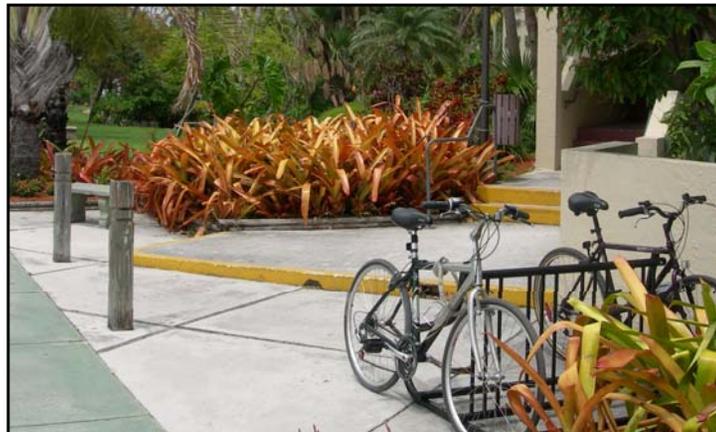
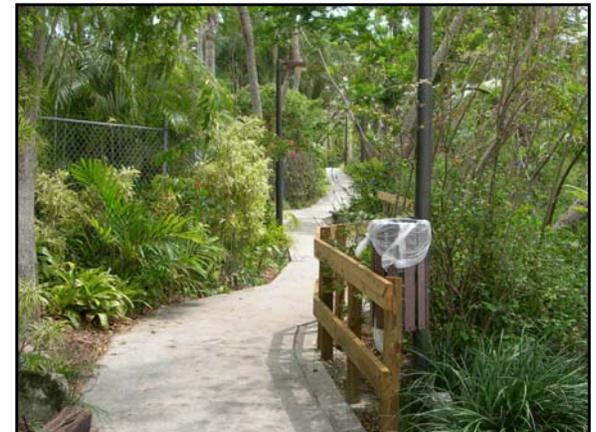
- Standard concrete paths and a tan concrete unit paver entrance plaza are in fair condition, with some blemishes and cracks.
- The standard concrete has a cold feeling that is not consistent with the library 'garden' atmosphere.

- Includes signage on building, a parking lot entrance sign, and a historical bronze plaque on limestone base.

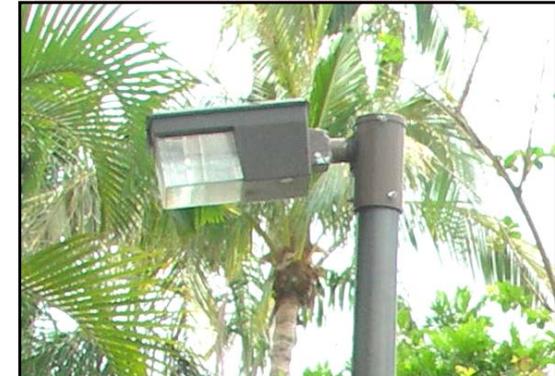
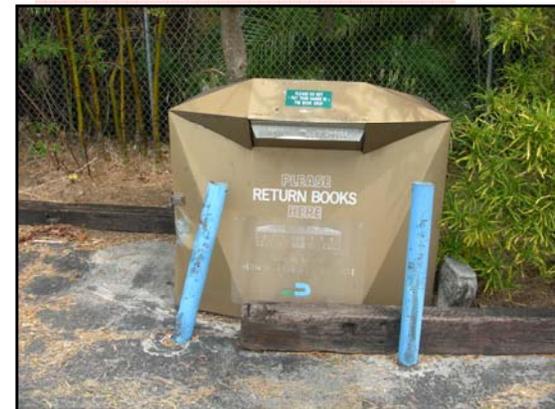
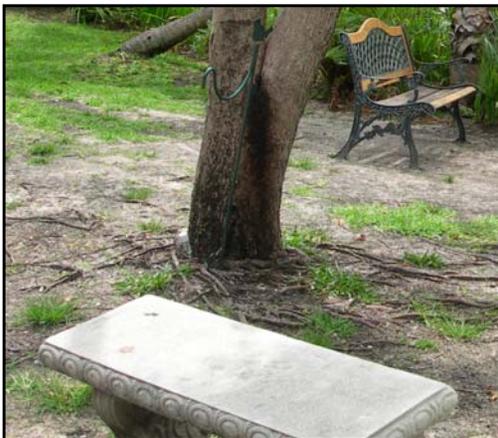
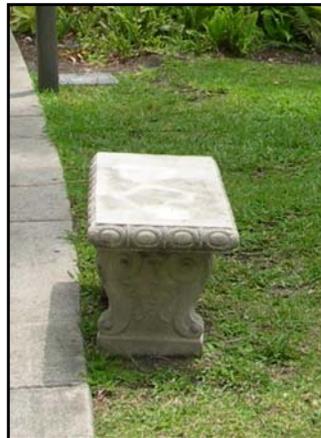
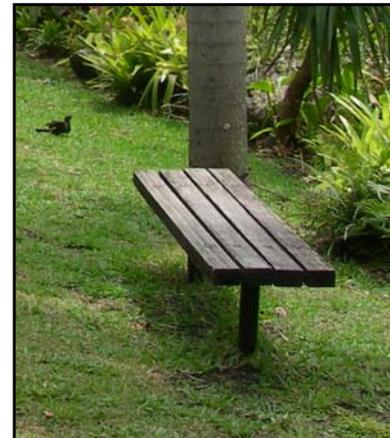
- Furnishings are inconsistent, with classical stone benches placed near modern wooden benches in some locations.
- Fixtures and furnishings should be integrated and adapted to reflect the botanical garden atmosphere of the library grounds.
- The book return receptacle is dented and rusted in places. The bollards in front of it are leaning and have chipped paint.
- Light fixtures are utilitarian and not consistent with the garden aesthetic. They do match the building architecture, and appear to be original.

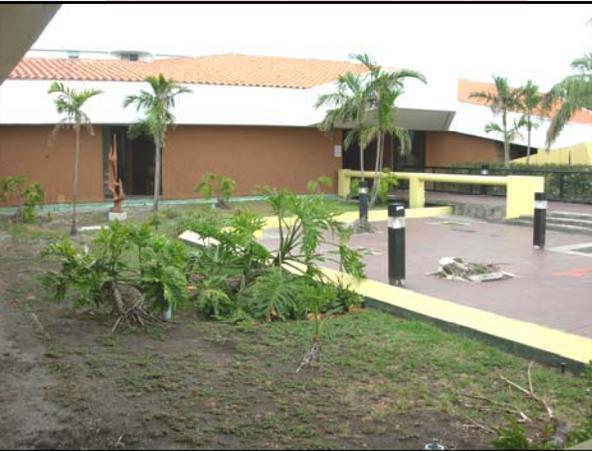
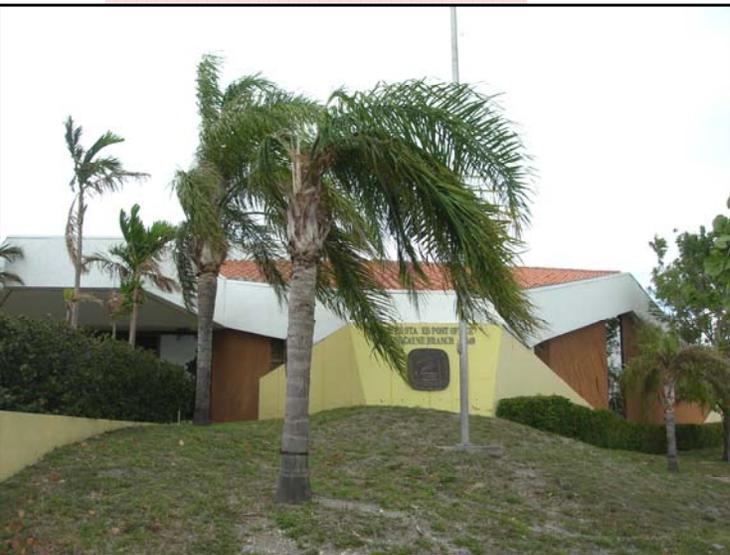
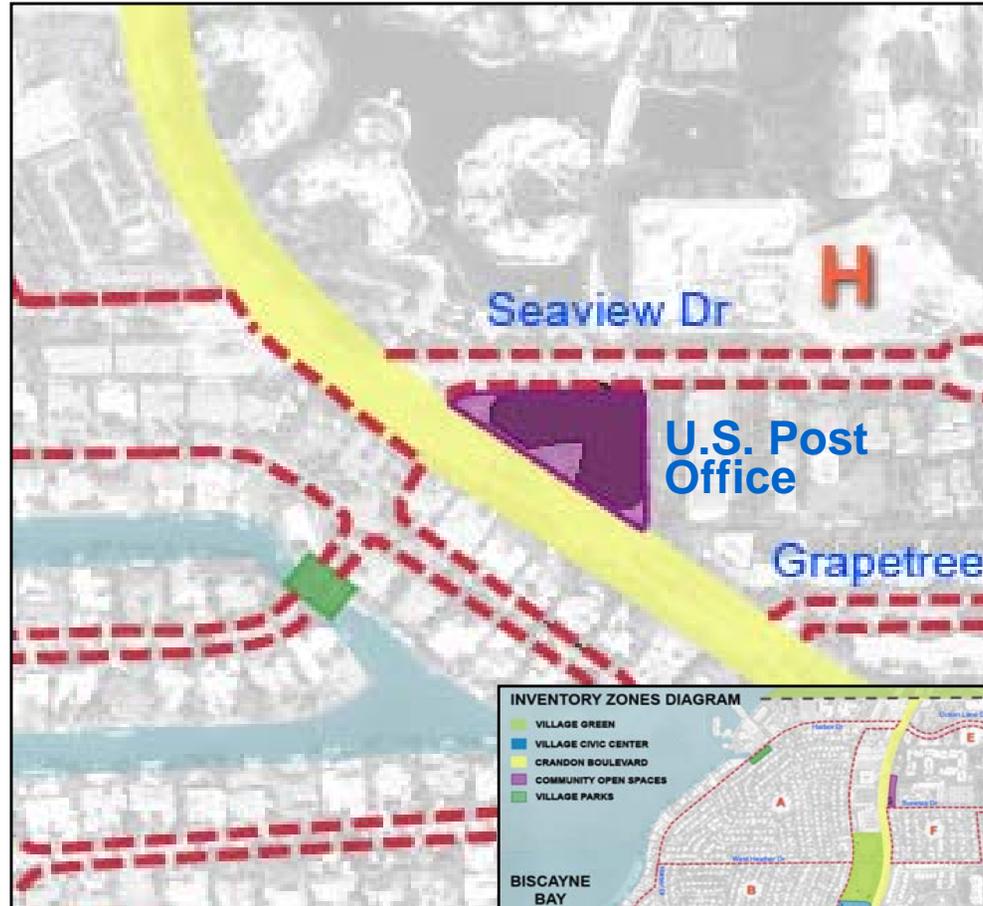
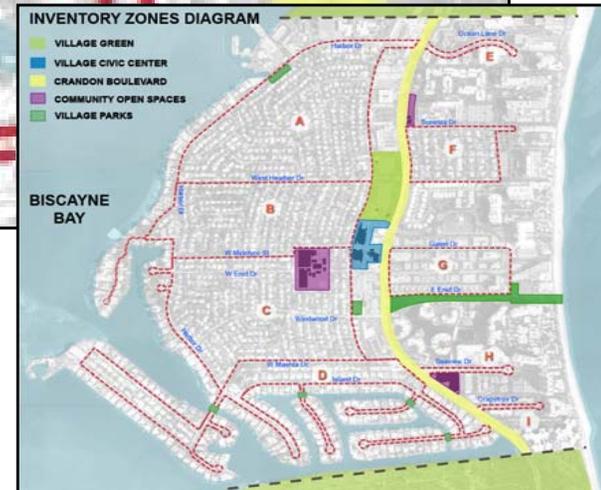
- The post office grounds are in poor condition.
- Missing plants, exposed/eroded soil, bare roots, mismatched pavement, and leaning bollards make this landscape an eyesore.
- Soil erosion on turf slopes has exposed roots and wires.
- A complete overhaul of this landscape should be undertaken.

- All pedestrian surfaces (entrance stairway, plaza) are cracked, broken, stained, or mismatched. There are many trip-hazards within the paved area.
- The front entrance of the building is not ADA-accessible. Post office patrons in wheelchairs or with walkers must enter the building through the parking garage elevator in the back of the building.

- L'Esplanade sign that faces Crandon Boulevard is damaged.

- Light bollards are in poor condition.
- Mailboxes near the parking parking garage exit are in good condition.
- Flagpole and flag are in good condition.

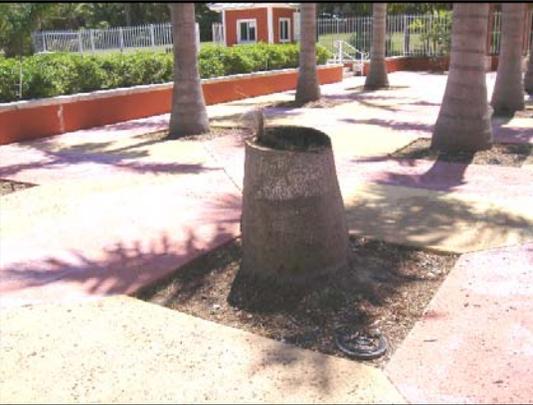
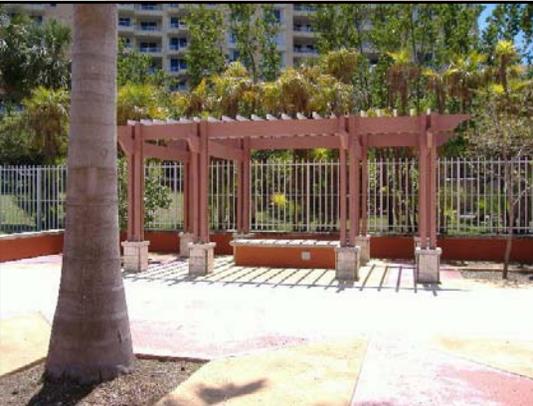
Village Beach Park: Entrance Area

- The formal raised deck area has royal palms planted in beds surrounded by decorative, colored concrete. One palm is missing.
- The trellised area near the security booth, just outside the fence, is uninviting with its fence backdrop, bare trellis, and single backless bench. Shade and foliage is severely needed in this area.

- The raised deck space appears to have been designed with no intended program use other than as a visual terminus to East End Drive.

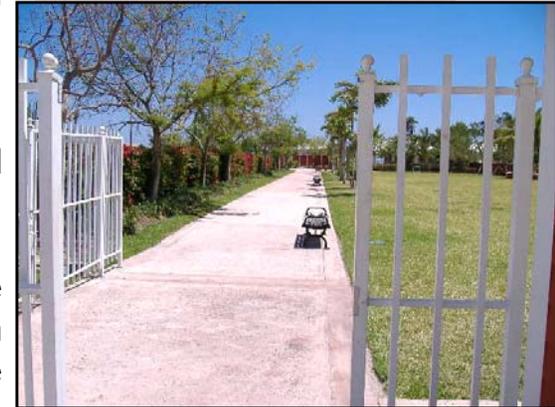
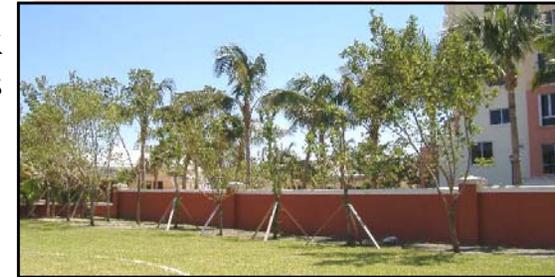
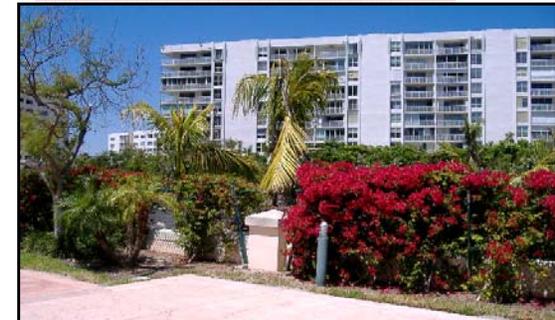
Village Beach Park: Interior Landscape

- Tree canopy covers less than 10% of this area. Solitaire palms and damaged wild tamarinds do little to shade the sidewalk and benches.
- Along the south park boundary, the plantings in front of the fence are sparse and poorly maintained. Groundcover and shrubs are in very poor condition, and do not buffer views from the park to the fence and neighboring property.
- Poorly maintained and damaged plantings along the north park boundary should be improved for aesthetics and to fully block views to the parking lot.

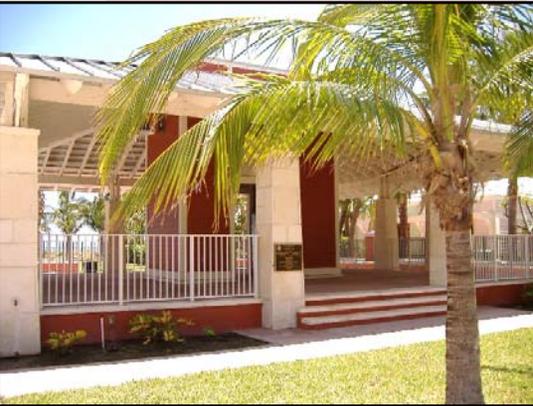
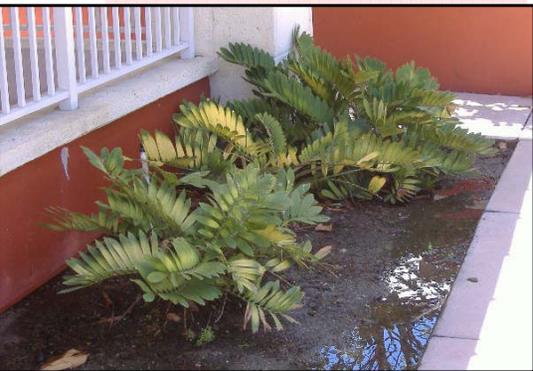
Village Beach Park: Pavilion Area

- Plantings surrounding the pavilion are largely dead or missing.
- There are severe drainage problems in the planting beds surrounding the pavilion, with standing water evident in after several weeks without rain.

- There are no benches or tables within the pavilion, which makes its programmed use unclear.

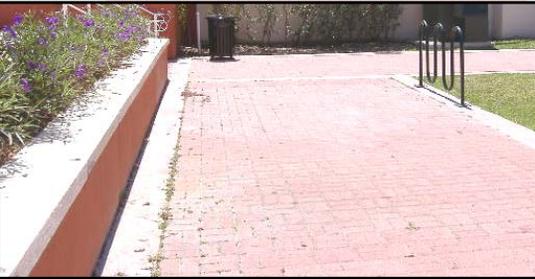
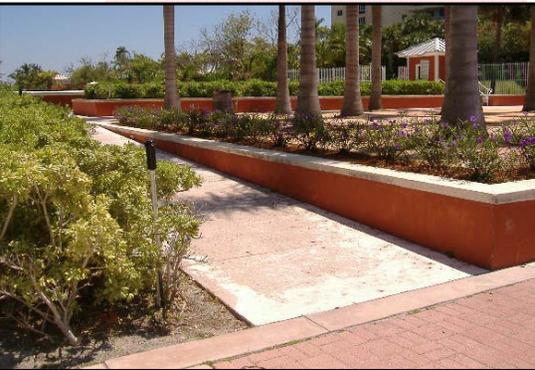
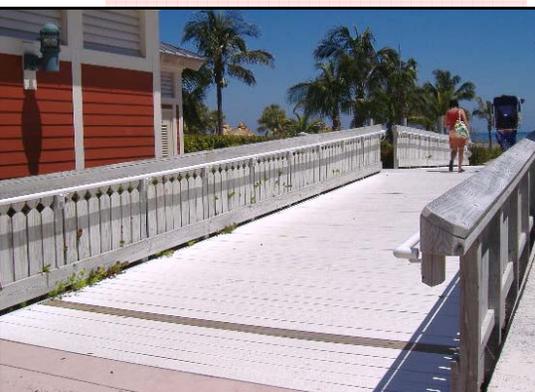
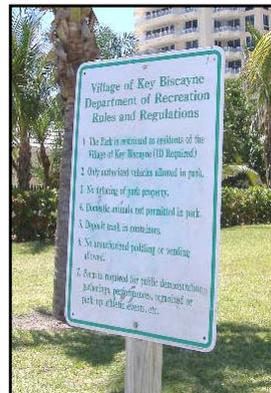
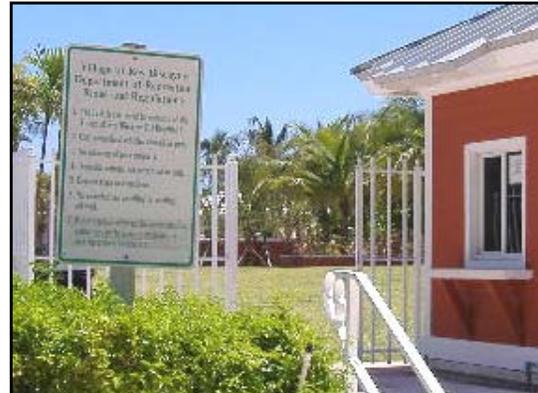
Village Beach Park: Amenities

- Most concrete is in fair condition, with some discoloration.
- Concrete bands around coral-colored concrete unit pavers are worn and weedy in places.
- Bridge materials are not consistent; discolored from repair work.

- Signage is limited to a few metal signs painted with park and beach rules.
- There is no decorative park entrance sign.

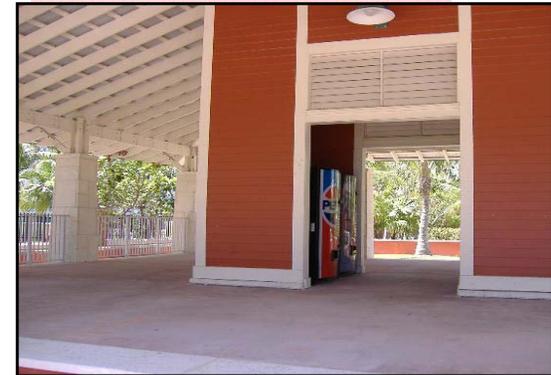
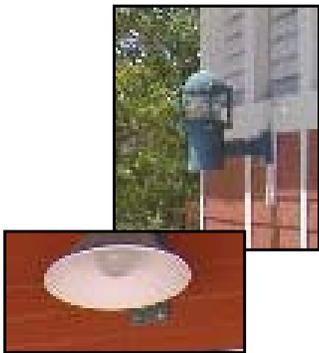
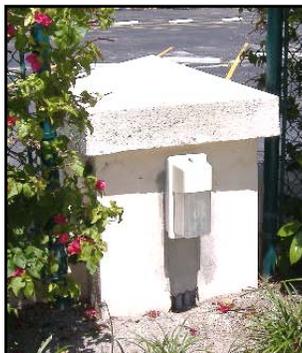
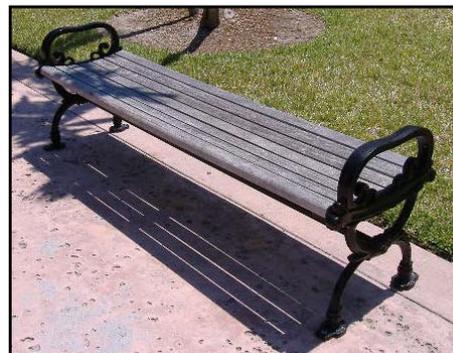
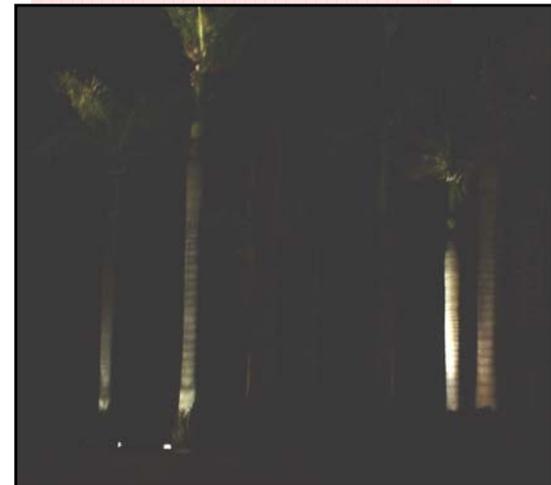
Village Beach Park: Amenities

- A Village standard bike rack (painted black) is present at the park entrance. On the opposite end of the park near the beach there is a bare aluminum bike rack that does not match the Village standard.
- Benches and trash receptacles match the Village standard :Victor Stanley C-7 backless bench in wood/black metal
- Benches are few, and placed in non-conversational arrangements.
- Benches and tables are not present in the pavilion.
- About 50% of the up-lights on royal palm trees are not working.
- Light bollards and wall mounted fixtures are mismatched.

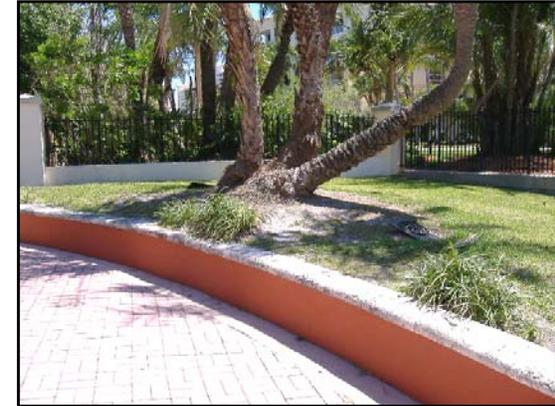
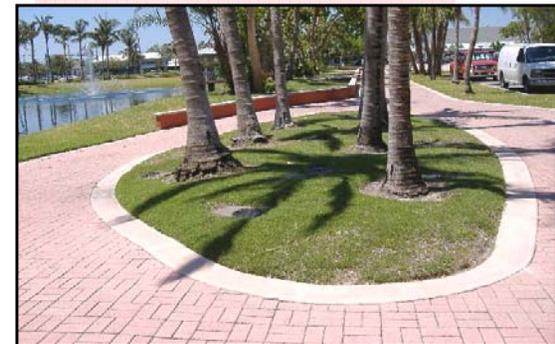
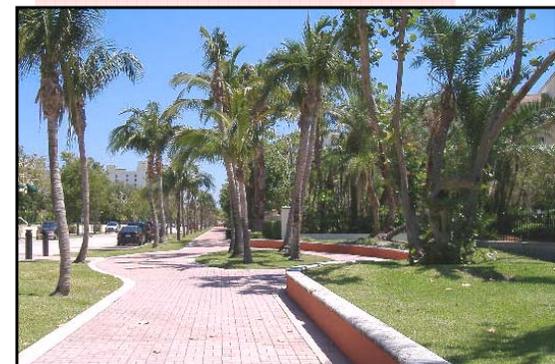
East Enid Lake Park: Landscape Character & Condition

- Most plantings at the park are sparse and in decline. Plantings lack variety of species, size, and features.
- Sea Grape trees and Coconut palms are in good condition, and could serve the park well if augmented by additional groundcovers, shrubs, and trees. Currently, these specimens do not provide enough shade to encourage park use.

- Plantings in the raised bed near Crandon, though new, do not enhance the park atmosphere or provide shade for people waiting for the bus.
- The pond is not attracting visitors. Edge condition, water color, and visible garbage (though in small amounts) detract from what could be a desirable community amenity.

- Turfgrass goes directly up to the pond edge. For this type of pond edge treatment to be visually appealing, it requires a level of maintenance that is not currently evident. This edge treatment also encourages park users to step into the pond, as there is not a physical or implied barrier to the water.

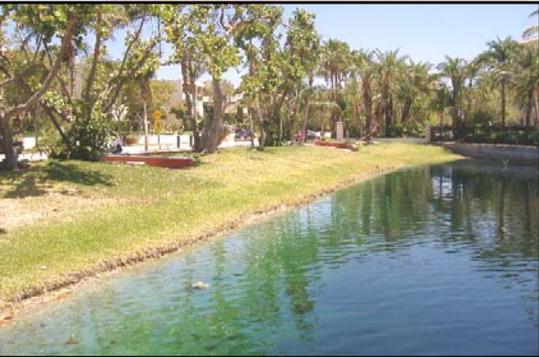
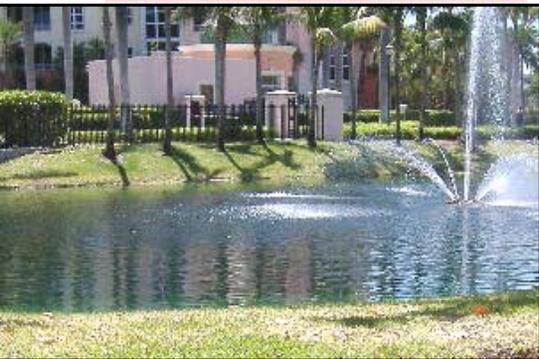
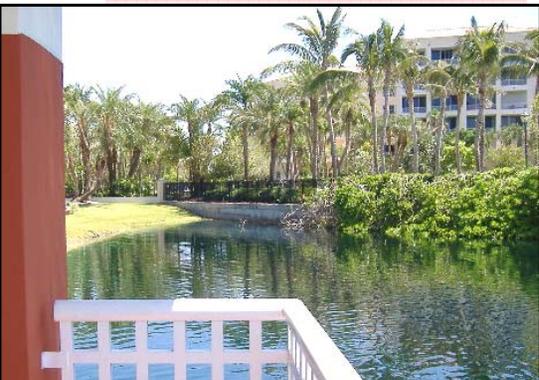
East Enid Lake Park: Landscape Character & Condition

- The color of the water is an unnatural blue color similar to that commonly seen at theme parks. This implies poor water quality to visitors and does not serve the positive image of Key Biscayne.
- The sloped area on the south side of the pond is not an appropriate location for turfgrass as it is difficult (and dangerous) to mow.
- Scaevola coming over the fence from the Ocean Club on the southeast edge of the pond gives an unkempt appearance to this part of the water's edge.
- The retaining wall on the southeast edge is an unattractive grey concrete, which gives the pond an 'urban' rather than 'island' aesthetic.

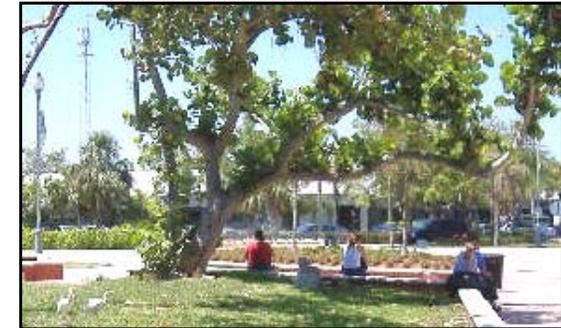
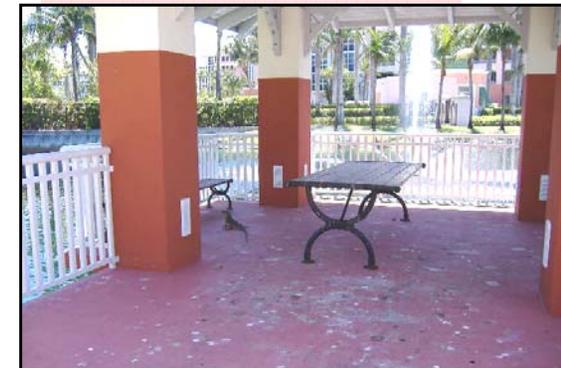
East Enid Lake Park: Urban Design & Infrastructure

- Successful passive-use park elements are present, but improvement is needed to make this a special place for Village residents and visitors.
- The park edge is used as a bus stop, while the park interior is used primarily by iguanas, ducks, and other wildlife. No visitors were observed within the park on numerous site visits.
- The pavilion provides an attractive shaded seating area over the water. If the pond and surrounding landscape are improved, this pavilion would be a pleasant viewing area.
- The random—and disassociated—location of the pavilion's seating and table detract from its appearance.
- The white painted metal railing makes it difficult to see through to the water when seated in the pavilion. If the railing was painted dark green or black it would alleviate this problem, while still serving its intended purpose.

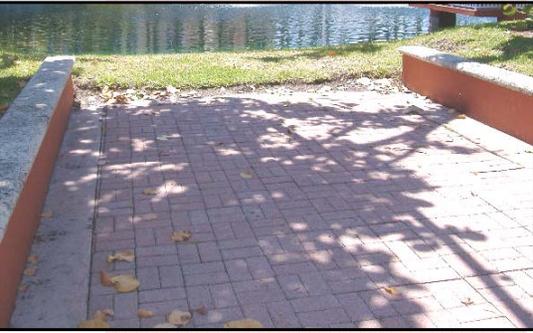
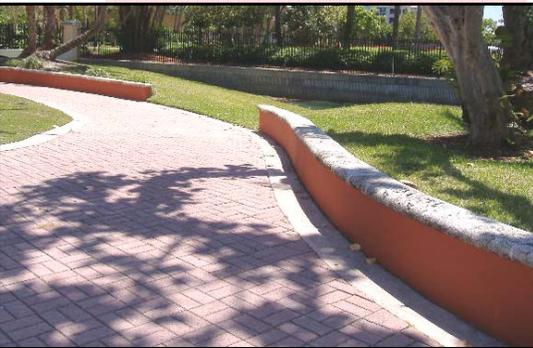
- Pavement consists of red cast-in-place concrete and coral concrete unit pavers. It is in good condition, though soiled by wildlife droppings in some areas.
- Seat walls are painted red stucco with a rounded keystone cap. The seat walls form planters on three sides and break away in places to expose turfgrass edges and slopes. This design, while providing a variety of places to sit, does not provide conversational seating arrangements.
- The breaks in the seat walls create unattractive turf edges and slopes that are difficult to maintain. As a result, turf on the sloped areas is dry, weedy, and sparse.
- The pavilion floor is soiled by wildlife droppings. Regular cleaning in this area is absolutely necessary, or people will not use this space.
