Master Landscape Plan

The Village of Key Biscayne

Working Paper I: *Inventory and Analysis of Existing Conditions*

January 20, 2009

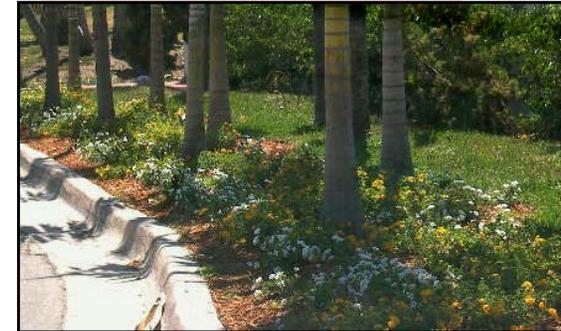
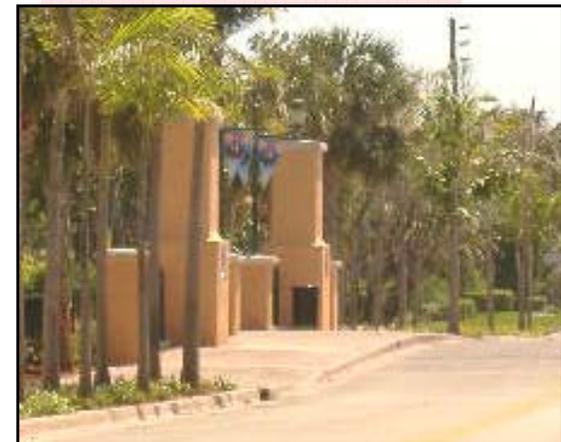
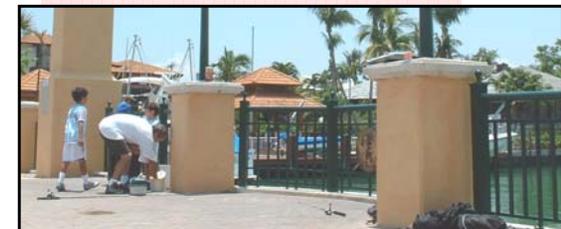
Mashta Island Bridge Vista Park: Landscape Character & Condition

- Plantings are newly installed and in good condition. Some of the plants chosen are fairly high maintenance for this location.
- Park elements have a consistent theme/style and work well together.

- The park is in good condition, but is rarely used as anything other than a transition space or fishing area. If benches and/or tables were provided, the park might receive increased use.
- An overhead utility line begins at the southern end of the vista park.

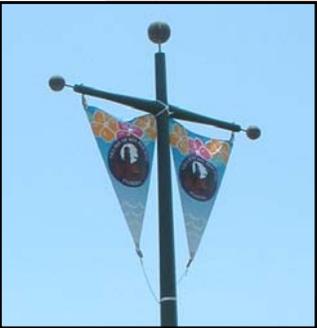
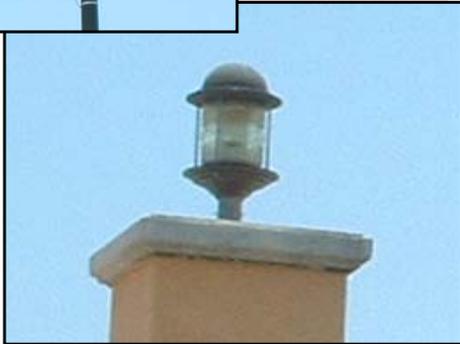
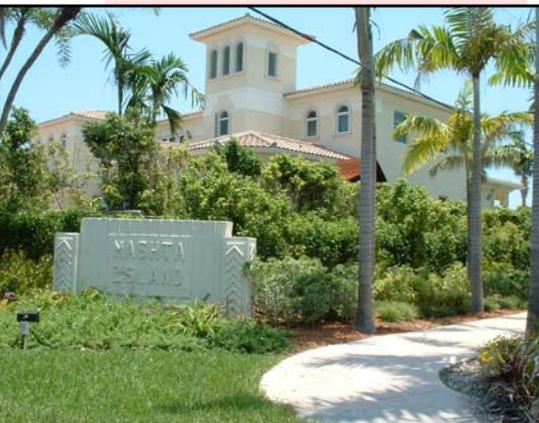
Mashta Island Bridge Vista Park: Amenities

- Hardscape is in good condition, consisting of coral concrete, concrete unit pavers, and asphalt.

- The “Mashta Island” concrete entrance sign is in good condition, but not in keeping with other signage throughout the Village.
- Decorative banner signs are compatible with those used along Crandon Boulevard, though slightly different in form.
- Bronze Village symbol and dedication/memorial plaques are present on bridge structures.

- Village standard trash cans are present on the bridge.
- No benches or tables are present.
- The bridge area is lit at night. Light fixtures have a nautical feel that is appropriate for the park location.
- The “Mashta Island” entrance sign light is not working.

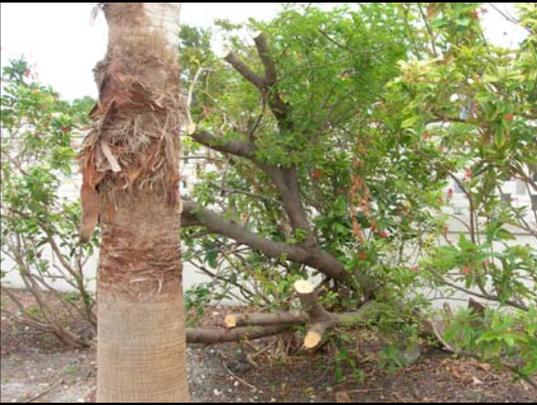
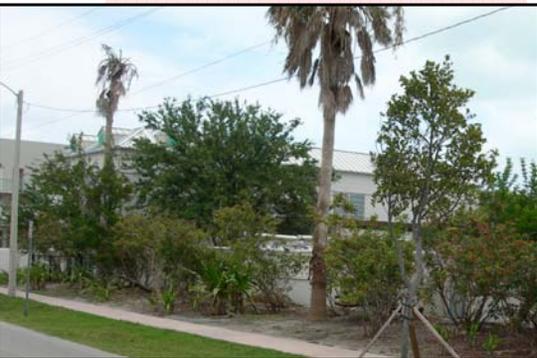
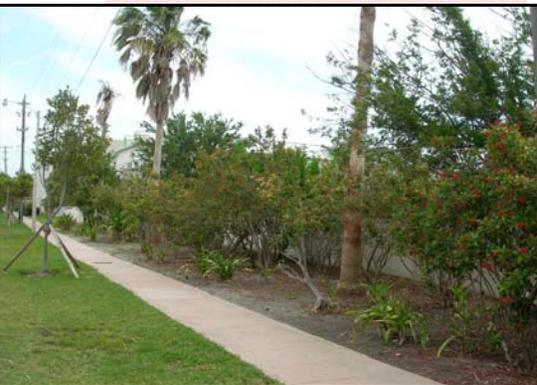
Bellsouth Easement Park

- This pocket park is suffering from maintenance neglect and inappropriate plant species selection. Plantings are sparse, toppled, and have an overall poor appearance.
- Furnishings consist of a single bench on a small concrete unit paver plaza. The plants around the plaza are leggy or missing. As a result, the unattractive, white concrete wall behind the plaza is visible. Weeds grow up through the cracks in the pavers.
- There is no tree canopy covering the plaza or sidewalk.
- Soil is bare in most places and is washing over the sidewalk. Mulch is desperately needed.

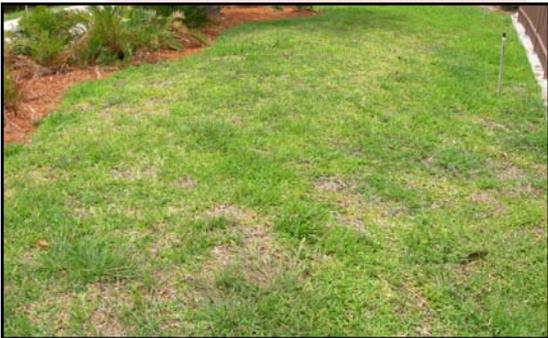
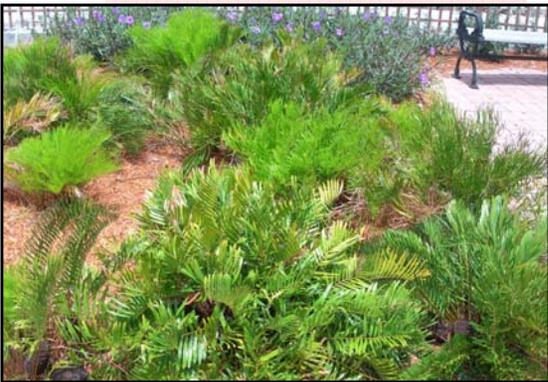
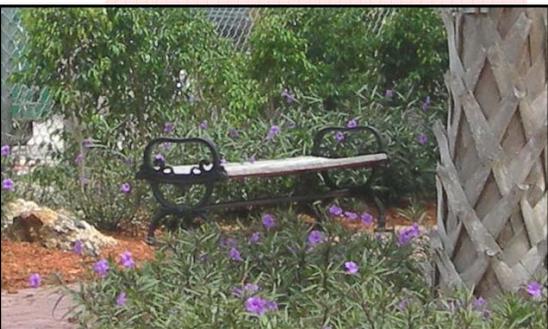
Canal Hacienda Pocket Park

- Planting appears to be recent and in good condition.
- Turfgrass is patchy.
- The 'pocket park' consists of two Village standard backless benches, a small plaza made of pink concrete unit pavers, planting beds, and sidewalks.
- No welcome sign or other signage is present.
- Nighttime visibility is good.

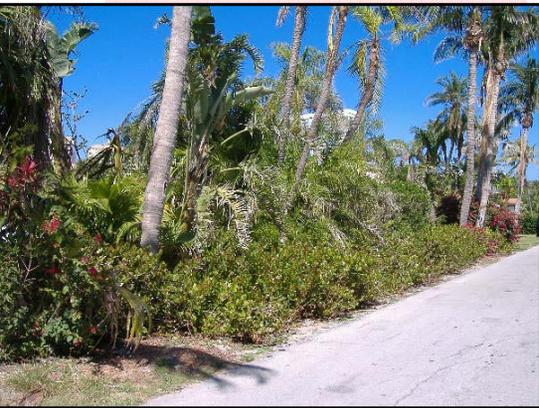
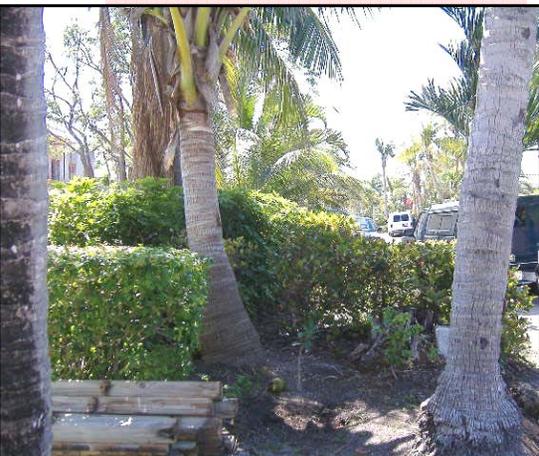
Cape Florida Drive South Vista Park

- No improvements are visible, save some poorly maintained plantings.
- No sidewalk is present.
- Views to the water are limited due to overgrown, unkempt vegetation.
- During inventory, nearby homeowner mentioned that he and a neighbor wondered if they could replant it.

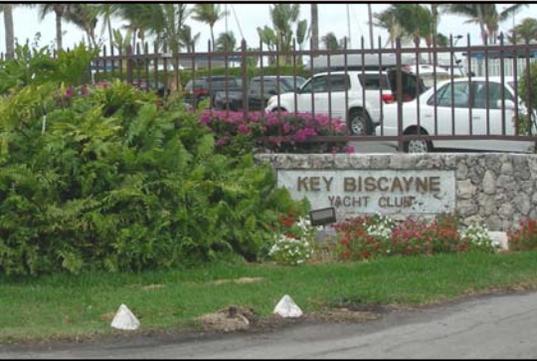
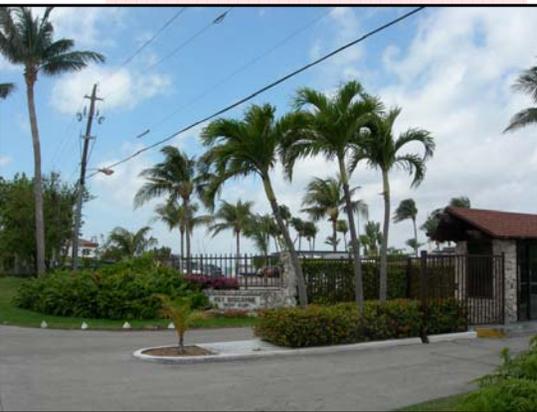
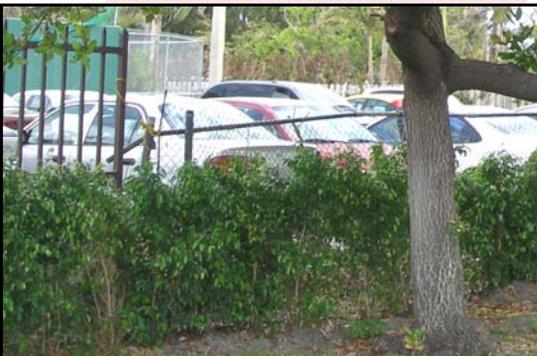
Key Biscayne Yacht Club Entrance

- The entrance plantings are a bit overgrown and in need of trimming. Overall appearance is good, except for a misplaced Bottle Palm in the entrance median. It is out of scale with the nearby palms, and is likely to be run over in its current location.
- Power lines cross directly over the entrance.
- Fixtures and furnishings are consistent with those of the Yacht Club.
- Pointed white concrete wheel stop stones line the edges of the entrance. These are a hazard to vehicles and can result in punctured tires.
- The chain link fence to the north of the entrance is damaged, bent, and does not match the black painted metal fence at the entrance.

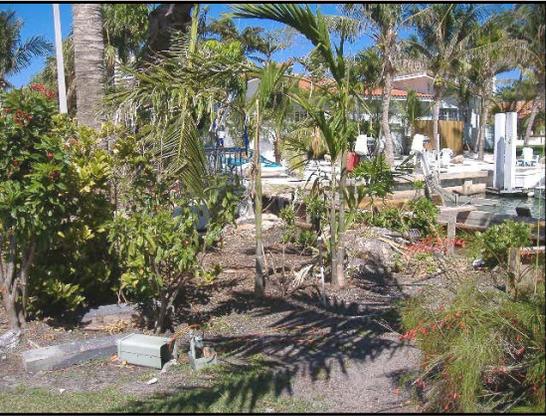
Knollwood Drive Vista Park

- No improvements or fixtures are visible, and no sidewalk is present.
- The vegetation is sparse in places and overgrown in others.
- Miscellaneous debris is present in the planting areas.

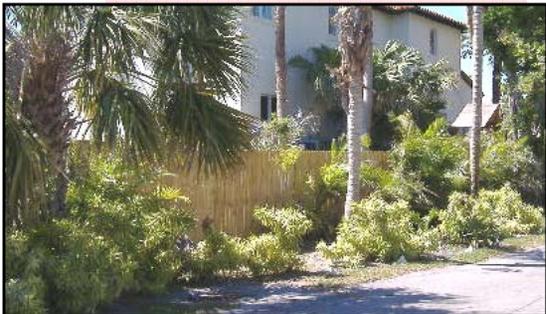
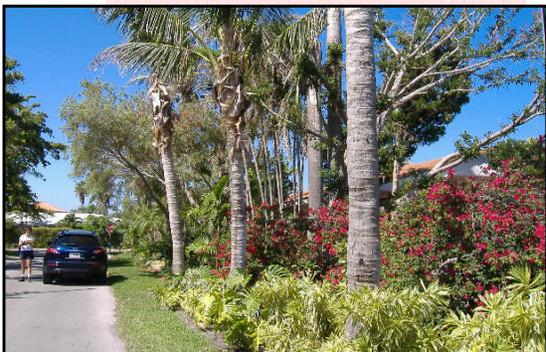
Mariner Drive Vista Park

- Planting appears to be relatively recent, with some pattern visible.
- No sidewalk is present.
- A wooden fence runs along the western boundary of the vista park.
- Pointed, white concrete wheel stops are present.
- The vegetation is moderately overgrown.

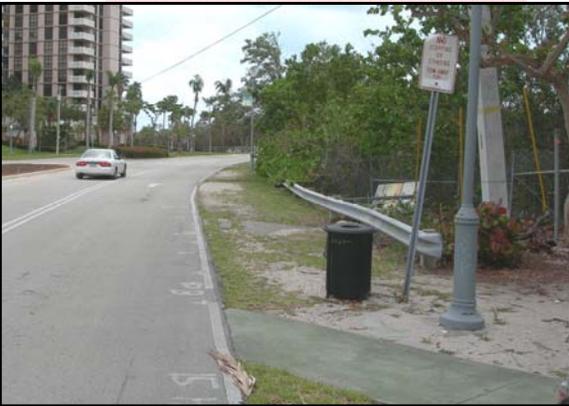
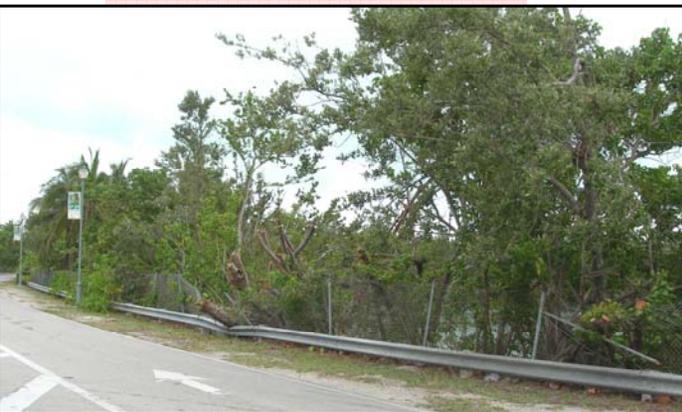
Pines Canal Vista Park

- This vista park has not been constructed. Plans for this vista park have been abandoned by the Village.
- Per the Crandon Boulevard Master Plan invasive/exotic plants will be removed from this area and it will be maintained as a natural area.

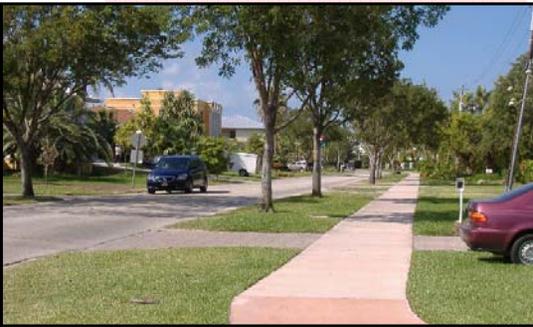
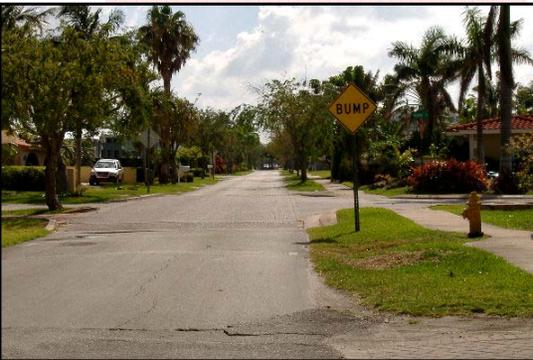
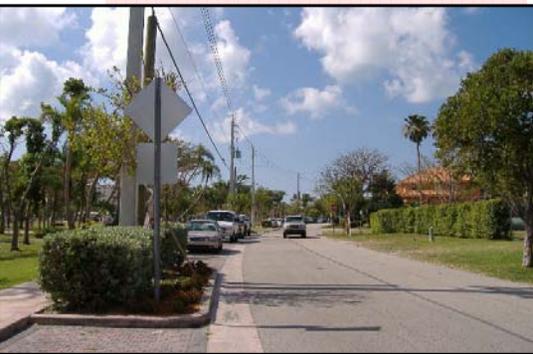
- These streets have all had recent traffic calming improvements, which distinguishes them from other streets in this zone.
- They all lack a unified streetscape appearance and have gaps in street tree plantings.
- Tree canopy coverage ranges between 10% and 30%. Some areas of these streets have no tree canopy coverage at all.
- Each has a sidewalk on one side.
- Overhead utility lines along streets and intersections conflict with streetscape plantings in about 20% of this zone.

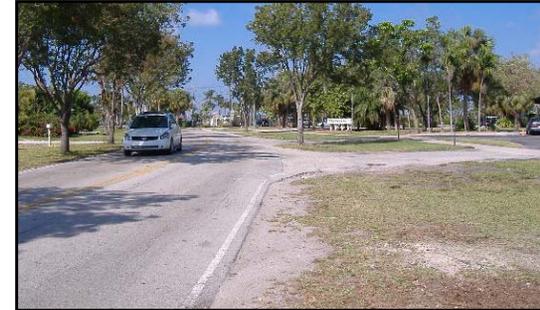
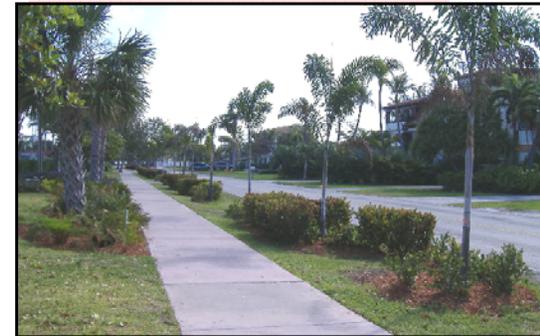
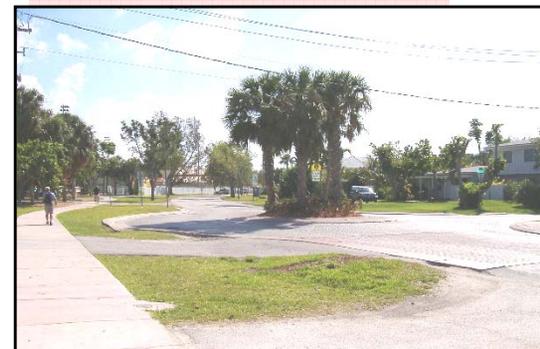
- Median plantings give Harbor Drive a unique identity among other streets in this zone. However, there is not a streetscape concept that unites the median plantings with the right-of-way plantings.
- NW right-of-way drainage swales have exposed soil in places due to vehicles parking there.
 - Parking on swales compacts soil, flattens swale grading, and reduces drainage capacity.
 - Water pools outside the swales after rain events, flooding parts of Harbor Drive.
- Hedge plantings within the right-of-way adjacent to the Yacht Club appear to have successfully prevented parking within drainage swales.
 - Swales behind the hedges in this area are in good condition.
- Some conflicts with overhead utility lines that cross Harbor Drive at Fernwood.

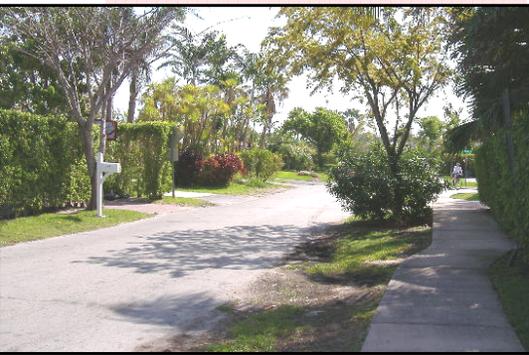
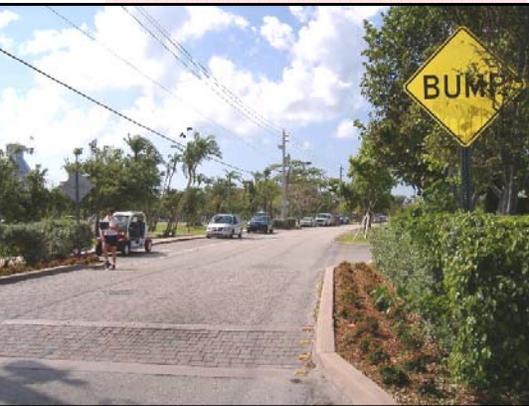
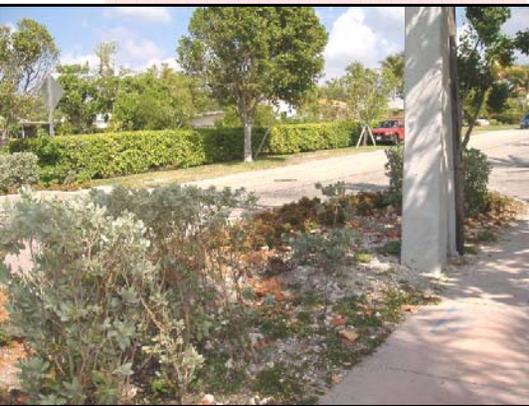
Fernwood Road

- On street parking adjacent to the Village Green.
- Utility lines in the east street right-of-way conflict with trees in some locations.
- Many of the streetscape trees and plants are damaged.

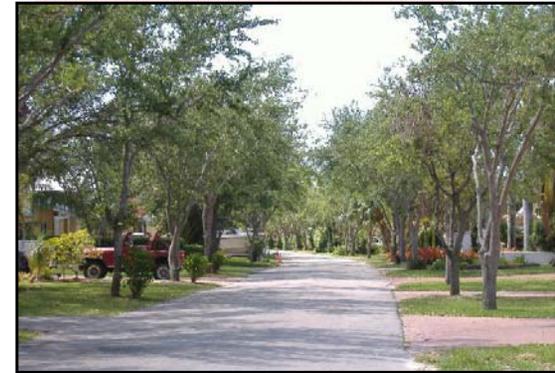
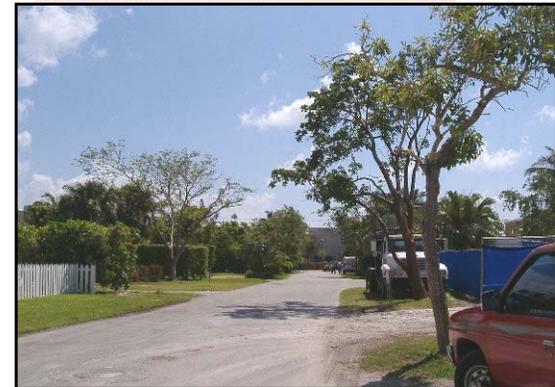
- Some of these streetscapes have unique appearances, but overall these streets exhibit similar trends.
- All of these streets have vehicles parking within the street right-of-way, which makes the grass patchy in places.
- Homeowner landscapes extend into the street right-of-way in many cases. With the exception of Woodcrest Road, the drainage swale areas on most streets are small to non-existent.
- Some street signs are damaged or missing.
- Overhead utility lines along streets and intersections conflict with streetscape plantings in about 20% of this zone.

- Glenridge Road has unified, exceptional street trees, with canopy coverage that exceeds 50%.
- Woodcrest Road and Cranwood Road have canopy coverage exceeding 50%, but street tree plantings are inconsistent.
- Hampton Lane and Harbor Court have unified coconut street tree plantings with few gaps.
- All other streets have inconsistent street tree plantings with frequent gaps.

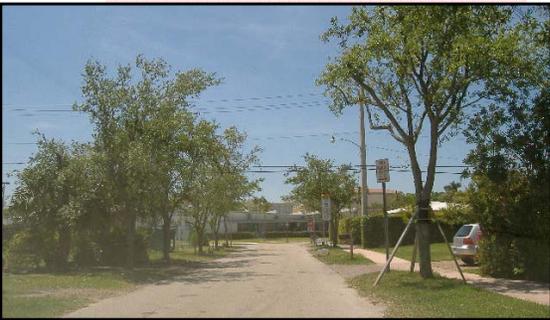
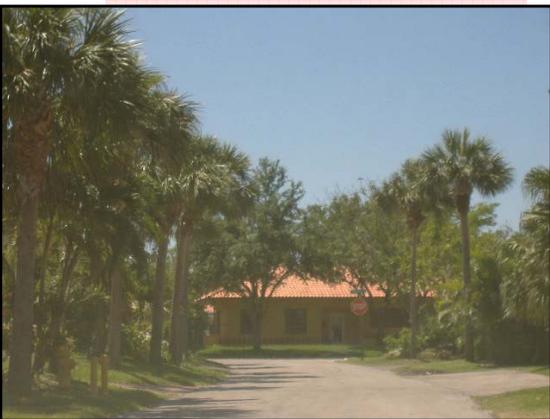
- Harbor Drive and Fernwood Road had recent traffic calming improvements, while West McIntyre Street has not.
- They all lack a unified, consistent streetscape appearance and have gaps in street tree plantings.
- Tree canopy coverage ranges greatly between 10% and 50%. Some areas of these streets have no tree canopy coverage at all, while others have high percentage of tree canopy coverage.
- Each has a sidewalk on one side.
- Overhead utility lines along streets and intersections conflict with streetscape plantings in about 20% of this zone.

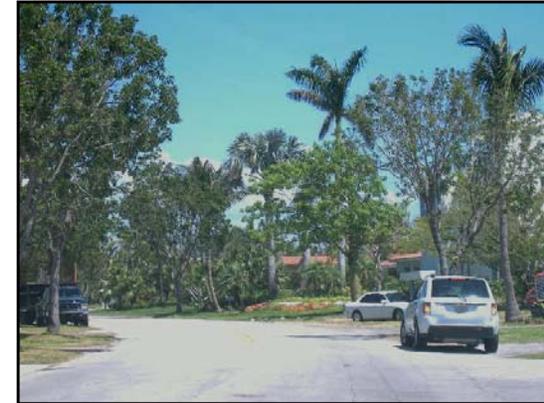
- Right-of-way drainage swales on the west side of the street have exposed soil in places due to vehicles parking there.
 - Parking on swales compacts soil, flattens swale grading, and reduces drainage capacity.
 - Water pools outside the swales after rain events, flooding parts of Harbor Drive.
- Median plantings give Harbor Drive a unique identity among other streets in this zone. However, there is not a streetscape concept that unites the median plantings with the right-of-way plantings.

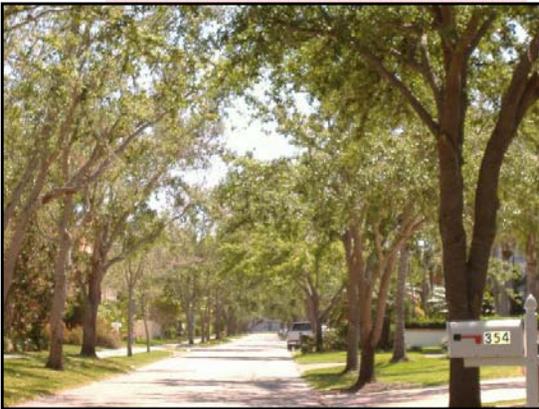
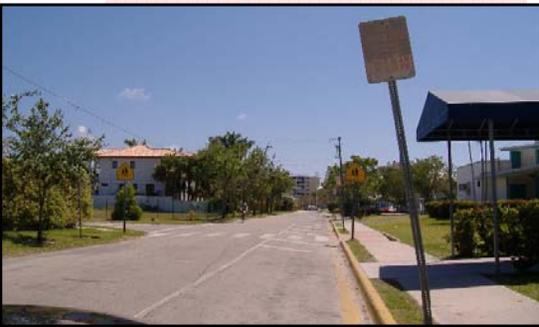
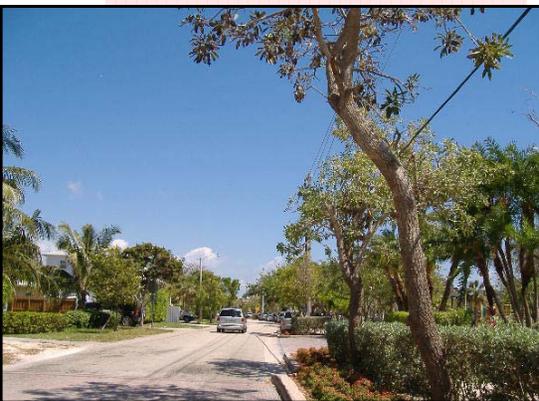
Fernwood Road

- On street parking adjacent to the Village Green.
- Utility lines in the east street right-of-way conflict with trees in some locations.
- Many of the streetscape trees and plants are damaged.

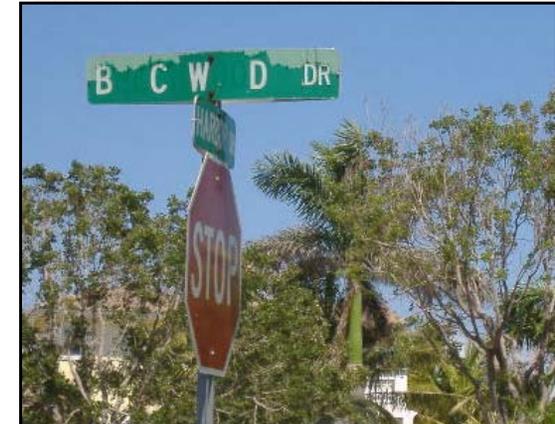
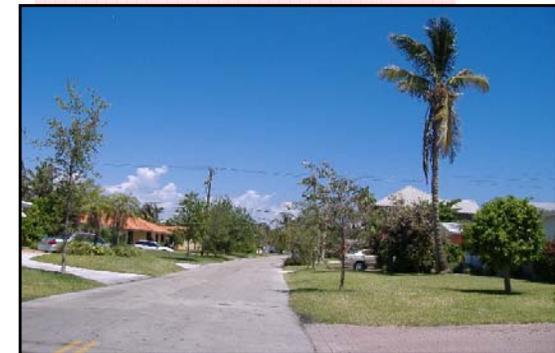
- Some of these streetscapes have unique appearances, but overall these streets exhibit similar trends.
- All of these streets have vehicles parking within the street right-of-way, which makes the grass patchy in places.
- Homeowner landscapes extend into the street right-of-way in many cases. Drainage swale size varies greatly in this zone, and Woodcrest Road was flooded after a significant rain event upon observation.
- Some street signs are damaged or missing.
- Overhead utility lines along streets and intersections conflict with streetscape plantings in about 20% of this zone.

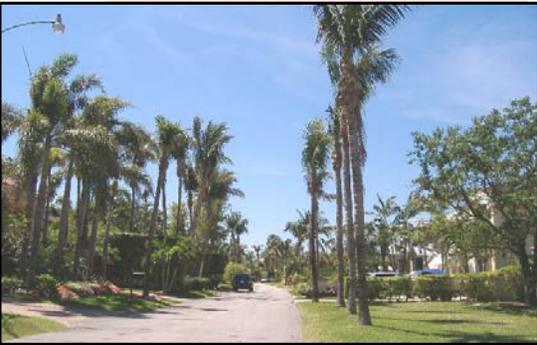
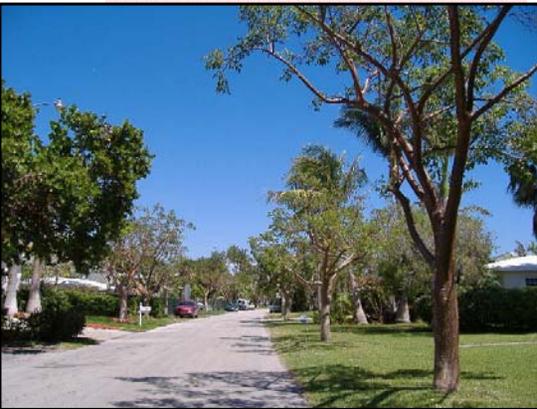
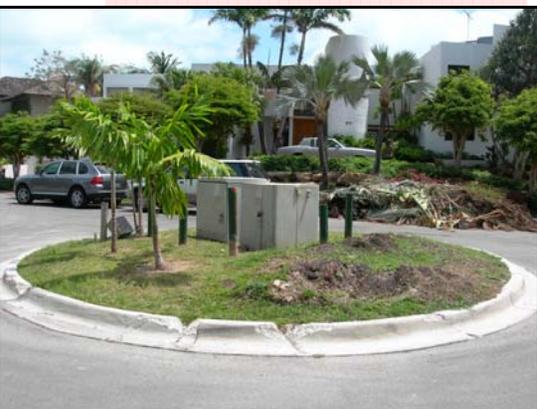
- Woodcrest Road has canopy coverage exceeding 50% on the northern half of the street, but street tree plantings are inconsistent.
- Harbor Point Drive has a lush, manicured streetscape that is consistent throughout. The high intensity of maintenance suggests that this is a privately maintained street.

- All other streets have inconsistent street tree plantings with frequent gaps.

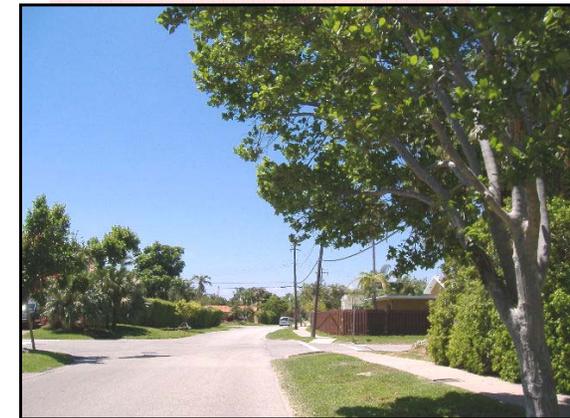
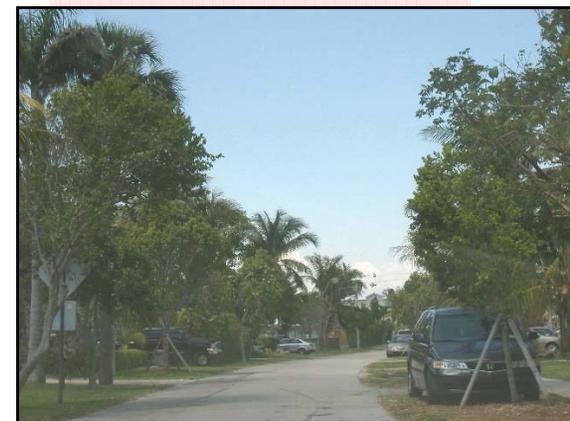
- Harbor Drive has recent traffic calming improvements, while the others have not.
- With the exception of West Enid Drive, streets in this group lack a unified, consistent streetscape appearance and have gaps in street tree plantings.
- Tree canopy coverage ranges greatly between 10% and 50%. Some areas of these streets have no tree canopy coverage at all, while others have high percentage of tree canopy coverage.
- Each has a sidewalk on one side, although West Enid Drive only has sidewalk between Woodcrest Road and Fernwood Road.
- Overhead utility lines along streets and intersections conflict with streetscape plantings in about 20% of this zone.

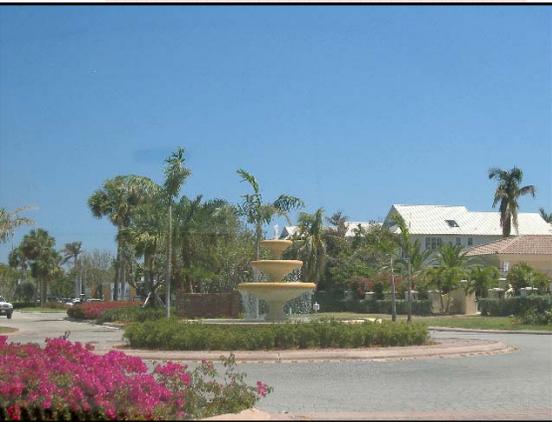
- Right-of-way drainage swales on the west side of the street have exposed soil in places due to vehicles parking there.
 - Parking on swales compacts soil, flattens swale grading, and reduces drainage capacity.
 - Water pools outside the swales after rain events, flooding parts of Harbor Drive.
- Median plantings give Harbor Drive a unique identity among other streets in this zone. However, there is no streetscape concept that unites the median plantings with the right-of-way plantings.
- Roundabout with fountain present at intersection with Mashta Drive.

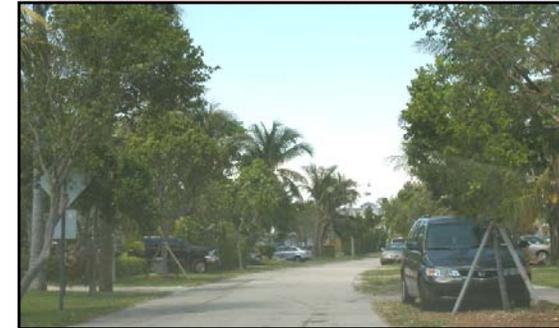
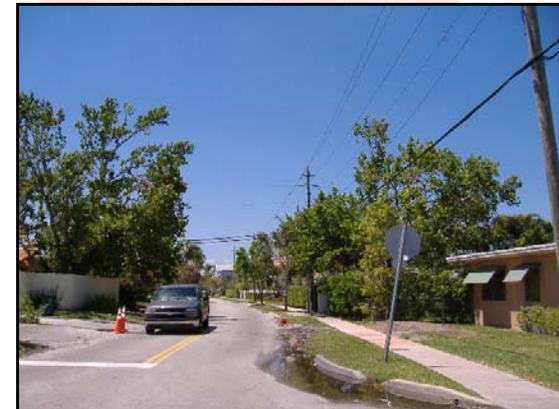
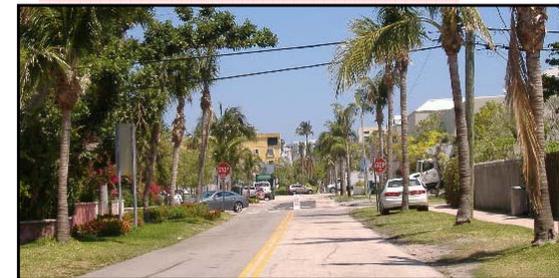
- Coconut street tree plantings help to unify West Enid Drive as it bends around the Key Biscayne Community School.
- Sidewalk does not extend the full length of the road.

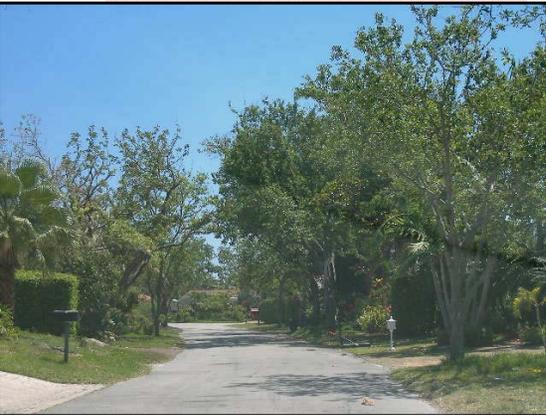
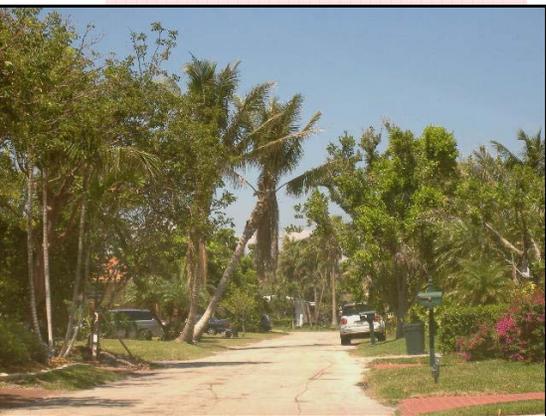
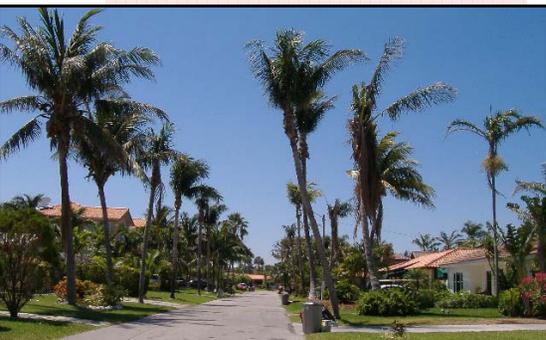
- Harbor Lane has a cohesive streetscape of coconut street trees.
- Glenridge Road has unified street trees, with canopy coverage that exceeds 50%.
- Ridgewood Road has consistent Gumbo Limbo street trees with few gaps, but the open canopy of these trees does not create much shade on the street.
- Warren Lane and Allendale Road have many damaged or missing street trees.
- All other streets have inconsistent street tree plantings with frequent gaps

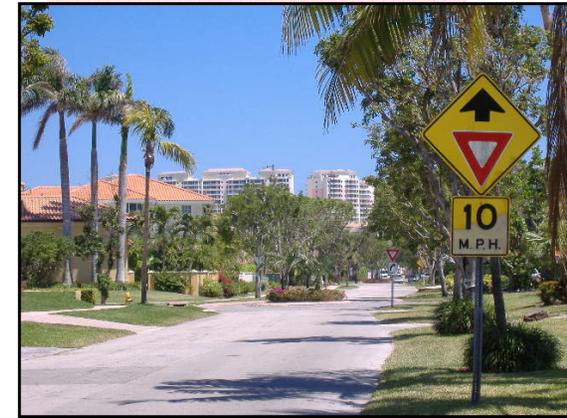
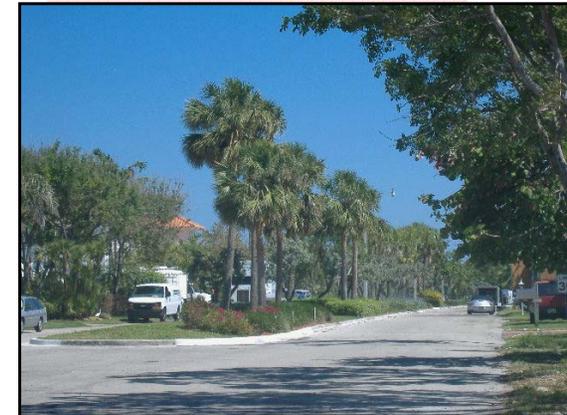
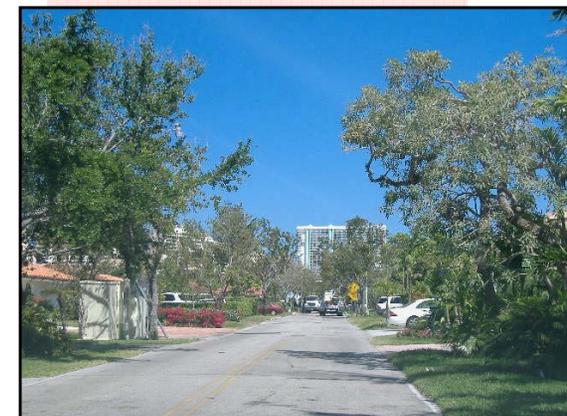
- All have had recent traffic calming improvements, except for Harbor Drive.
- With the exception of West Mashta Drive, streets in this group lack a unified, consistent streetscape appearance and have some gaps in street tree plantings.
- Tree canopy coverage ranges between 10% and 30%.
- West Mashta Drive is the only street in this group that has a sidewalk.
- Overhead utility lines along streets and intersections conflict with streetscape plantings in about 5% of this zone.

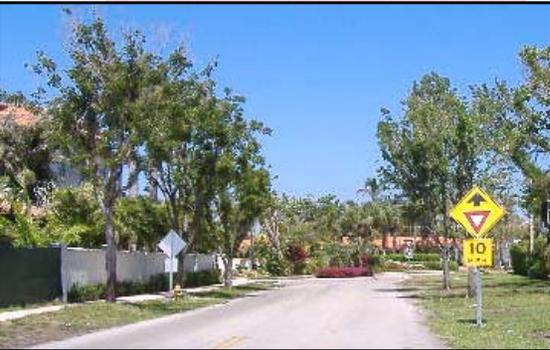
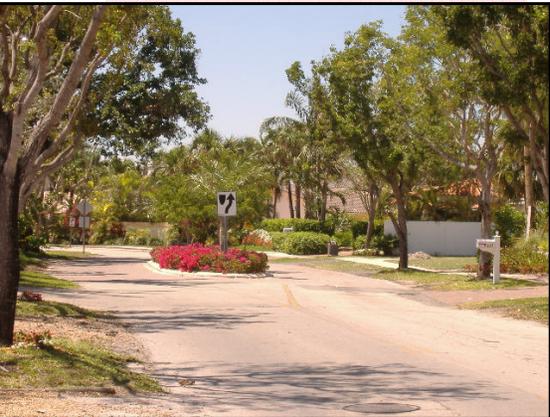
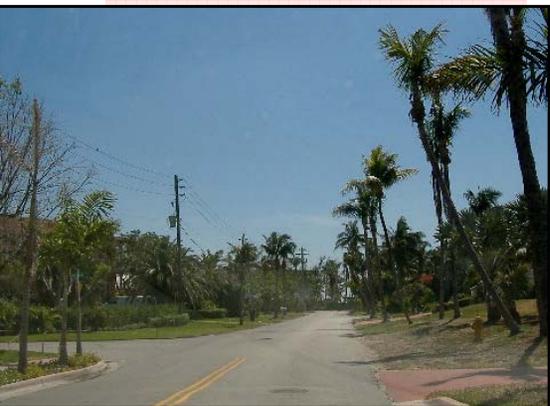
- A brick sign structure sits in the Harbor Drive median where Harbor Drive and Mashta Drive intersect. This structure does not have any lettering or signage.

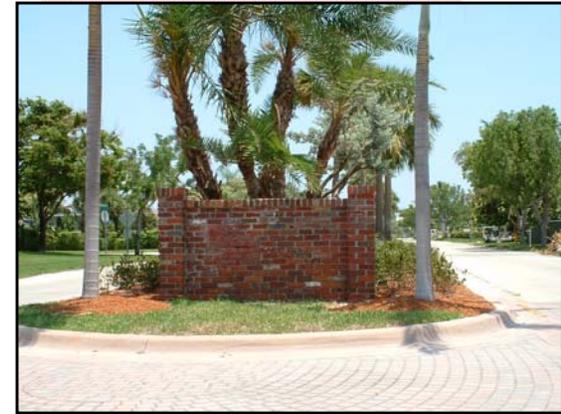
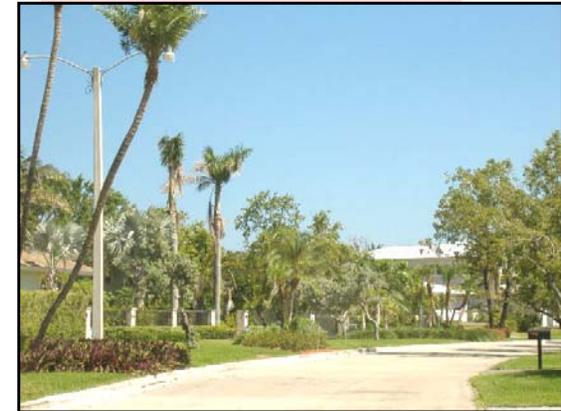
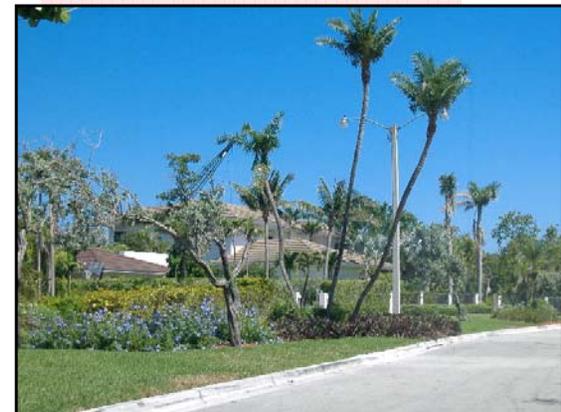
Island Drive

- A wide median spans the length of Harbor Drive south of West Mashta Drive. This streetscape condition is unique to the neighborhoods west of Crandon Boulevard, which gives this street a recognizable identity.
- The plantings within the medians contain a variety of species that require high maintenance.
- Many of these specimens are overgrown and not sufficient with the upscale character of the homes along the street.
- Despite the wide medians and ample planting room, tree canopy coverage on this street is between 10% and 20%.
- Large utility boxes are visible within the street median.

- Has been improved with traffic calming trays.
- Inconsistent character throughout, with no unified streetscape concept.

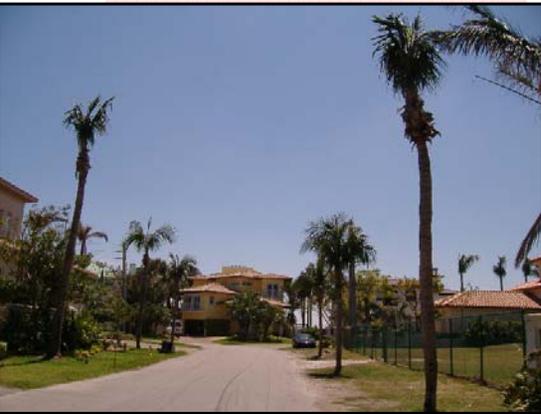
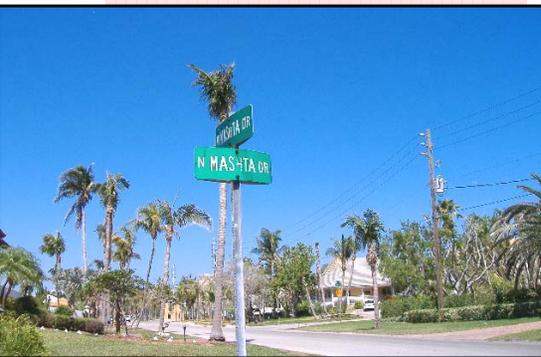
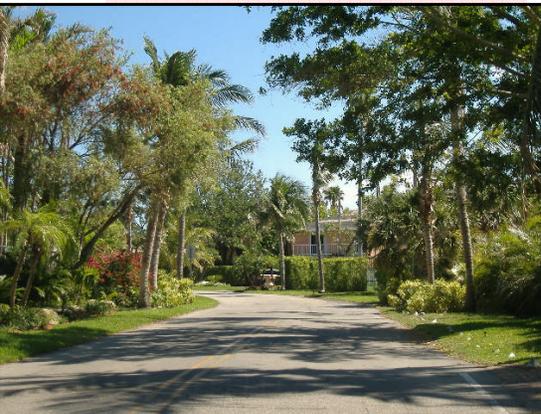
- Some of these streetscapes have unique appearances, but overall these streets exhibit similar trends.
- All of these streets have vehicles parking within the street right-of-way, which makes the grass patchy in places.
- Homeowner landscapes extend into the street right-of-way in many cases. Drainage swale size varies greatly in this zone.
- Some street signs are damaged or missing.
- Overhead utility lines along streets and intersections conflict with streetscape plantings in about 30% of this zone.

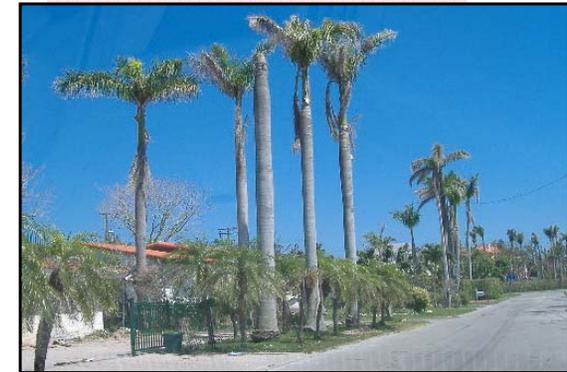
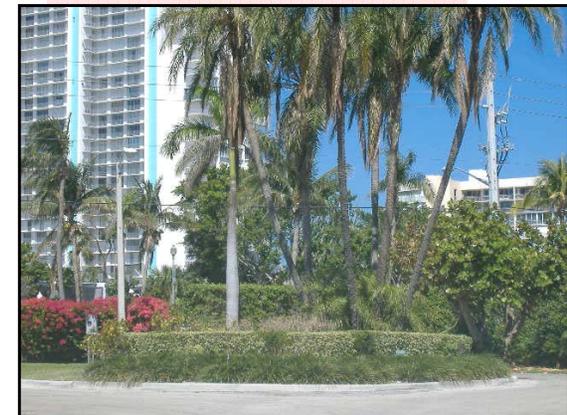
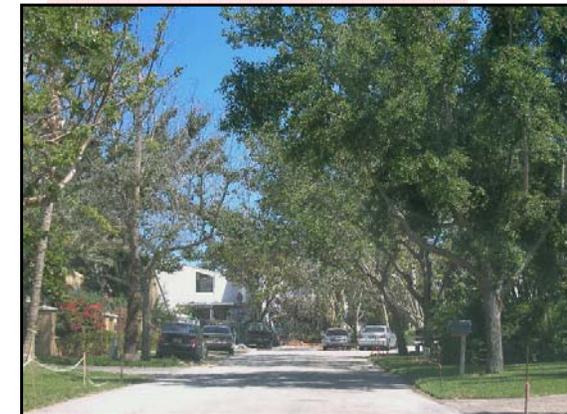
- Mashta Island is missing street trees in most places, with the exception of North Mashta Drive east of West Mashta Drive and the coconut trees on Mashta Place.
- Most streets in Mashta Island retain water/flood after rain events.
- North Mashta Drive has 50% tree canopy coverage, but the streetscape and cul-de-sac median plantings are extremely inconsistent.
- Cape Florida Drive streetscape is extremely inconsistent. Street trees are difficult to distinguish from private plantings. Cul-de-sac medians at either end of the street do not complement each other, and are suffering from neglect.
- Knollwood Drive has a marginally consistent streetscape of coconut trees.
- Mariner Drive has consistent coconut street tree plantings, but the cul-de-sac understory plantings are overgrown and leggy.
- All streets in this group lack unique streetscape identity.

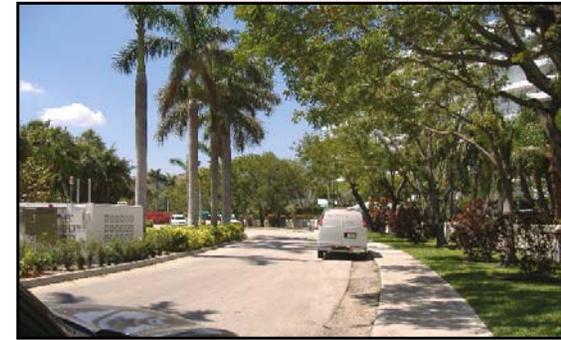
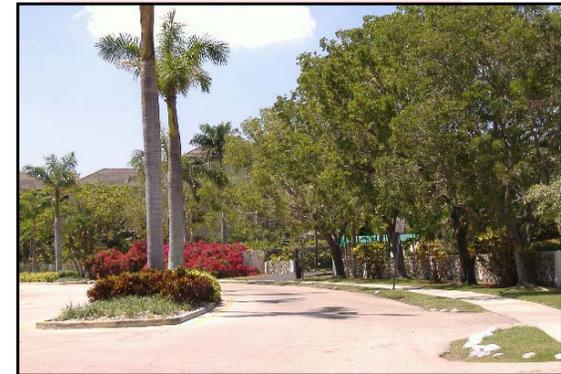
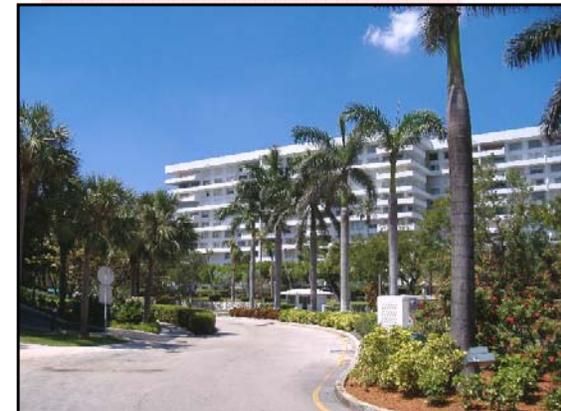
Ocean Lane Drive:

Though this street has planted medians and some landscape upgrades, Ocean Lane Drive does not realize its full streetscape potential. Plantings lack unity along the right-of-way, and the medians (especially the cul-de-sac median) are planted at random with many ubiquitous species. A unified planting concept along Ocean Lane Drive would clearly improve this streetscape.

- Each private development has different streetscape plantings along Ocean Lane Drive. While it is desirable for each development to reflect their identity in their entrance landscape, this should not detract from the overall streetscape environment of Ocean Lane Drive.
- Each development has planted their own street trees, with the exception of the Commodore Club right-of-way, which has Mahogany trees planted by the Village.
- Canopy covers less than 20% of the street and about 40% of the sidewalks.
- Sidewalks line both sides of the street.

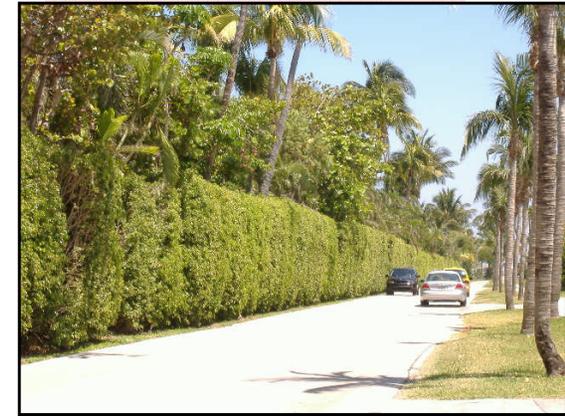
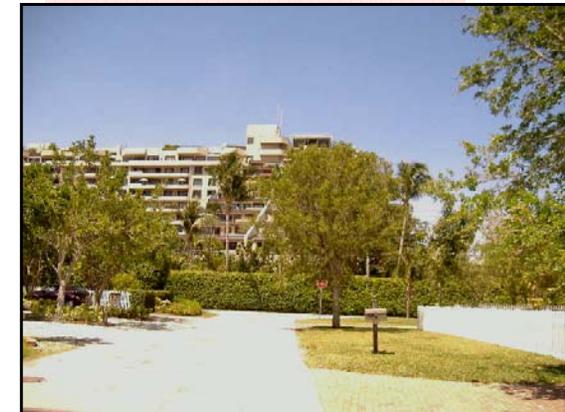
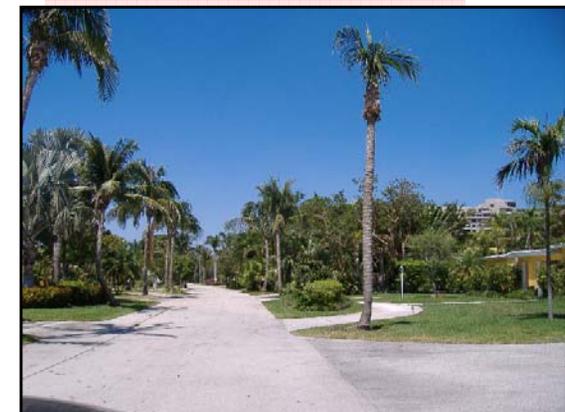
- Streetscapes in this zone need some improvement.
- Homeowner landscape plantings dominate this zone, and in many cases overlap into the street right-of-way.
- Tree canopy over the street is at about 20% coverage throughout the zone, except East Heather Drive, where the coverage is over 50%.
- Sidewalks are at a minimum in this zone. East Heather Drive and Sonesta Drive are the only streets with sidewalks, and they are just on one side of the street.

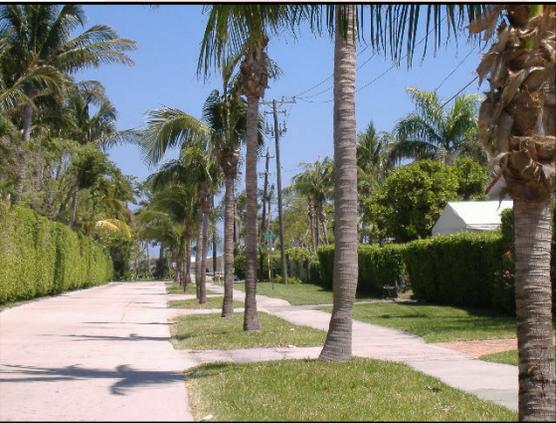
Sonesta Drive

- A utility line/easement borders the south side of the street, with a sidewalk underneath. This limits possibilities for street tree plantings here.
- Coconut trees border the south side of the street. They are up-lit at nighttime.
- A 7-8' ficus hedge borders the north side of the street.

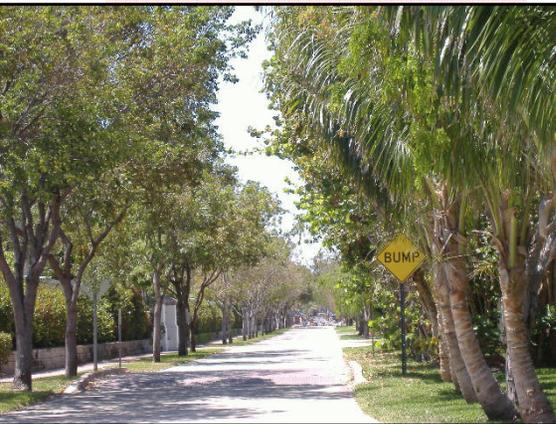
East Heather Drive

- Canopy coverage exceeds 50%. Bordered by mahogany and sabicu trees in good condition. Mahogany trees are up-lit at night.
- Sidewalk borders the south side of the street, and is well shaded by tree canopy.
- Traffic control tray present mid-street.

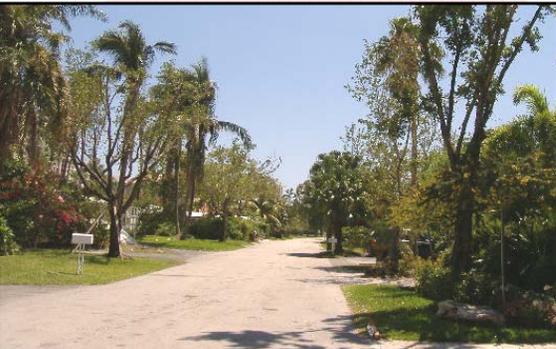
Caribbean Road, Gulf Road, Atlantic Road, and Pacific Road

- These streets are all without sidewalks. Homeowner plantings overlap into the street right-of-way.
- It is difficult to discern street tree plantings from homeowner landscape plantings. There are many gaps in street tree plantings.

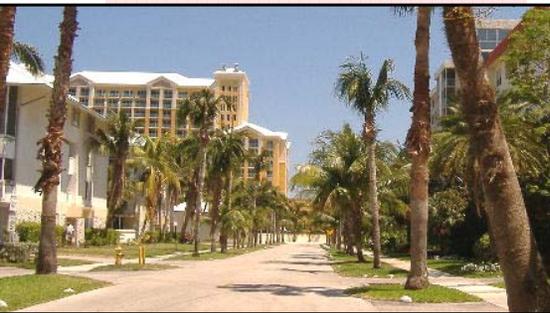
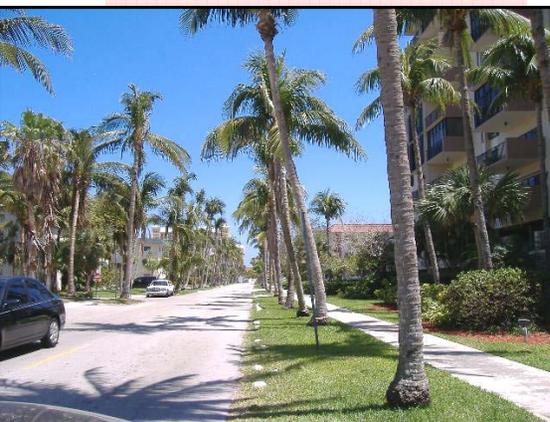
- Streetscapes in this zone work well to unify the 'neighborhood' and reinforce the island feel.
- Coconuts are the dominant street tree in this zone, so canopy coverage over the streets is low.
- Sidewalks in good repair line both sides of all streets in this zone, except the west side of Ocean Drive.
- Drainage problems were not observed.
- Signage consists of painted metal street and traffic control signs on metal u-posts.

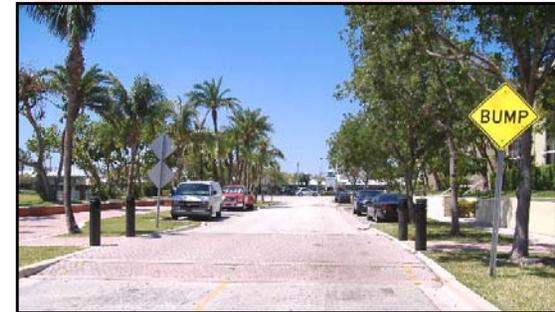
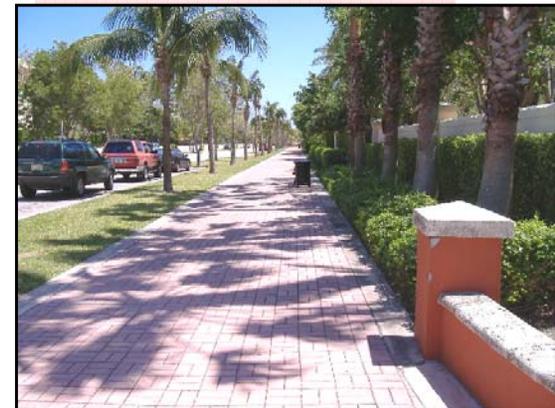
- Traffic control improvements consist of the following:
 - Tray present at mid-street
 - Curbs
 - On-street parking
- The south side of East Enid Drive is lined by coconuts that are uplit at night. Maintenance is good. Also on this side of the street a wide, pink concrete unit paver pathway leads from the East Enid Lake Park to the Village Beach Park. Village standard benches. The combination of the wide walkway, shade, and benches create a successful pedestrian corridor.
- Street trees (mahogany trees) on the north side of East Enid Drive appear to have suffered pretty extensive hurricane damage. Many trees are missing or damaged.

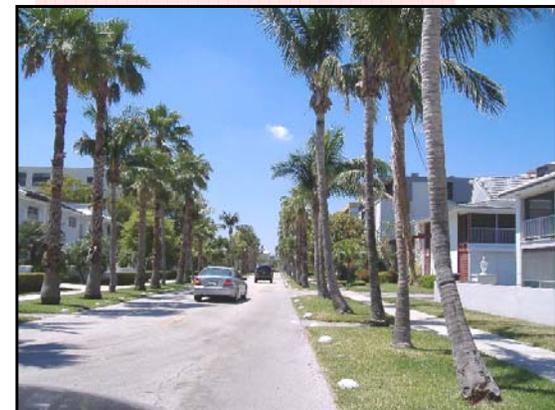
Sunrise Drive and Galen Drive

- Coconut street tree plantings create a recognizable image for this 'neighborhood'.
- White wheel control stones are placed randomly along these streets.

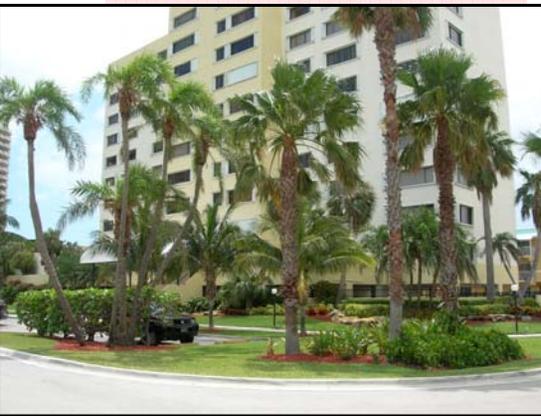
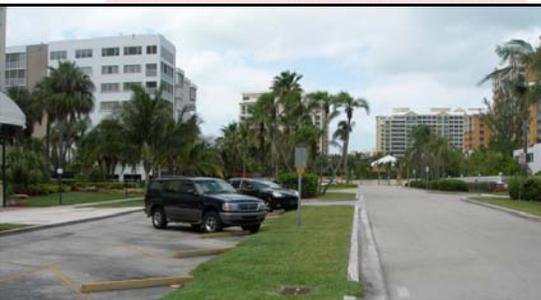
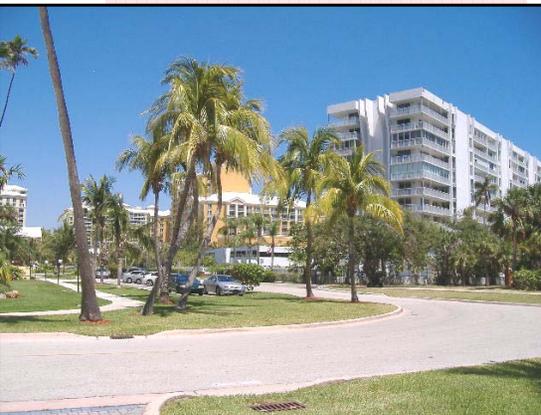
- The east side of Ocean Drive has Queen Palm/Ixora Hedge plantings that are commonly seen throughout Miami, and perhaps overused.
- The west side of Ocean Drive has off-street parking for the Bahia Mar condominiums. This area is maintained by the Village, is in good condition, and is consistent with the landscape around the rest of the Bahia Mar condominium property.
- Curbs are present along Ocean Drive and surround the off-street parking areas.
