Master Landscape Plan

The Village of Key Biscayne

Working Paper I: *Inventory and Analysis of Existing Conditions*

January 20, 2009

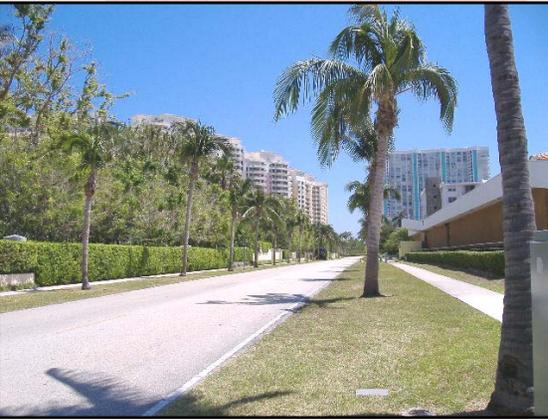
Seaview Drive:

- Improvements are needed along Seaview Drive to realize its full streetscape potential.
- The street has sidewalks on both sides of the street and is lined by beautifully uniform coconut trees, but other improvements are needed to visually engage pedestrians and drivers.
- Streetscape elements do not address valuable community amenities on Seaview Drive (Post Office, Beach Access Corridor)

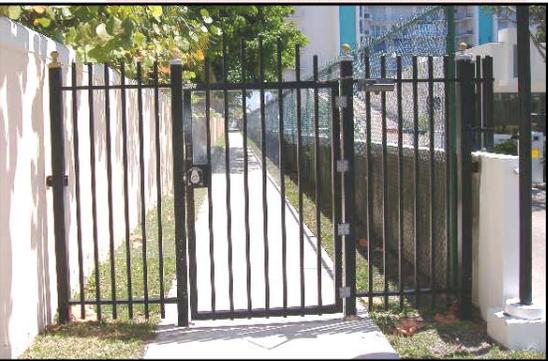
The present beach access corridor (as mapped in the Village of Key Biscayne 2020 Vision Plan) does not welcome community members to the waterfront. Instead, it greets them with a confusing gated entrance (with lock, though unlocked on day of observation) that appears to lead to public condominium property. Beach access identification signage is not present. This access corridor does not send a welcoming message to Village of Key Biscayne community members, visitors, or island guests.

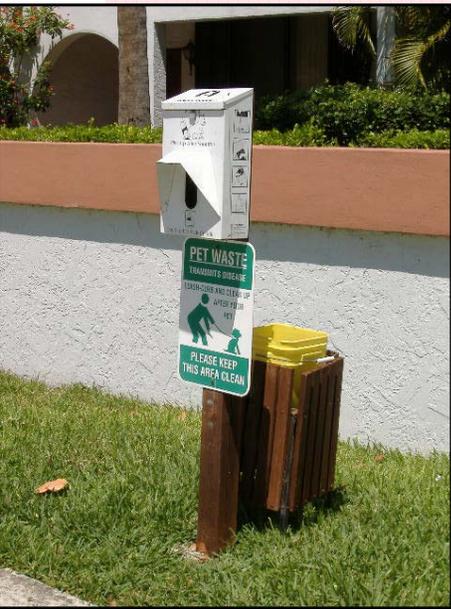
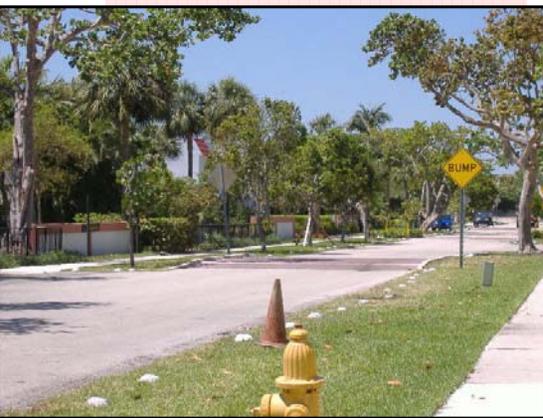
- A pet waste station is present along the street to encourage dog owners to clean up after their pet.
- The cul-de-sac at the end of Grapetree Drive is consistent with Mar Azul landscape, but is not consistent with the Grapetree Drive 'neighborhood' image. However, the recent paver upgrades within the cul-de-sac are consistent with the cobblestone pavement throughout Key Biscayne.
 - Plant species in the cul-de-sac median are ubiquitous to Miami-Dade
 - Specimens are leggy and over-sheared, and turf is patchy

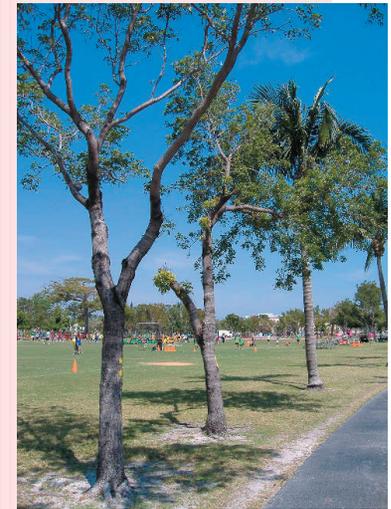
Storm Damage

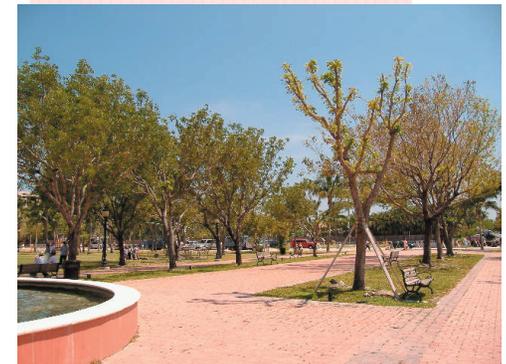
The promenade is lined with mahogany trees on both sides, and in two strips down the center. Some trees are older than others, but none are larger than about 12 inches in trunk diameter. There is a fair amount of limb damage caused by storms. Several trees are staked-up, having been reset following toppling in the storms. They were not properly reset, as their rootballs are above grade and air pockets are present. They do not appear to have been root-pruned. Their long-term survival and structural stability is questionable.

Improperly Reset Mahogany

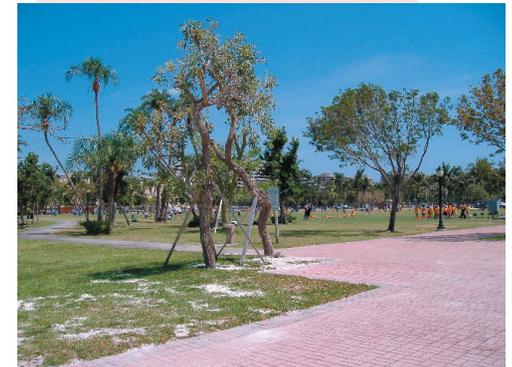
On the west side of the promenade there are numerous silver trumpet trees, many of which have previously toppled and are staked up. Their long-term survival and structural stability is doubtful.

Staked Silver Trumpet Trees

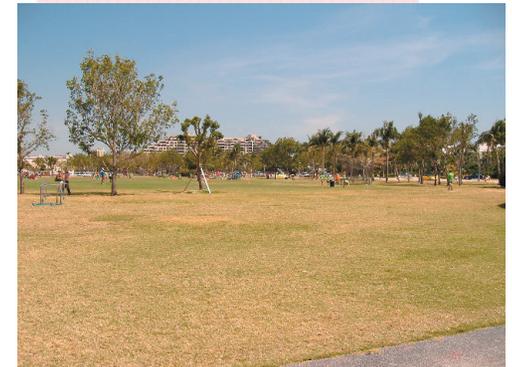
Dry, Weedy Turf

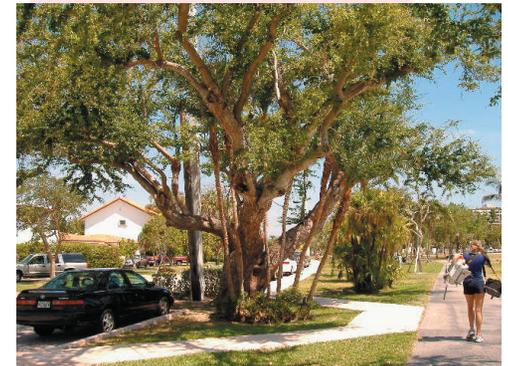
Species	Condition	Comments
Manila Tamarind (2)	Poor	Severe Trunk and Limb Damage/Decay

Manila Tamarind

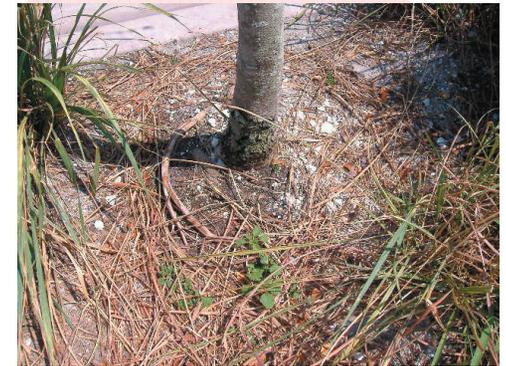
One tree in front of the Community Center is defoliated and loose in the ground. Large circling roots are apparent at or just below the soil surface.

Mahogany with Circling Roots

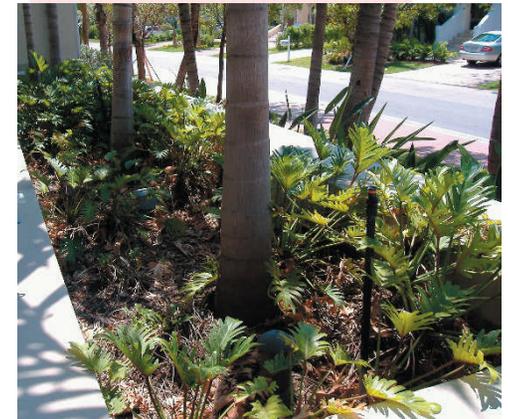
Veitchia Palm	Fair	Nutritional Deficiencies
Philodendron 'Xanadu'	Poor	Sections Rotted Out

Philodendron 'Xanadu' with
Die-out from Fungal Rot

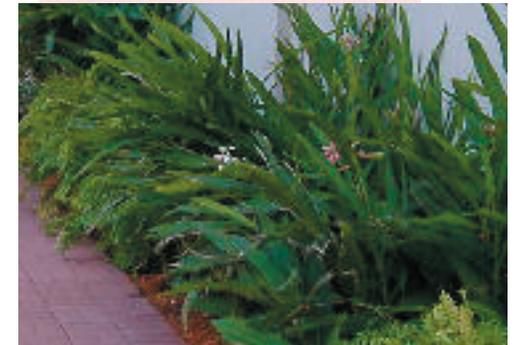
Shell Ginger	Fair	Dry/Wind Damaged Improperly Pruned
Heliconia psittacorum	Fair	Susceptible to Nutritional Problems

Wind Damaged Shell Ginger

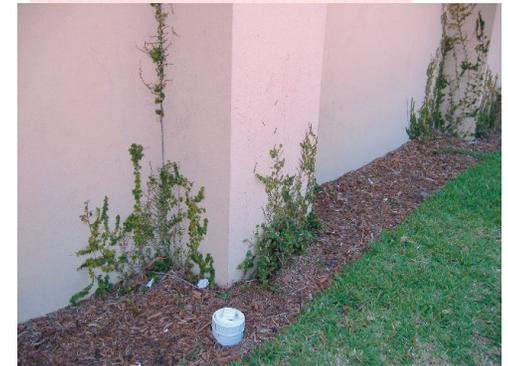
On the east side, there are small planters at the base of each column, each of which contains creeping fig vines. The plants are not performing well. The soils are dry and rocky, and there is a lot of foot traffic damage. Bubbler heads are present but may not be working properly.

Species	Condition	Comments
Creeping Fig	Poor	In Decline/Trampled

Creeping Fig in Decline

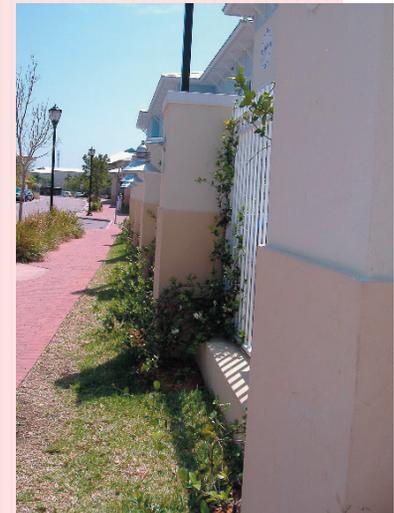
Confederate Jasmine
in need of Training

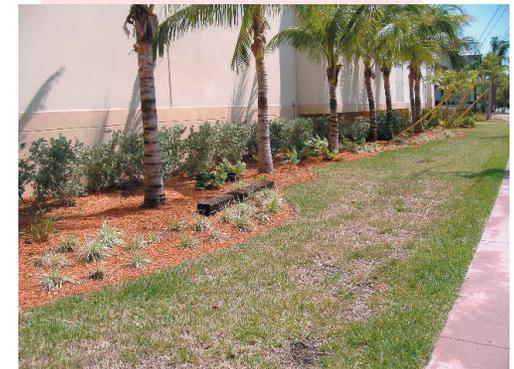
On the west side there appear to be irrigation problems. The St. Augustine turfgrass is very dry, with some chinch bug infestation. The bed lines are very irregular.

Irregular Bed Lines and
Chinch Bugs in Turfgrass

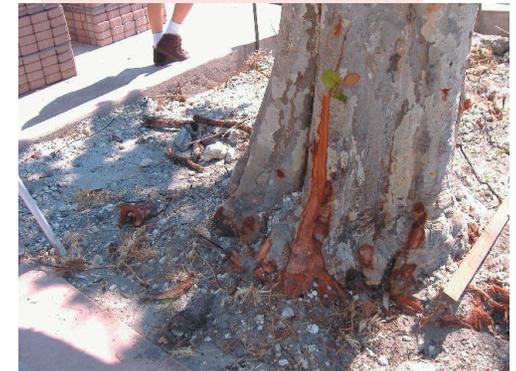
Damaged Sea Grape

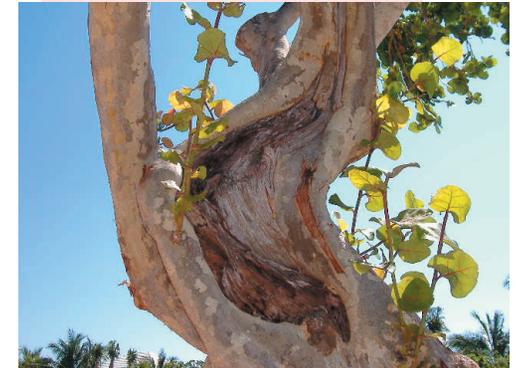
Damaged Sea Grape

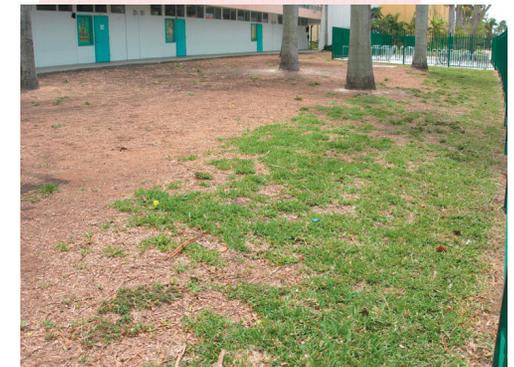
It appears that there may have been some large tree losses due to hurricane damage in this area. One large Benjamin fig tree is in poor condition, and one old poinciana tree is in fair condition. Several large royal palms are in good condition. The St. Augustine turfgrass is in extremely poor condition due to foot traffic.

St. Augustine Turfgrass
in Poor Condition

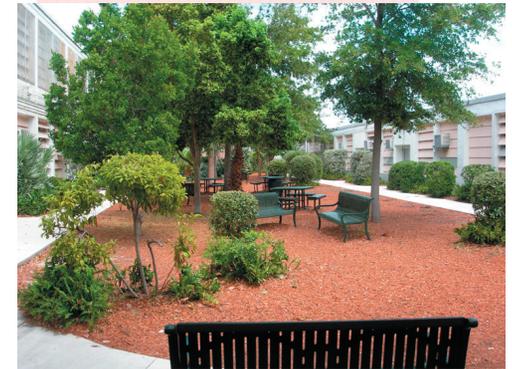
There is one large courtyard area in between two buildings in which native trees, shrubs, and ground covers have been planted. There are mulched paths and seating areas. This was apparently intended to be a naturalistic native planting, but some non-native species were used. Most the plants are in good condition, but many of the native trees and shrubs have been pruned to shape or round them over into an unnatural form.

Unnaturally Pruned Plants

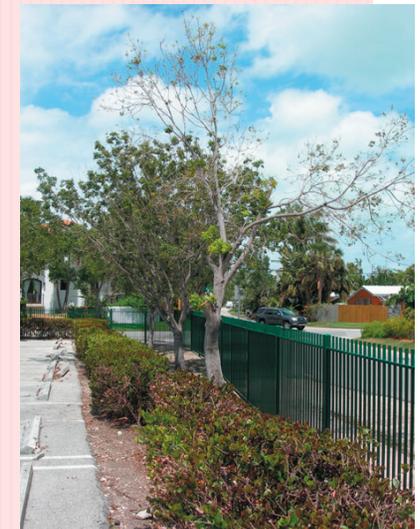
The parking lot contains mahogany trees and a cocoplum hedge around the perimeter. The trees are in good condition except for those which have been hurricane-damaged. There are numerous gaps in the planting. The cocoplum hedge is in good condition except where damaged by the storms. There are gaps in the hedge where trees have been removed.

Damaged Mahogany Tree

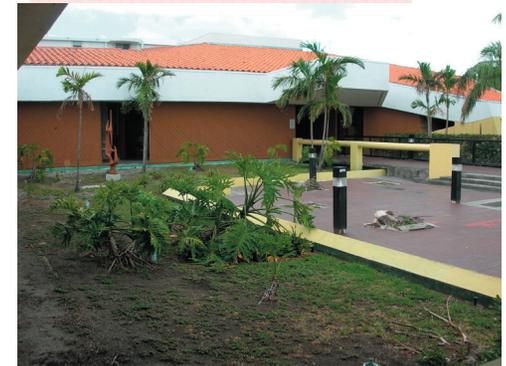
The post office plantings are old and in very poor condition. Many plants are dead or dying, or missing altogether. There are wash-outs on the slopes, broken concrete planter borders, tree stumps, and obvious irrigation issues (broken heads, lines, and no water being delivered). There is virtually no plant material here worth salvaging, except for one Senegal date palm and the old seagrape trees in the right-of-way (included in Crandon Boulevard section).

Post Office Landscape

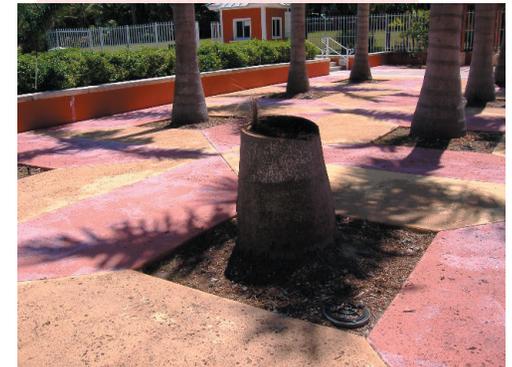
Species	Condition	Comments
Royal Palm	Fair	1 dead; others with correctable nutritional deficiencies
Ruellia	Good	
Wax Jasmine	Good

Missing Royal Palm in Formal Planting

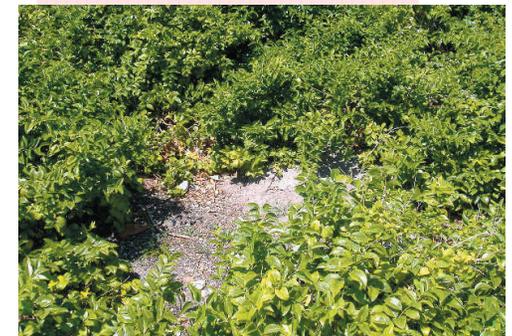
It appears as though there may have been trees or palms within the wax jasmine planting at some time in the past (storm damage?).

Possible Missing Plant Location in Wax Jasmine

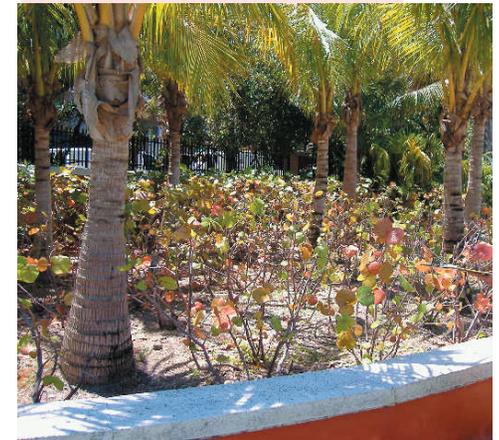
Sea Grape Hedge

This area has a walkway to the pavilion/shower buildings, adjacent to the north fence. There is a large open turf area, with plantings along the edges. Plant and soil conditions suggest past and/or present irrigation issues. The turf is rutted and weedy, suggesting that there has been an underground irrigation leak or break; there was no longer any standing water, therefore, the break has probably been repaired. The shrub plantings are generally leggy and stressed, suggesting that they were previously watered at high rates, then at low rates (or none) due to irrigation problems. The plantings include the following:

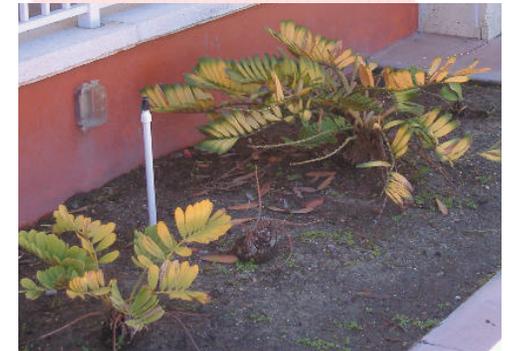
There are plantings around the building perimeters but most have died out, probably due to excess water. There was standing water in the beds on the west side of the pavilion, where there is most likely a broken water line. The beds on the east side are nearly bare.

Flooded Cardboard Plants

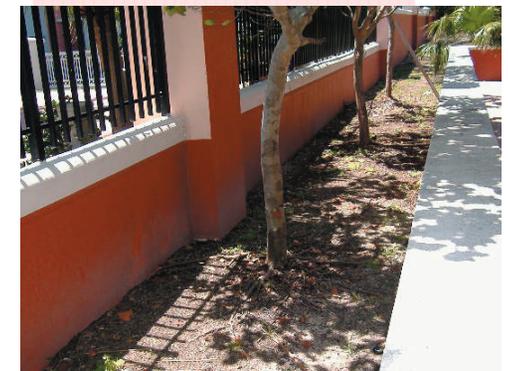
There is a walkway to the beach, with hedges along each side and turfgrass in an open area. Some plantings line the north and south perimeters. Those along the south perimeter have largely died out (possibly due to storms, shade, or excess water accumulation), and trash and weeds have accumulated next to the wall.

Empty Planting Beds

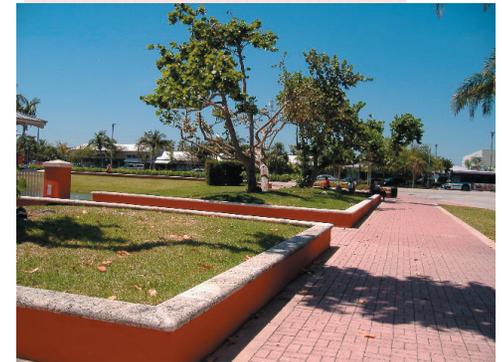
East End Lake Park Landscape

Species	Condition	Comments
St. Augustine turfgrass	Fair to Good	Some dry spots/chinch bugs Uneven grade near planters
Seagrape	Good	
Senegal Date Palm	Fair	
Coconut Palm	Good	
Liriope 'Evergreen Giant'	Fair	A few plants only
Beach Naupaka	Fair to Poor	Growing over fence from Ocean Club – needs pruning, but there is no access except by boat

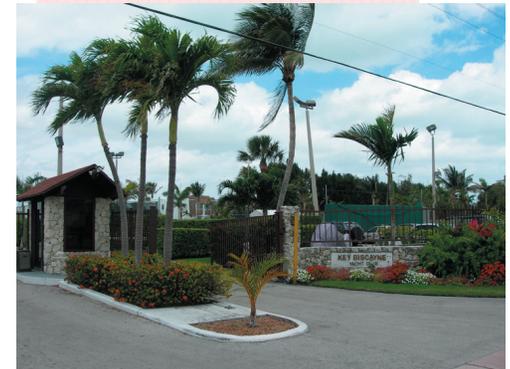
Yacht Club Entrance

The front entrance to the Yacht Club is maintained by the Village. There are palm and hedge plantings along the edge of Harbor Drive, and some specimen plantings in front of the guardhouse. On either side of the entrance there are mixed species plantings which are over-grown and need some separation. Shade trees and ficus hedges line outside of the chainlink fence on both sides of the entrance. It is generally well-maintained.

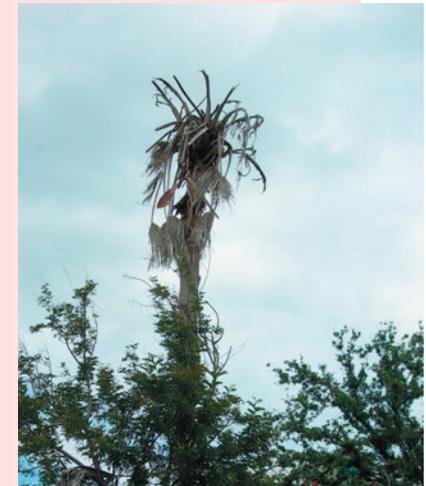
This is an older planting which is generally in poor condition. The trees incurred significant storm damage and there is evidence of past and/or current irrigation issues. Conditions suggest that irrigation had been provided at high rates prior to the storms, then at low rates or none at all after the storms due to damages incurred. There is barely any mulch present; there is mostly bare soil. The paver bricks by the seating area have weeds in the cracks.

Dead Mexican Fan Palm

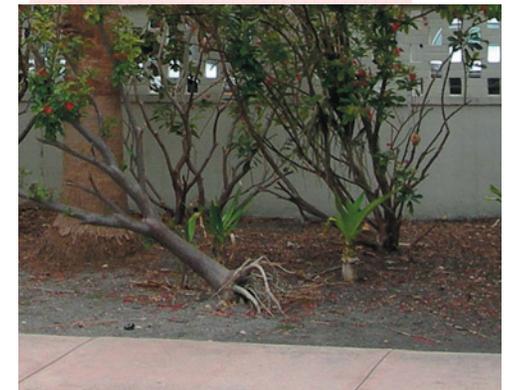
Species	Condition	Comments
Peregrina	Fair to Poor	Many toppled or leaning Many chlorotic
Cinnecord	Fair to Poor	Most toppled
Mexican Fan Palm	Good	1 dead
Crinum Lily	Fair	Some Stunted/Chlorotic Some with thrips insects

Toppled Cinnecord

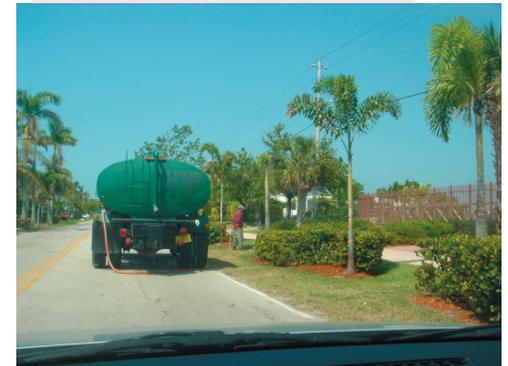
1. Harbor Drive – north of West Mashta Drive: There is no irrigation in any of the medians or traffic circles. The area in front of the Yacht Club at the edge of Harbor Drive has no irrigation. Watering of these areas is being done by a City water truck (observed).

Water Truck on Harbor Drive

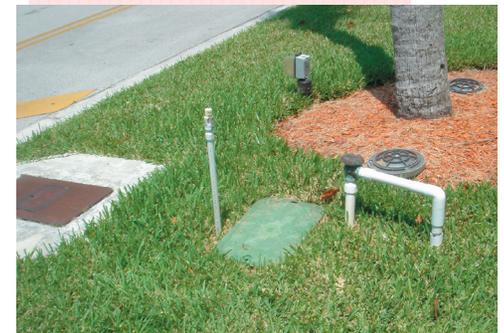
2. Harbor Drive – south of West Mashta Drive: Medians have marginal irrigation. They consist of spray heads on white risers, some 4" pop-ups in turf areas and battery operated control valves. Coverage for these landscape spaces is not adequate.

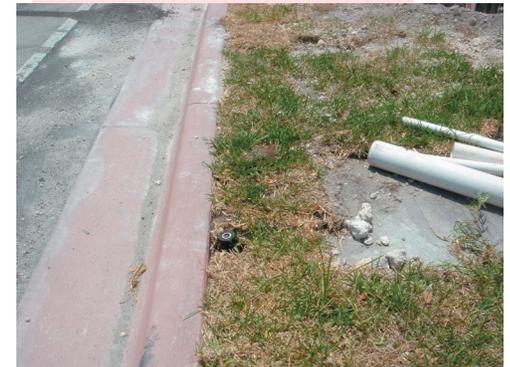
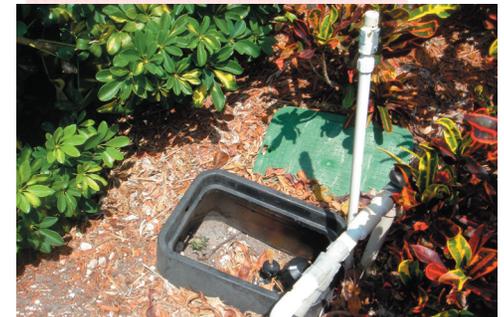
1. Park at Entrance – Some irrigation working. Hunter rotor heads, and Hunter controller. Heads are operational, coverage is marginal.

2. The landscape strip on the south side of E.Enid Dr., does not appear to have irrigation. The landscape areas were dry, and in poor condition due to lack of water.

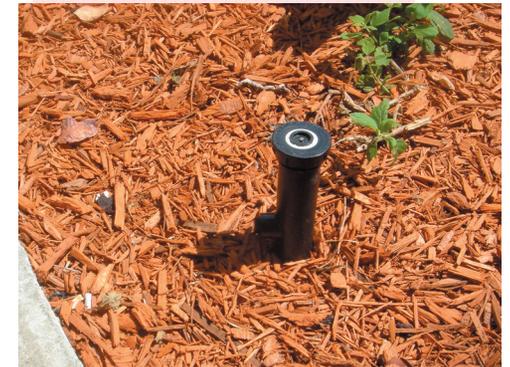
2. Play fields are dry. No sign of irrigation was observed, and we could not find any irrigation equipment on the play fields.

3. The east side of the school, has some irrigation equipment (pop-up spray heads) around the entrance to building. Many areas along the street, and grass paver block parking, do not have any irrigation. The irrigation on the east side of the building did not appear to be working, or has been shut off.
