Stormwater Management Master Plan Update

Village of Key Biscayne

June 28, 2011

TETRA TECH

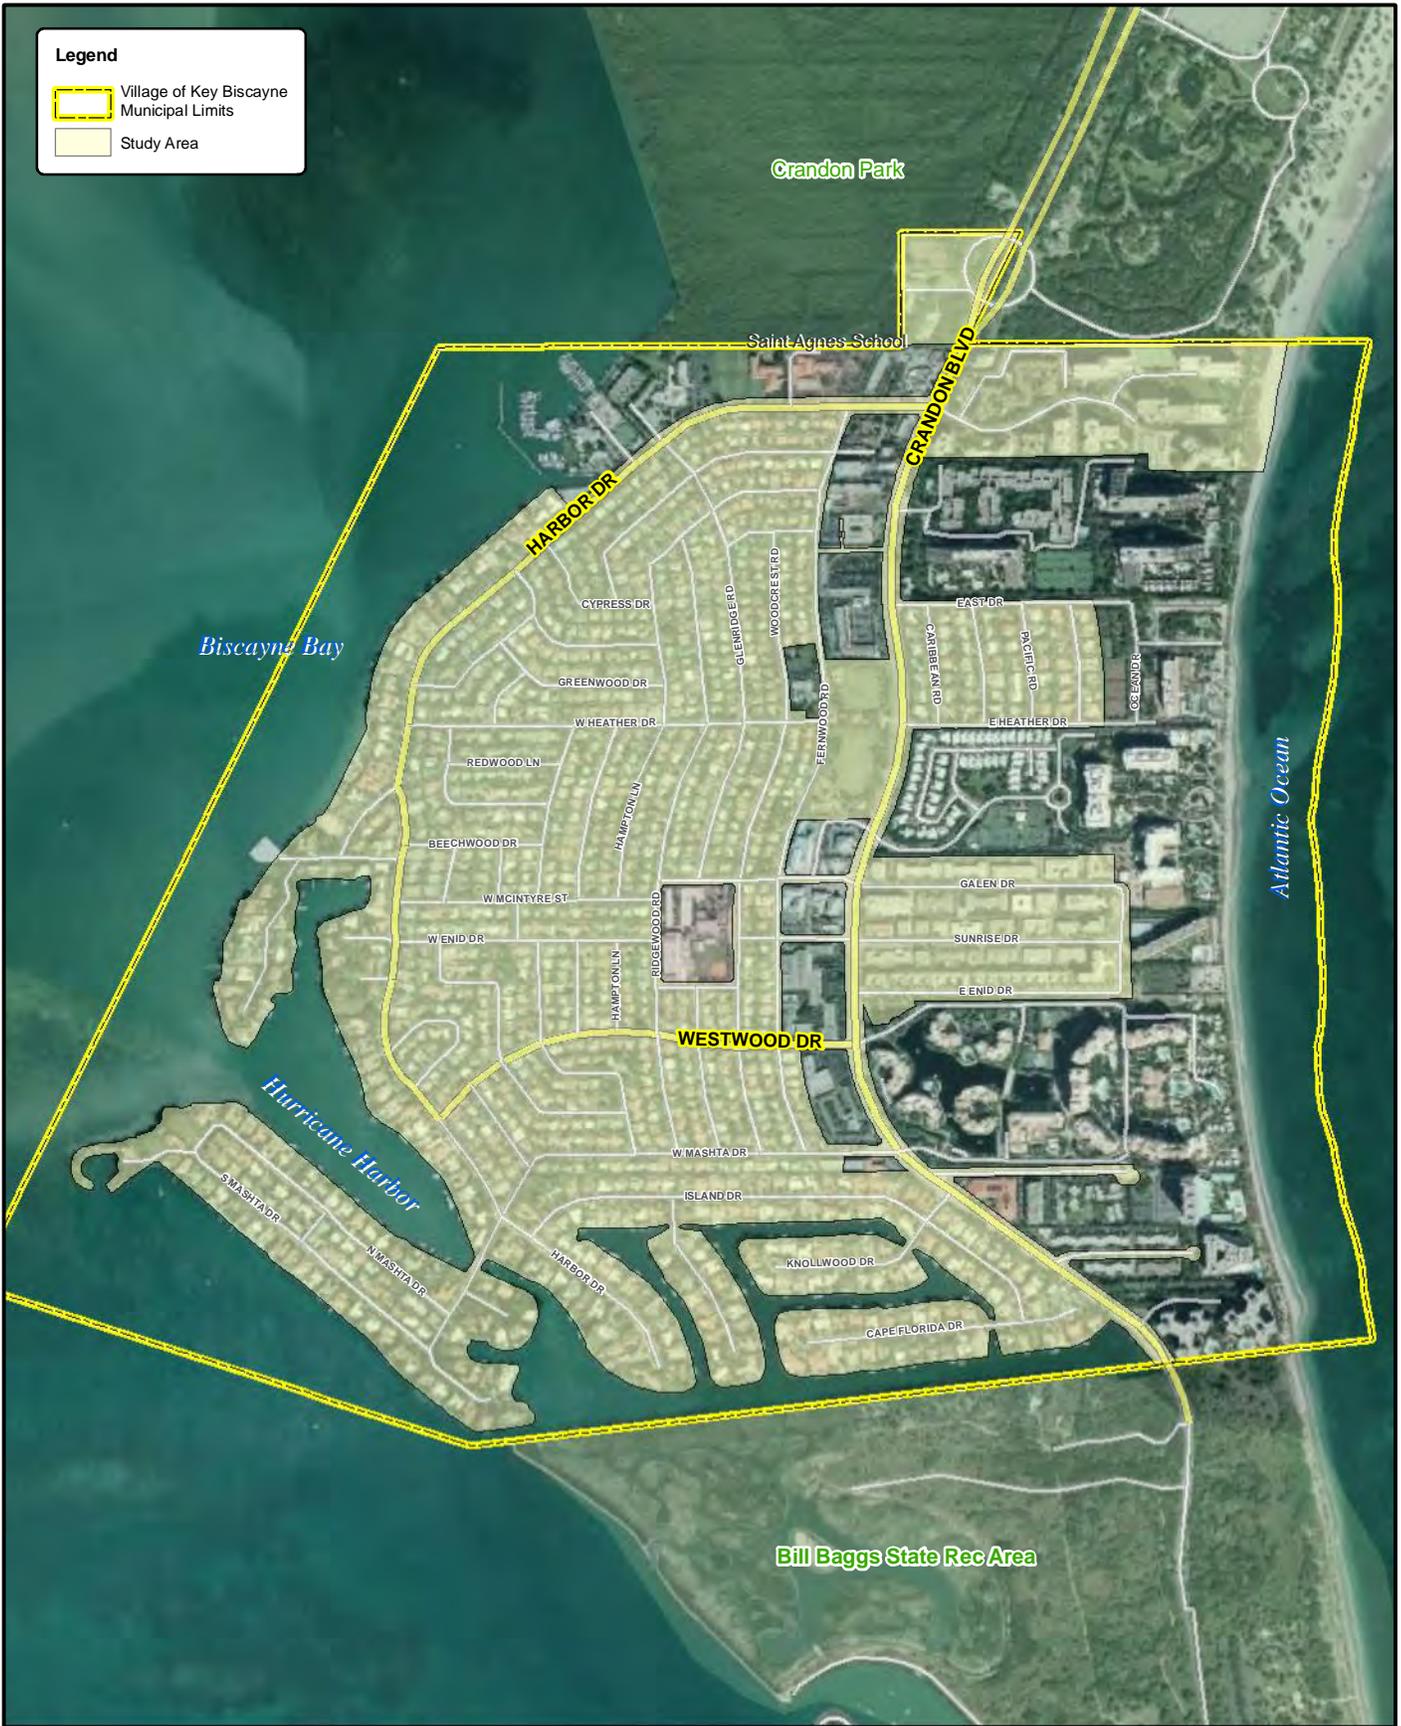
Figure 2.1

**STUDY AREA MAP
STORMWATER MASTER PLAN UPDATE
VILLAGE OF KEY BISCAINE, FLORIDA**

The project area encompasses the entire area within the Village municipal boundary, though the study area, for purposes of master plan recommendations, does not include the entire Village. The study area is described below, along with the characteristics that affect stormwater management planning. This stormwater master plan updates the previous master plan efforts by improving the utility atlas, including GIS mapping and running hydraulic/hydrologic models to determine the existing capacity of the system and defining the deficiencies by offering solution alternatives. **Figure 2.1** illustrates the limits of the Village.

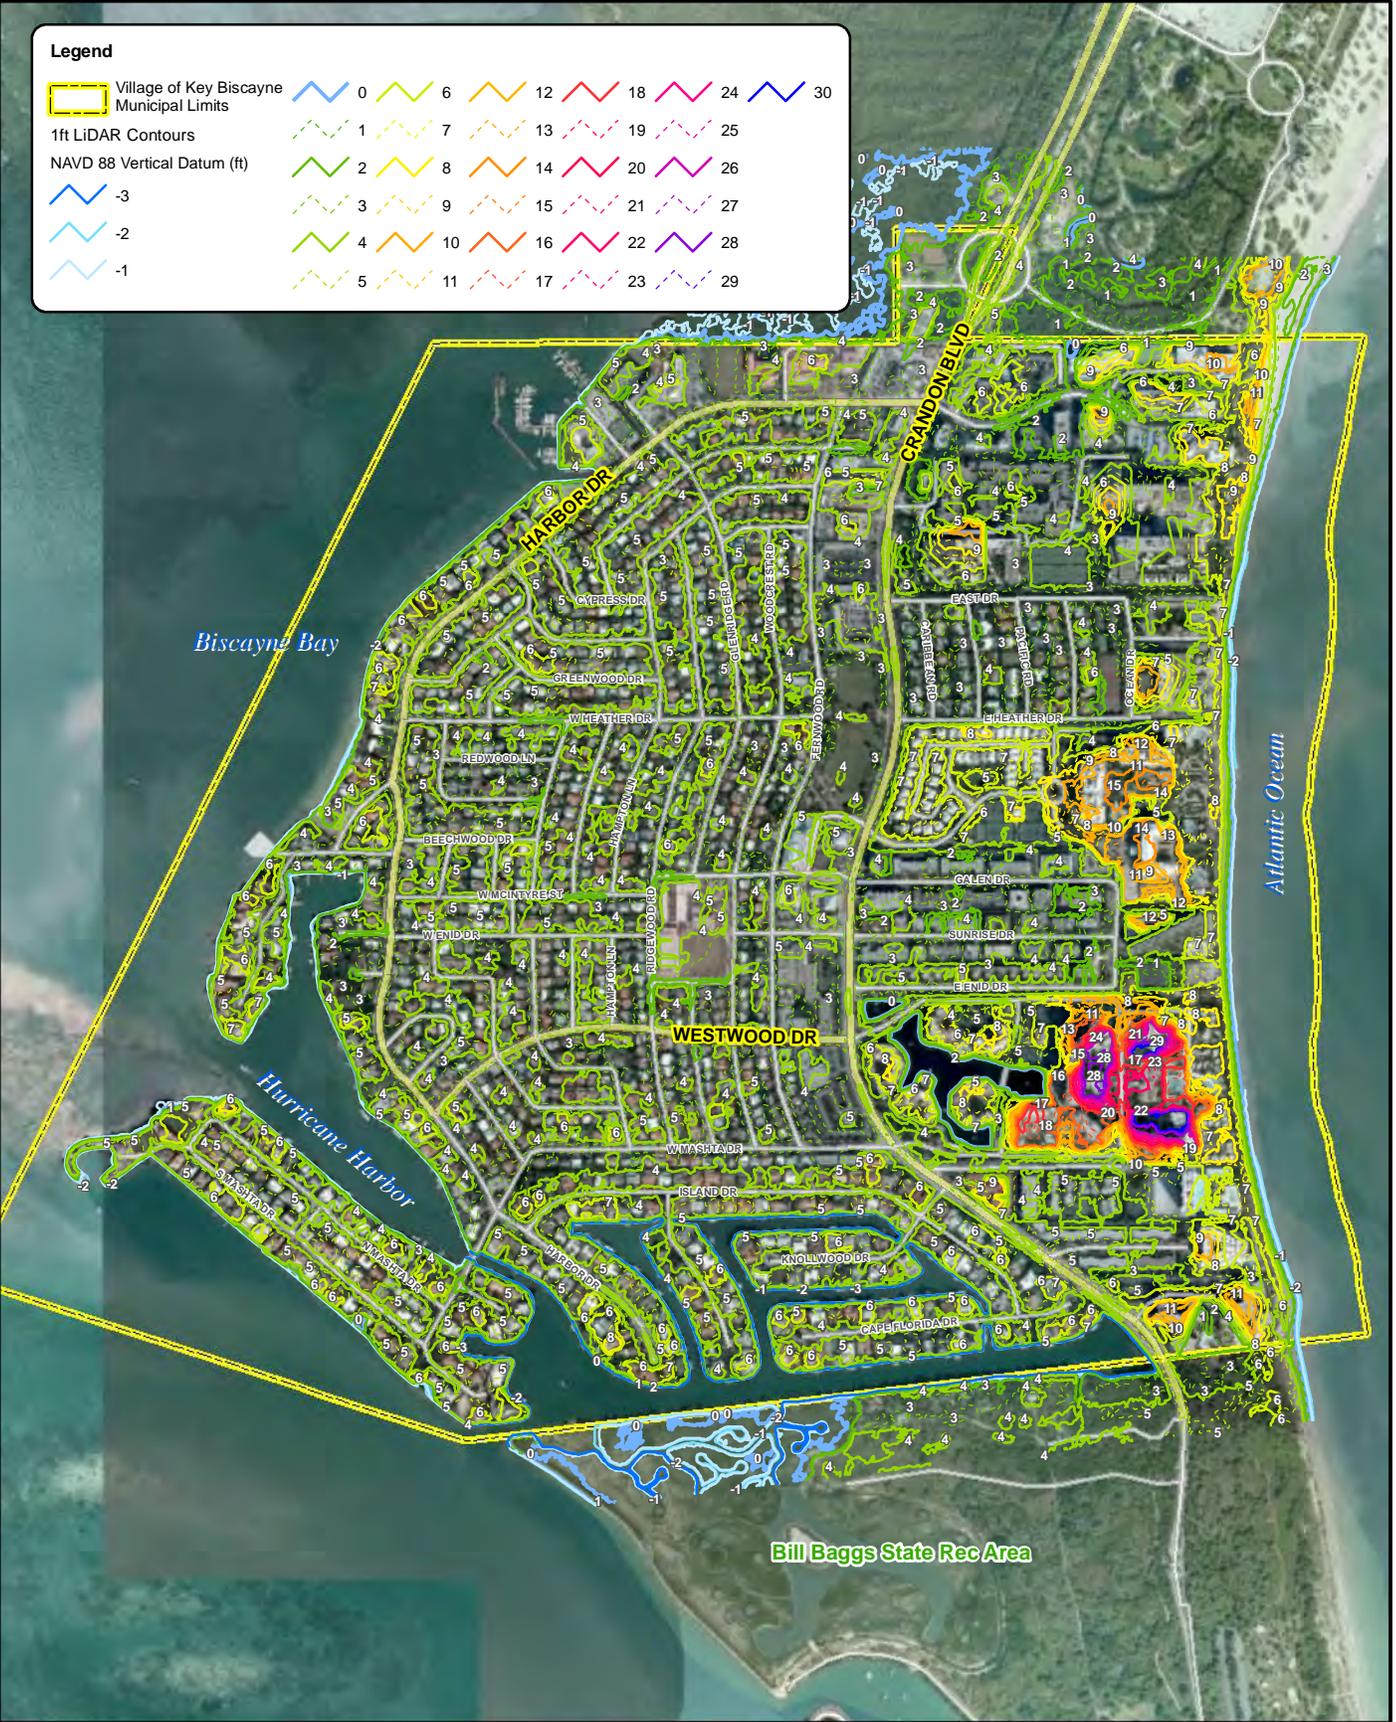
**LIDAR CONTOUR MAP
STORMWATER MASTER PLAN UPDATE
VILLAGE OF KEY BISCAIYNE, FLORIDA**

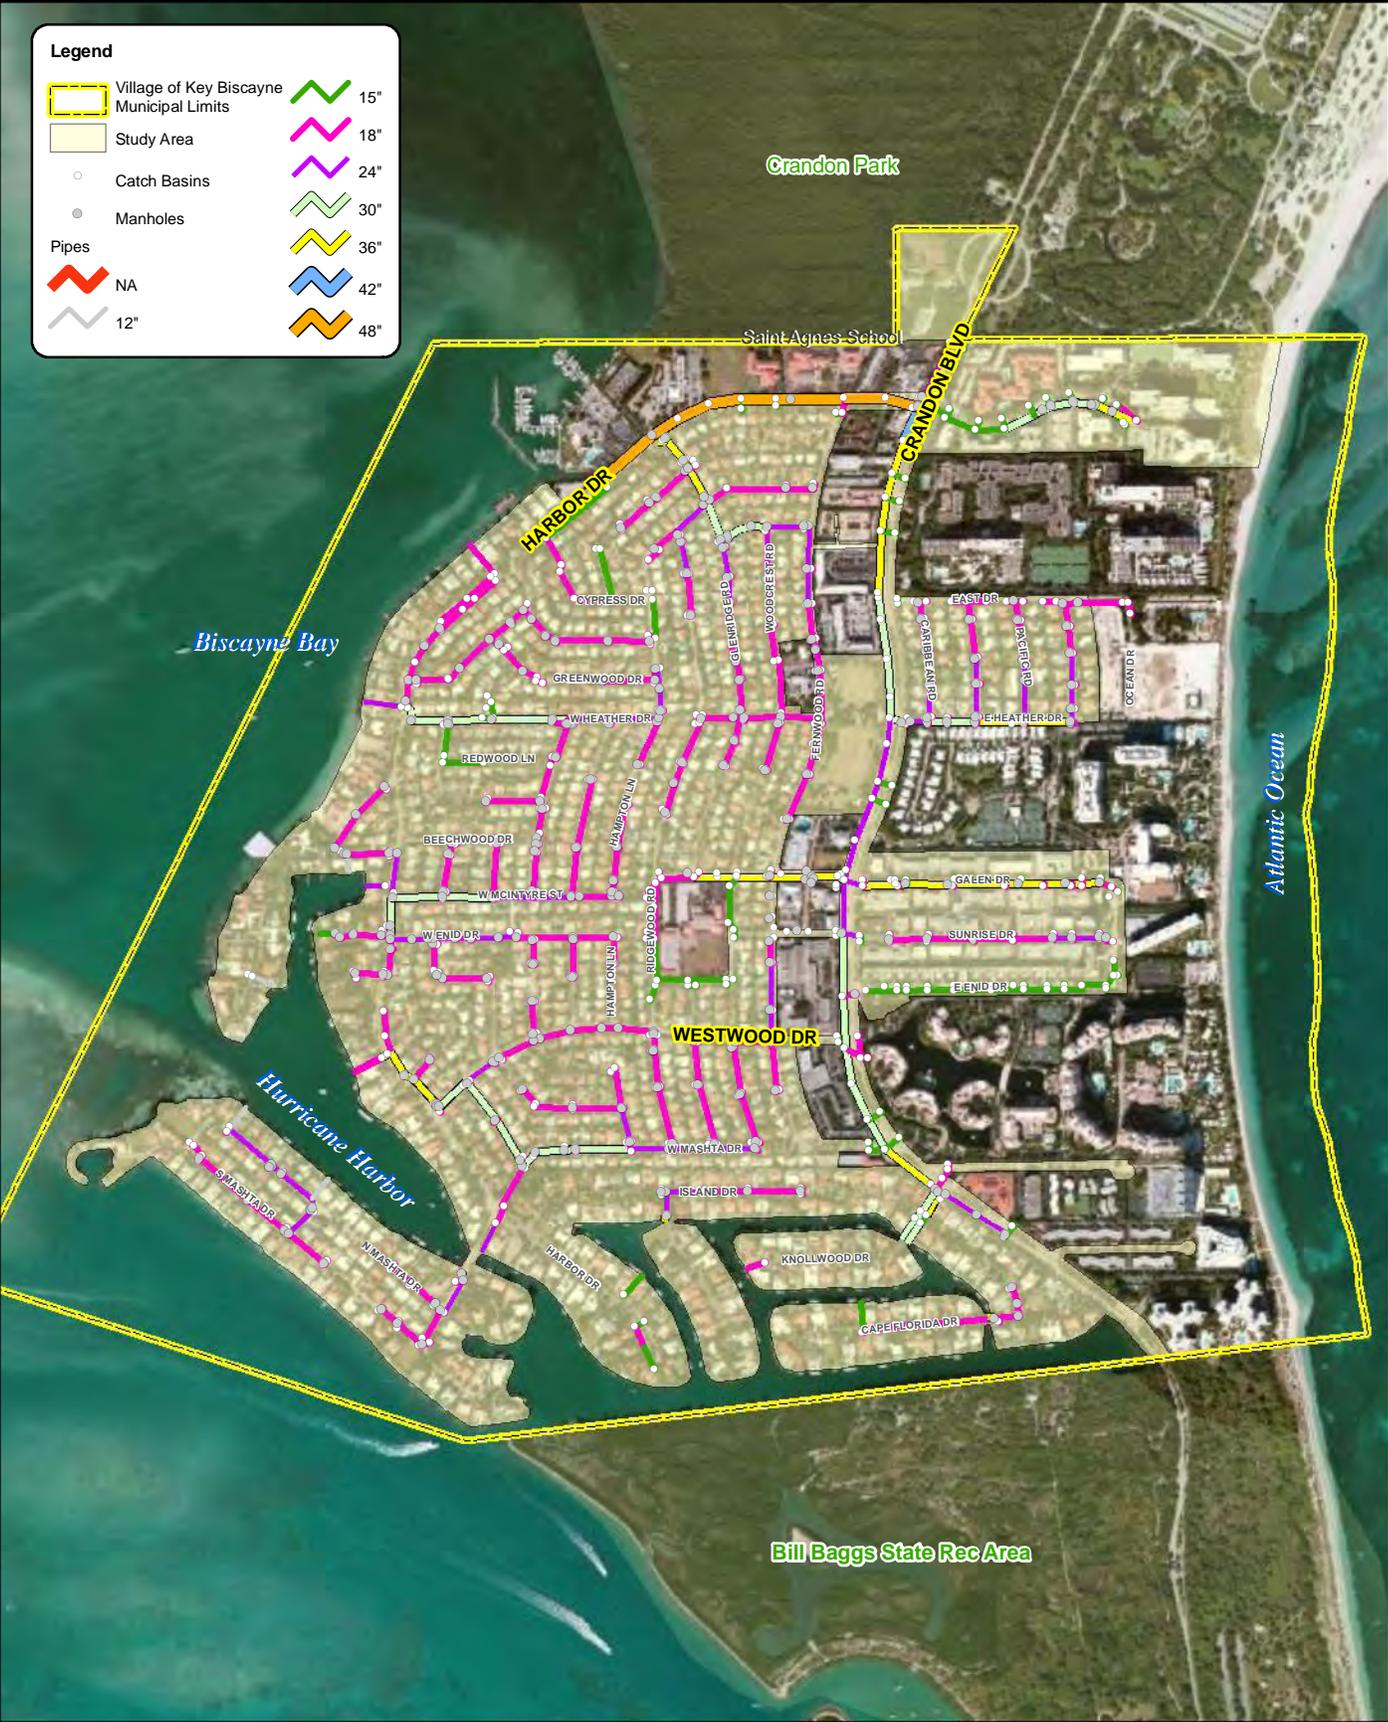
- Village of Key Biscayne Municipal Limits
- Study Area
- Catch Basins
- Manholes
- Pipes**
- NA
- 12"
- 15"
- 18"
- 24"
- 30"
- 36"
- 42"
- 48"

**EXISTING STORMWATER SYSTEM MAP
STORMWATER MASTER PLAN UPDATE
VILLAGE OF KEY BISCAINE, FLORIDA**

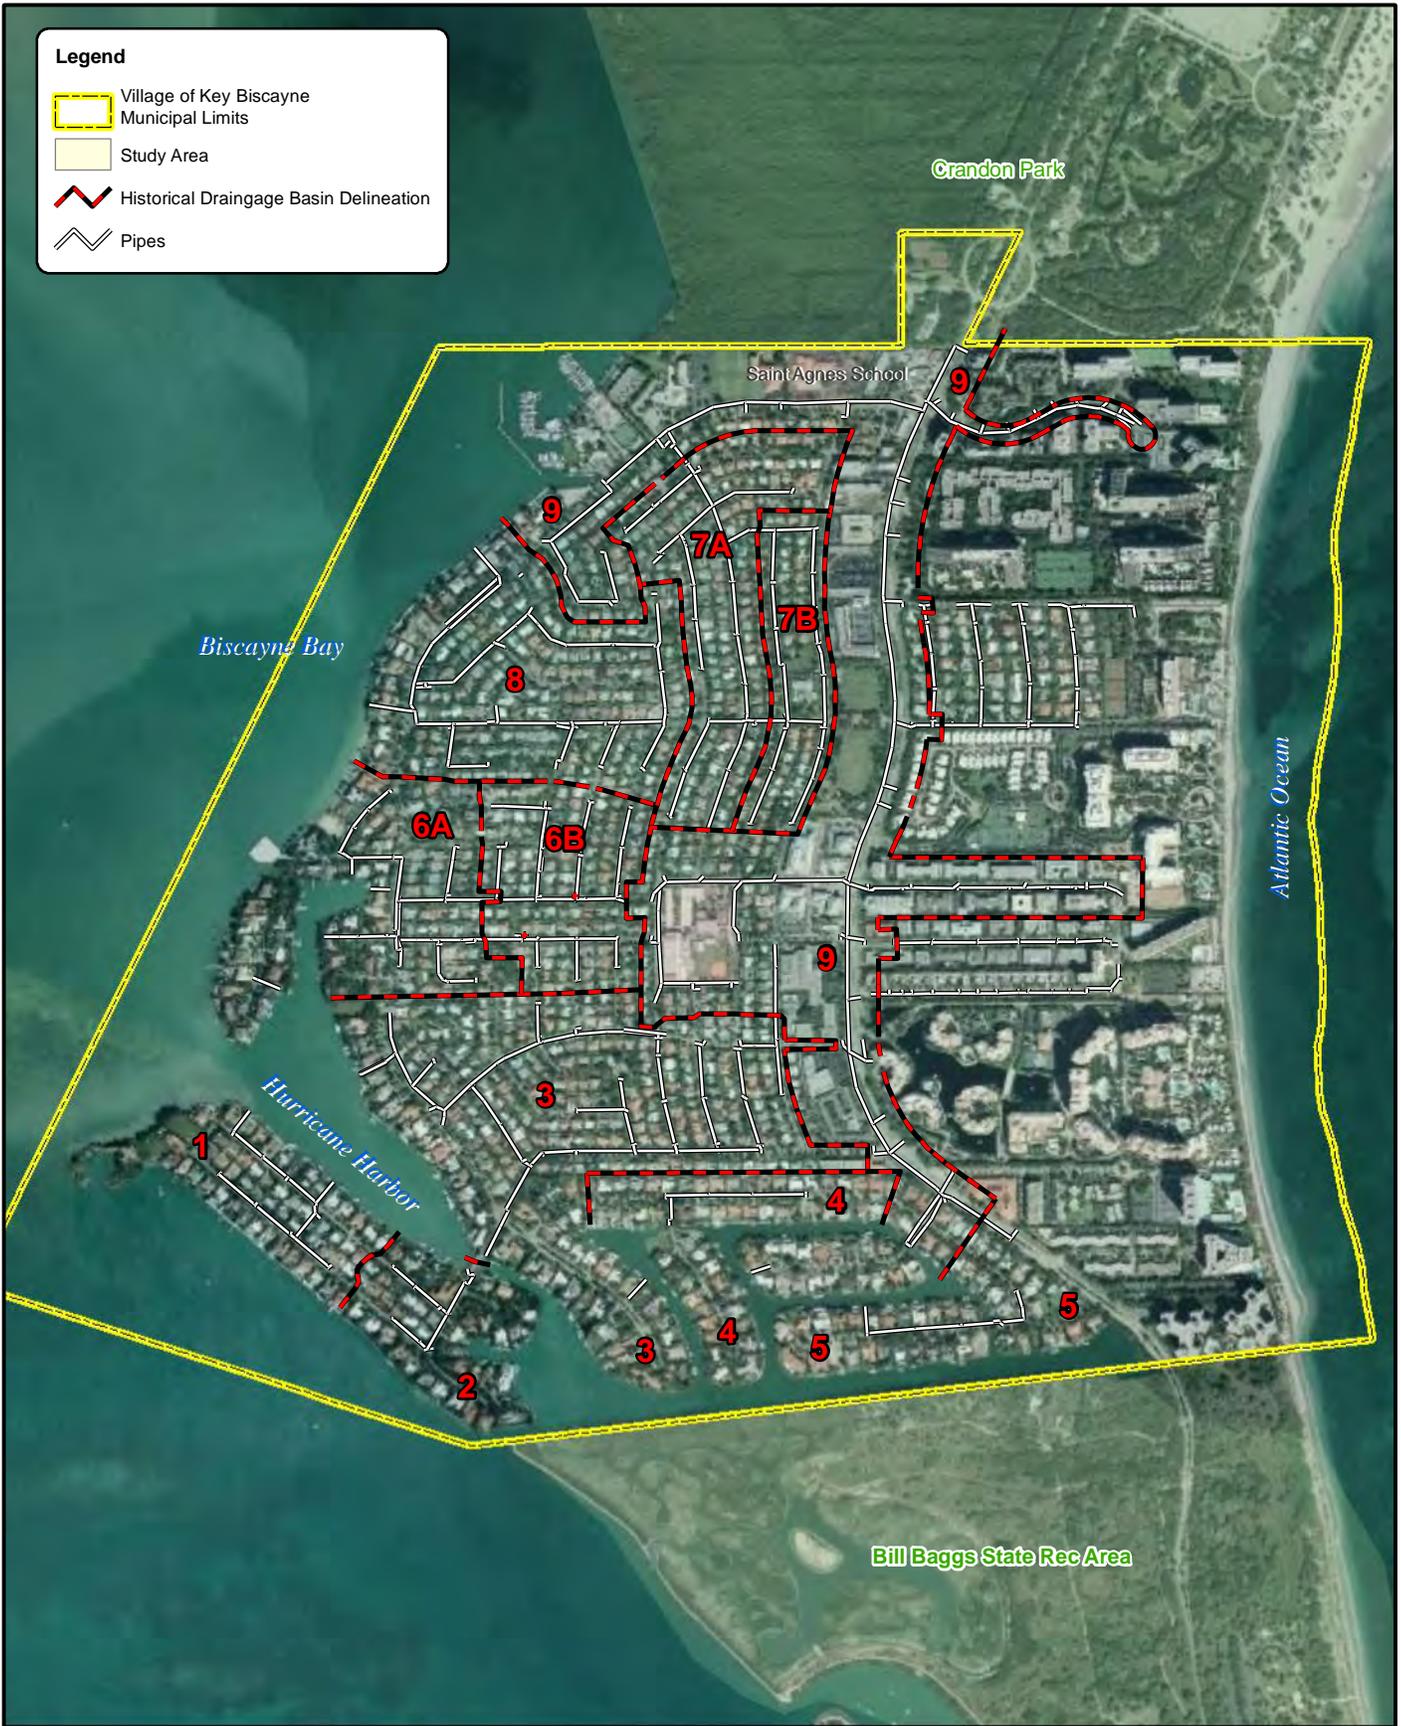
**HISTORICAL DRAINAGE
BASIN DELINEATION
STORMWATER MASTER PLAN UPDATE
VILLAGE OF KEY BISCAINE, FLORIDA**

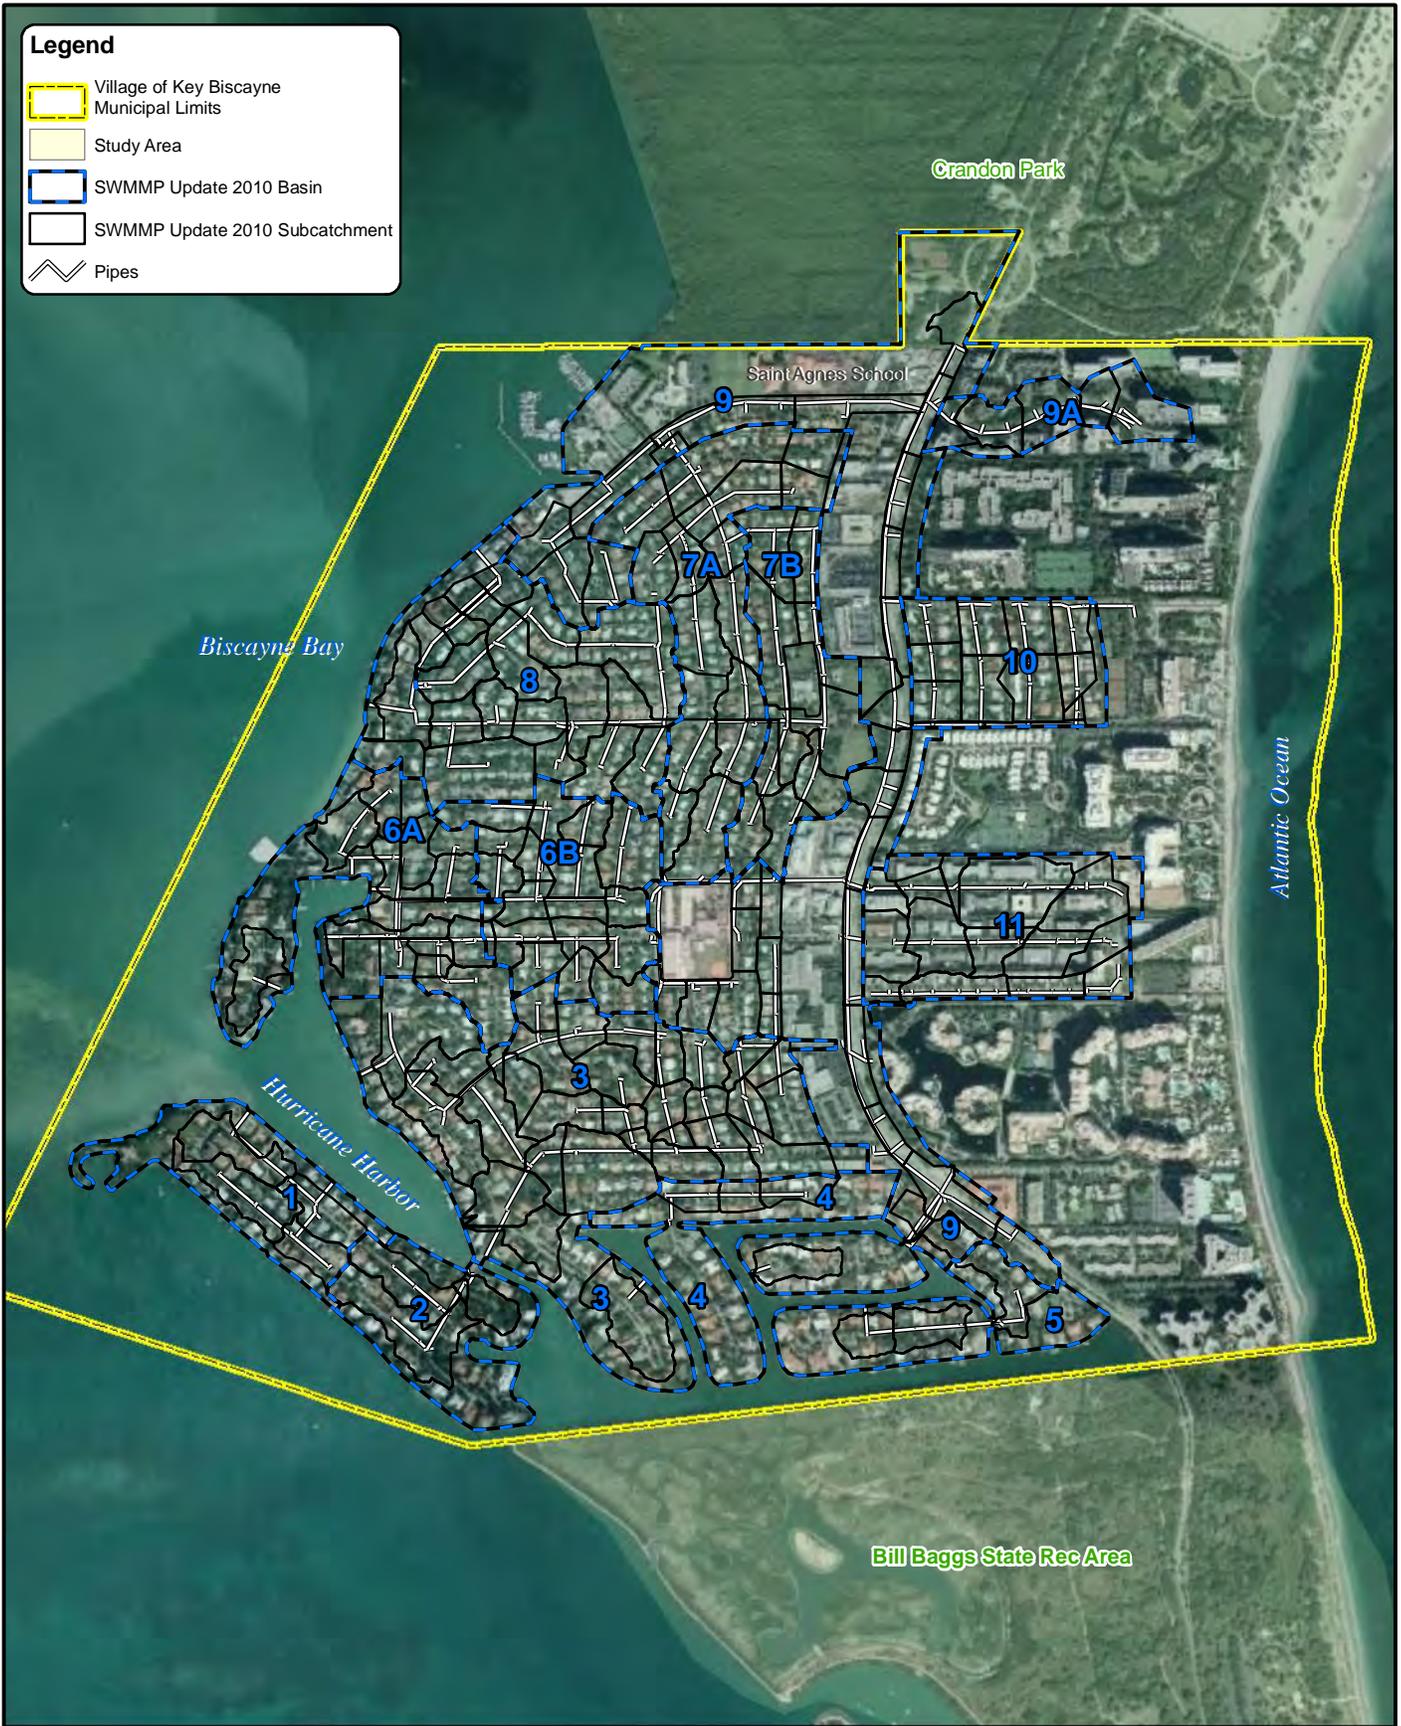
**UPDATED DRAINAGE
BASIN DELINEATION
STORMWATER MASTER PLAN UPDATE
VILLAGE OF KEY BISCAIYNE, FLORIDA**

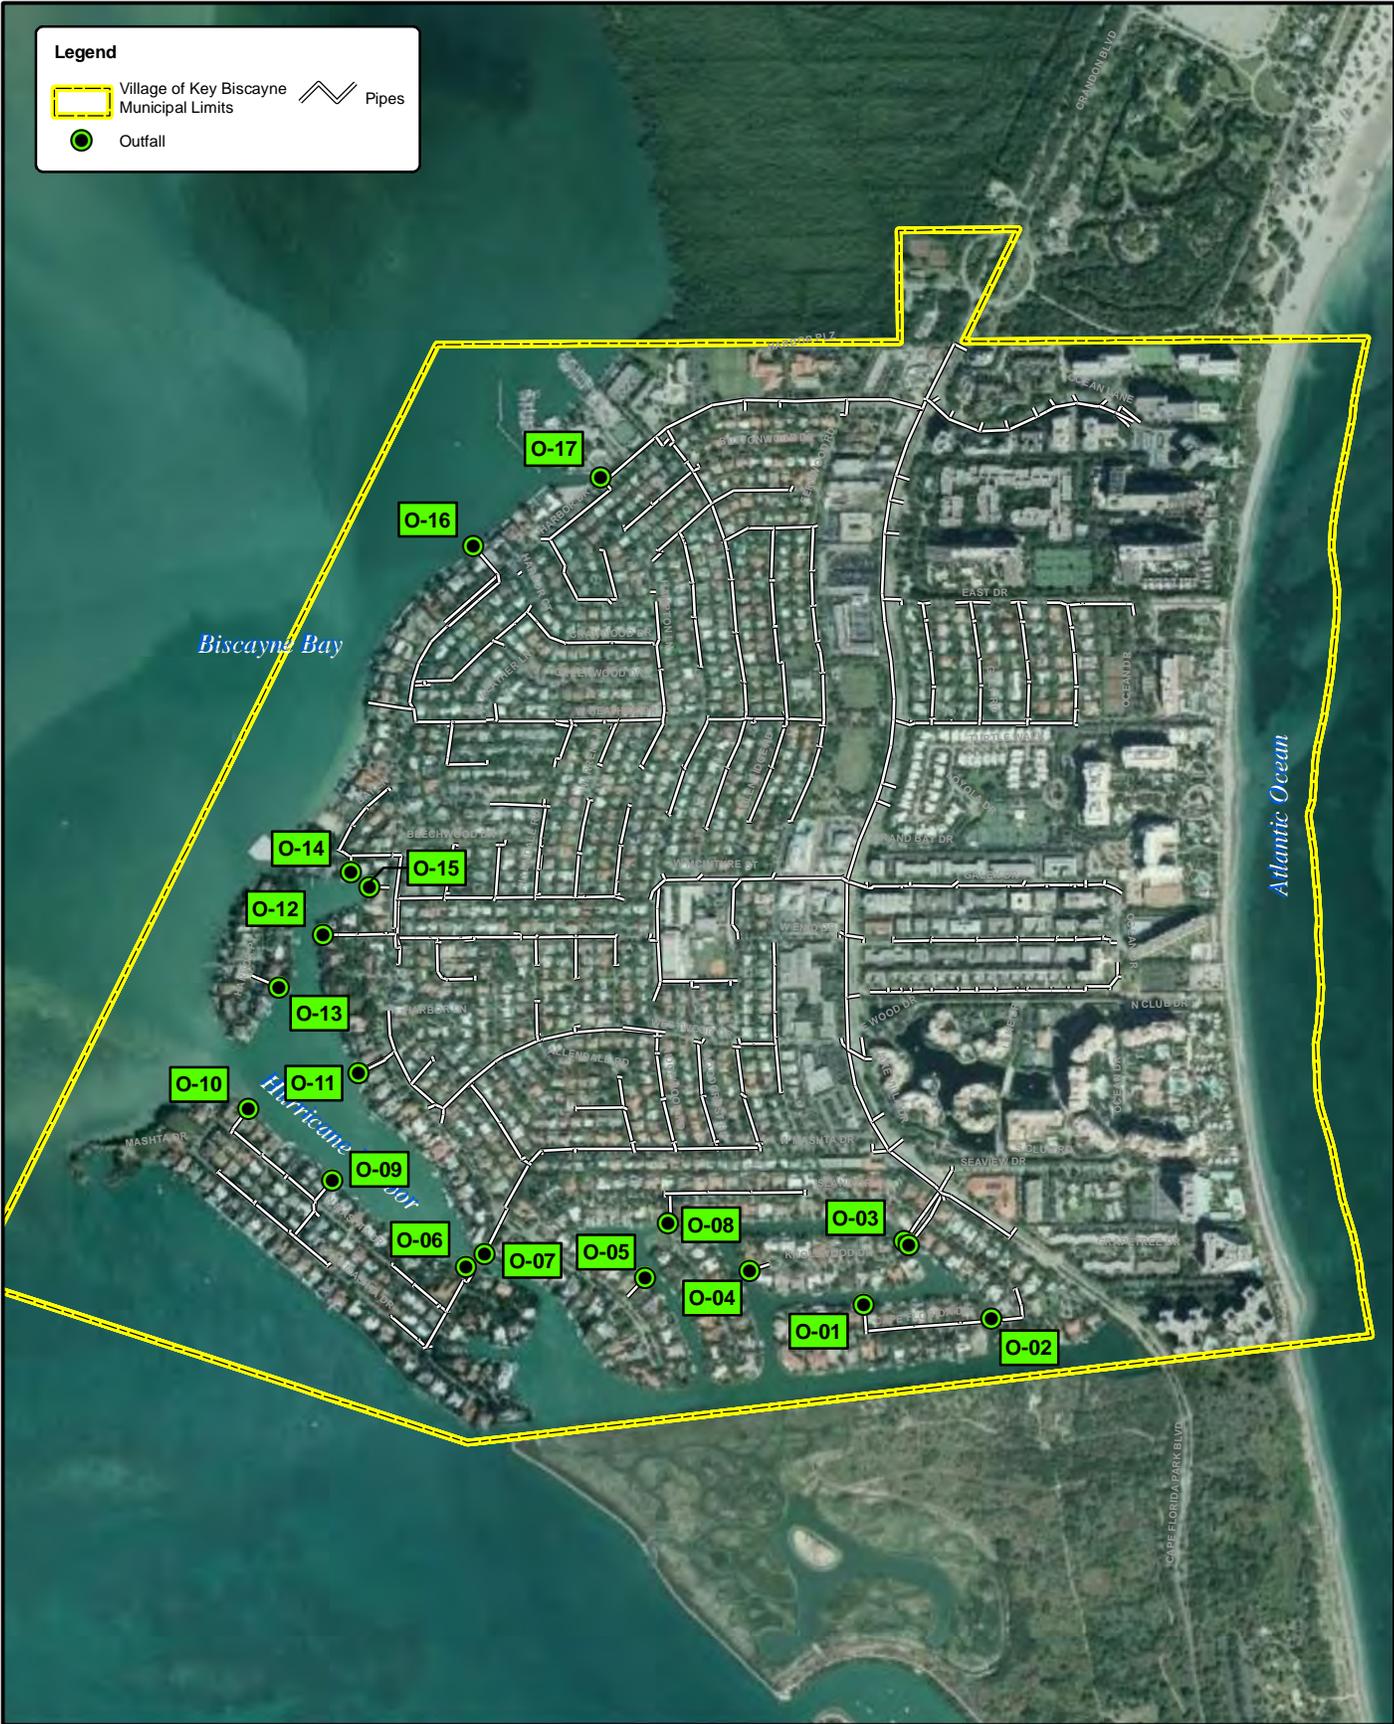
Figure 2.9

**OUTFALL LOCATION MAP
STORMWATER MASTER PLAN UPDATE
VILLAGE OF KEY BISCAINE, FLORIDA**

There are 17 outfalls from individual drainage systems permitted by DERM in the Village. The outfalls range from 8" to 48" in size and were permitted and installed between 1969 and 1992. Many of the outfalls were constructed between residential lots, which limit access to them. It could not be determined, therefore, if all of these outfalls are open and functioning. Some may be silted over or otherwise inoperable. Positive outfall locations are shown in **Figure 2.9**.

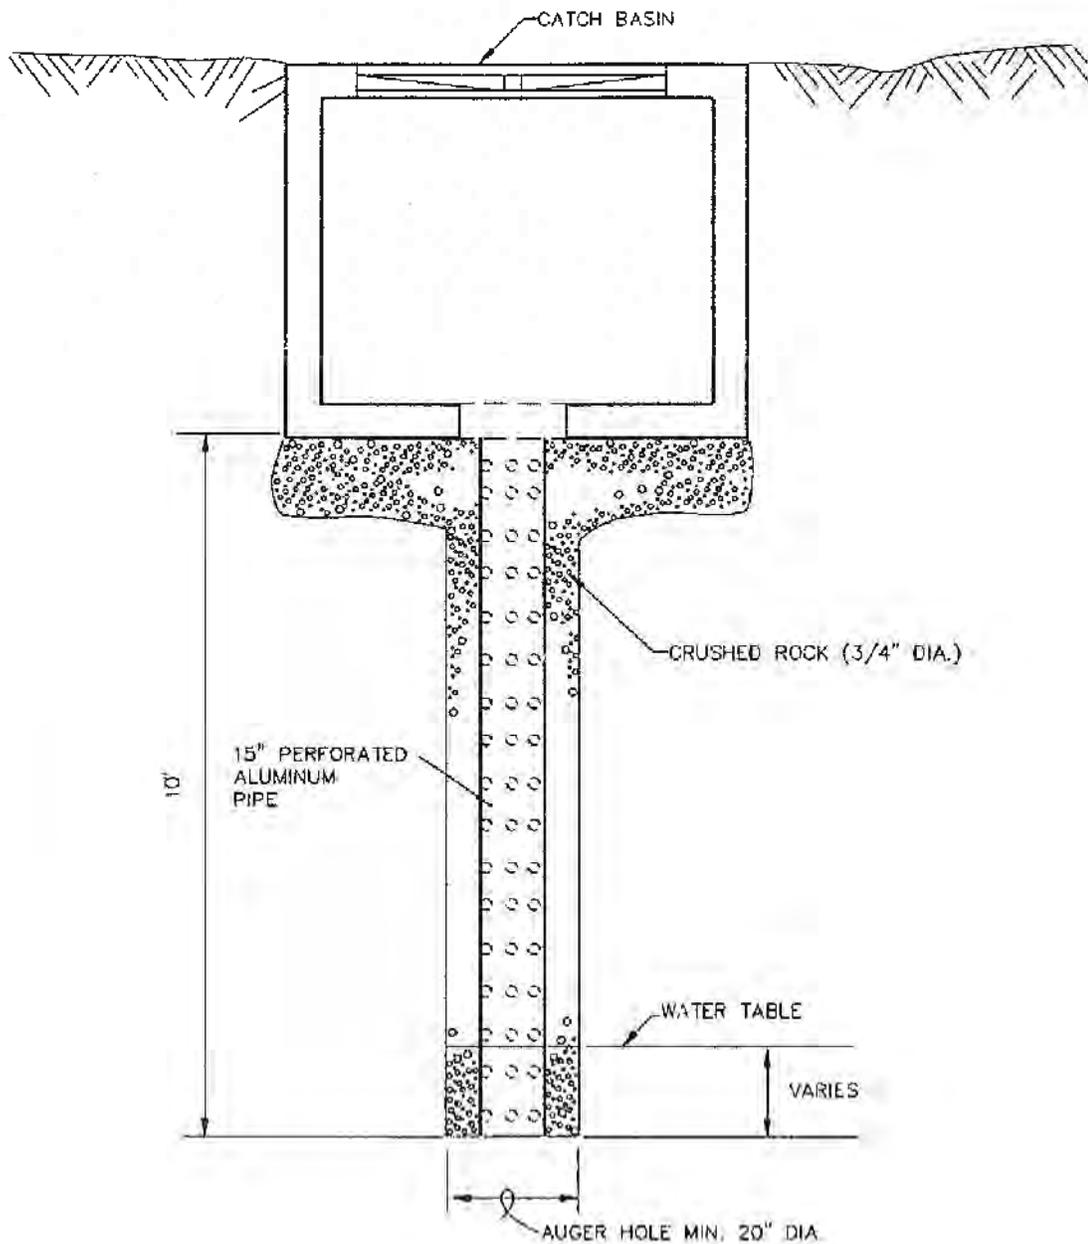
Figure 2.10

CROSS SECTION

One primary component of the Village's original exfiltration (seepage) system was the 15-inch auger well installed to a depth of 10 feet and lined with gravel. Auger wells consisted of a catch basin atop a vertical perforated corrugated aluminum pipe with a depth of 10 feet. These wells were installed in many locations along the public rights-of-way throughout the Village. **Figure 2.10** shows a typical cross section of an auger well.

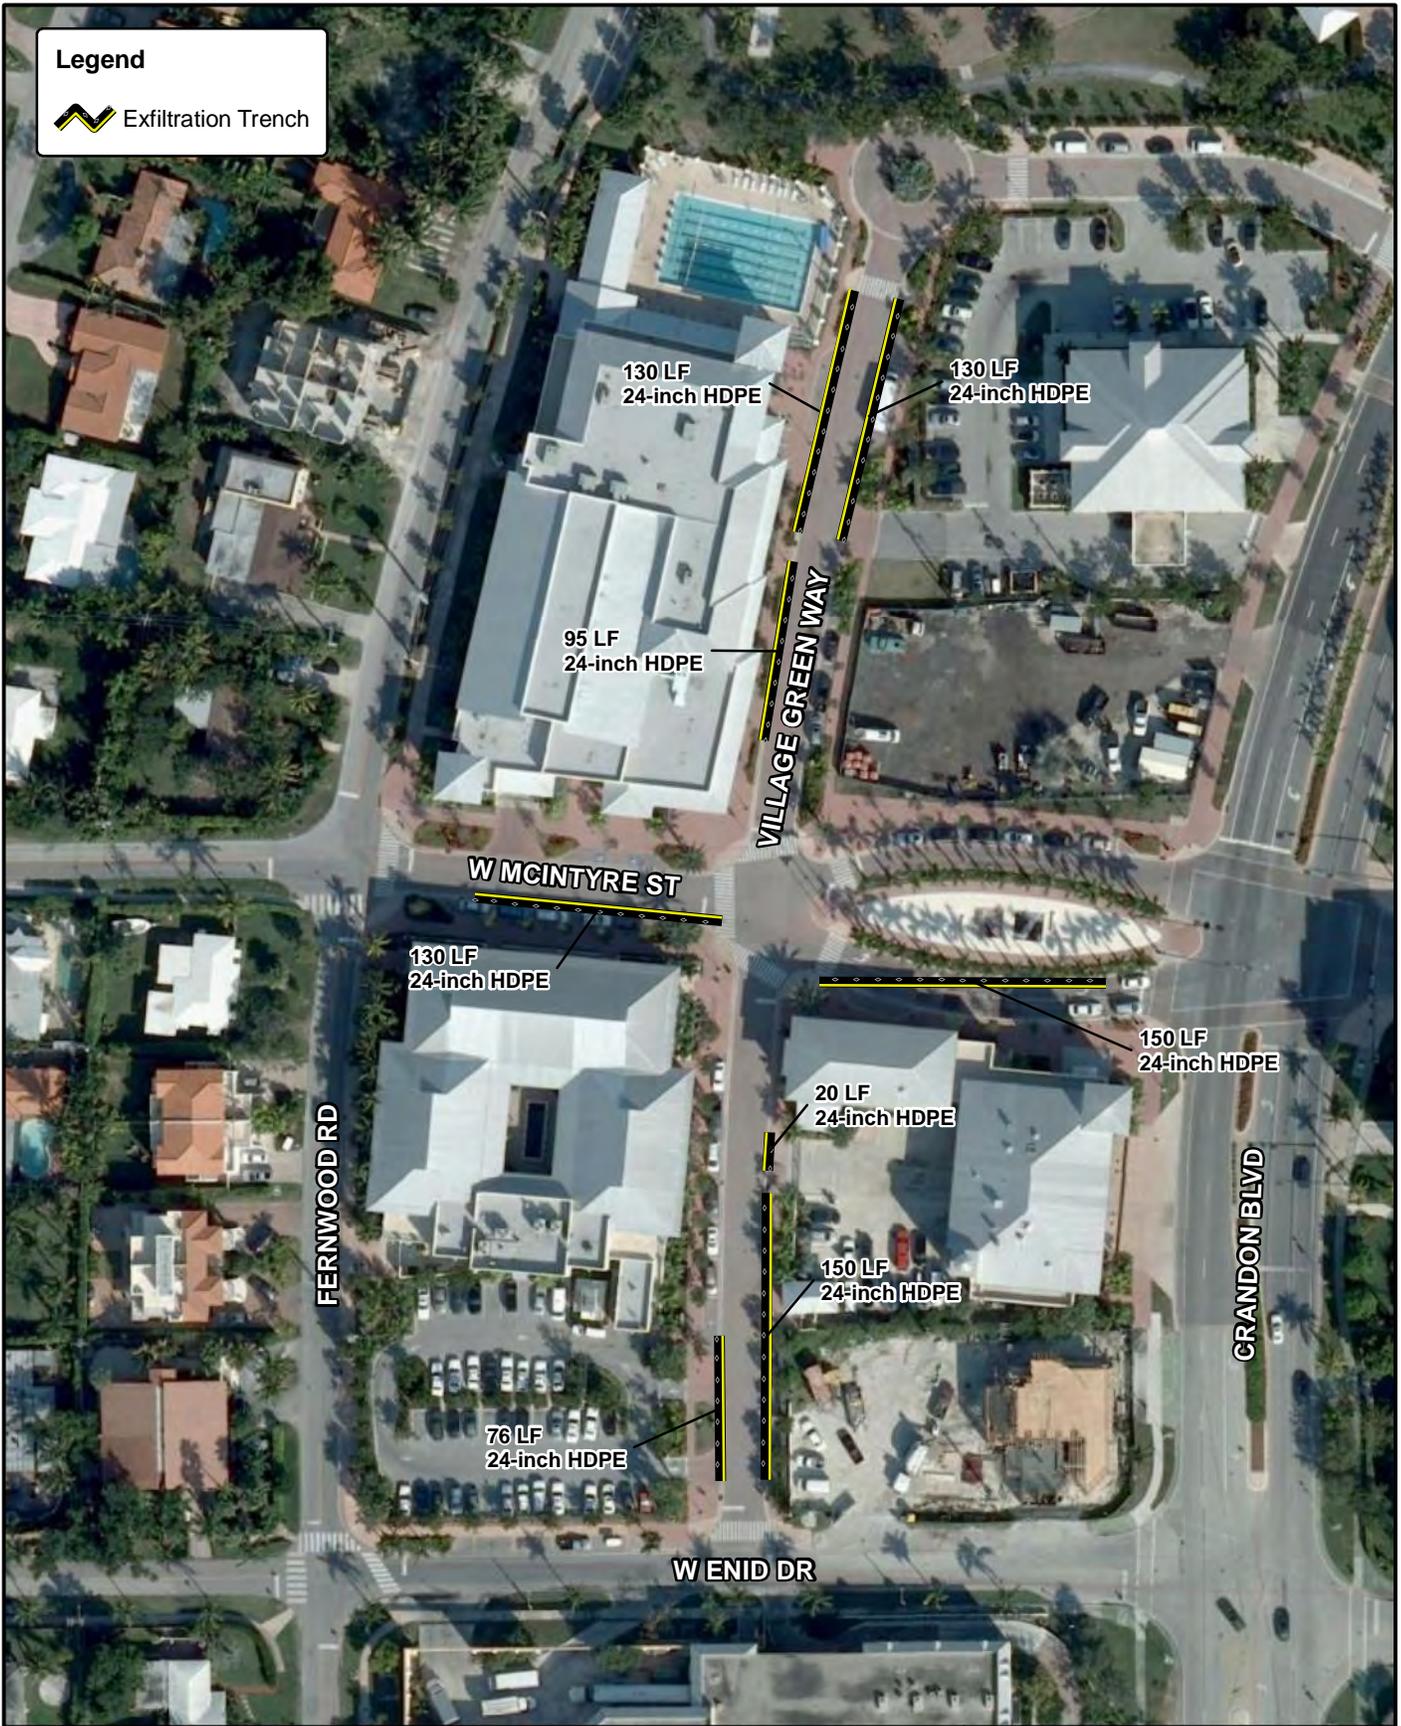
Figure 2.11

**EXFILTRATION LOCATION MAP
STORMWATER MASTER PLAN UPDATE
VILLAGE OF KEY BISCAIYNE, FLORIDA**

Exfiltration trenches have been installed in a small area by the Village Hall as indicated in **Figure 2.11**. An exfiltration trench is a perforated pipe laid in a trench 10 to 15 feet deep and surrounded by gravel and a filter material (see **Figure 2.12**). These drains function much like the auger wells with the primary difference being they are laid horizontally rather than vertically and have a greater surface area to facilitate exfiltration.

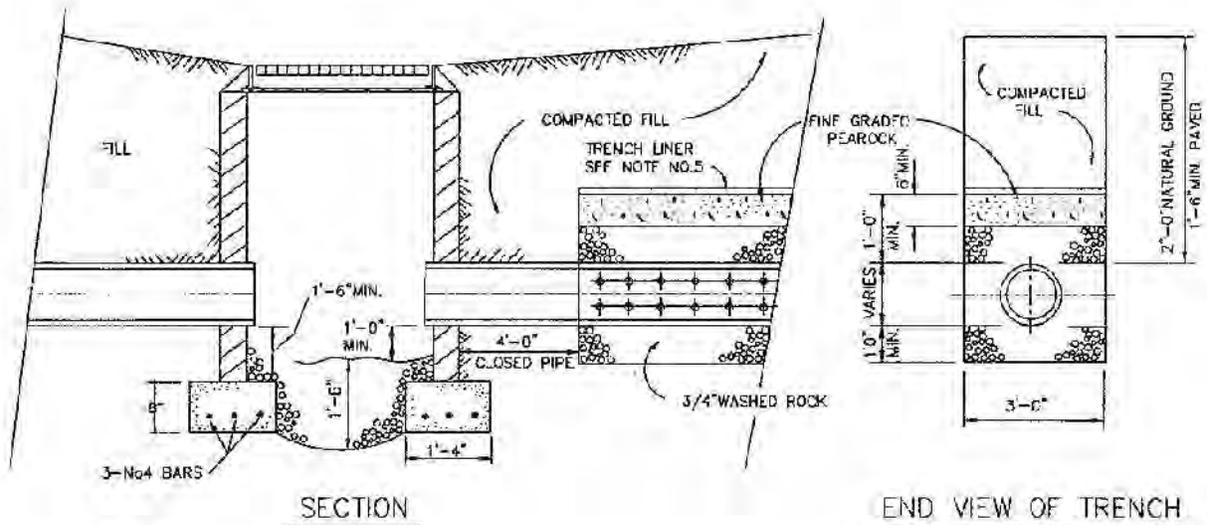
1. DRAIN FIELD MAY BE OF SLOTTED CONCRETE PIPE OR PERFORATED METAL PIPE.
2. PIPES SHALL TERMINATE 2 FEET FROM END OF TRENCH OR CONNECT TO ADDITIONAL CATCH BASINS AS REQUIRED.
3. COVER PIPE ENDS WITH NO. 10 GALVANIZED OR ALUMINUM SCREEN. OPENING SHALL BE NO LARGER THAN 1/2" x 1/2".
4. BALLAST ROCK SHALL BE FROM FRESH WATER WASHED FREE OF DELETERIOUS MATTER.
5. SIDES AND TOP OF TRENCH SHALL BE LINED WITH A PLASTIC BLANKET (GEOTEXTILE FABRIC) AND SHALL COMPLY WITH F.D.O.T. "STANDARD SPECIFICATIONS FOR ROAD AND BRIDGE CONSTRUCTION" AND SECTION 965, 1986 EDITION.

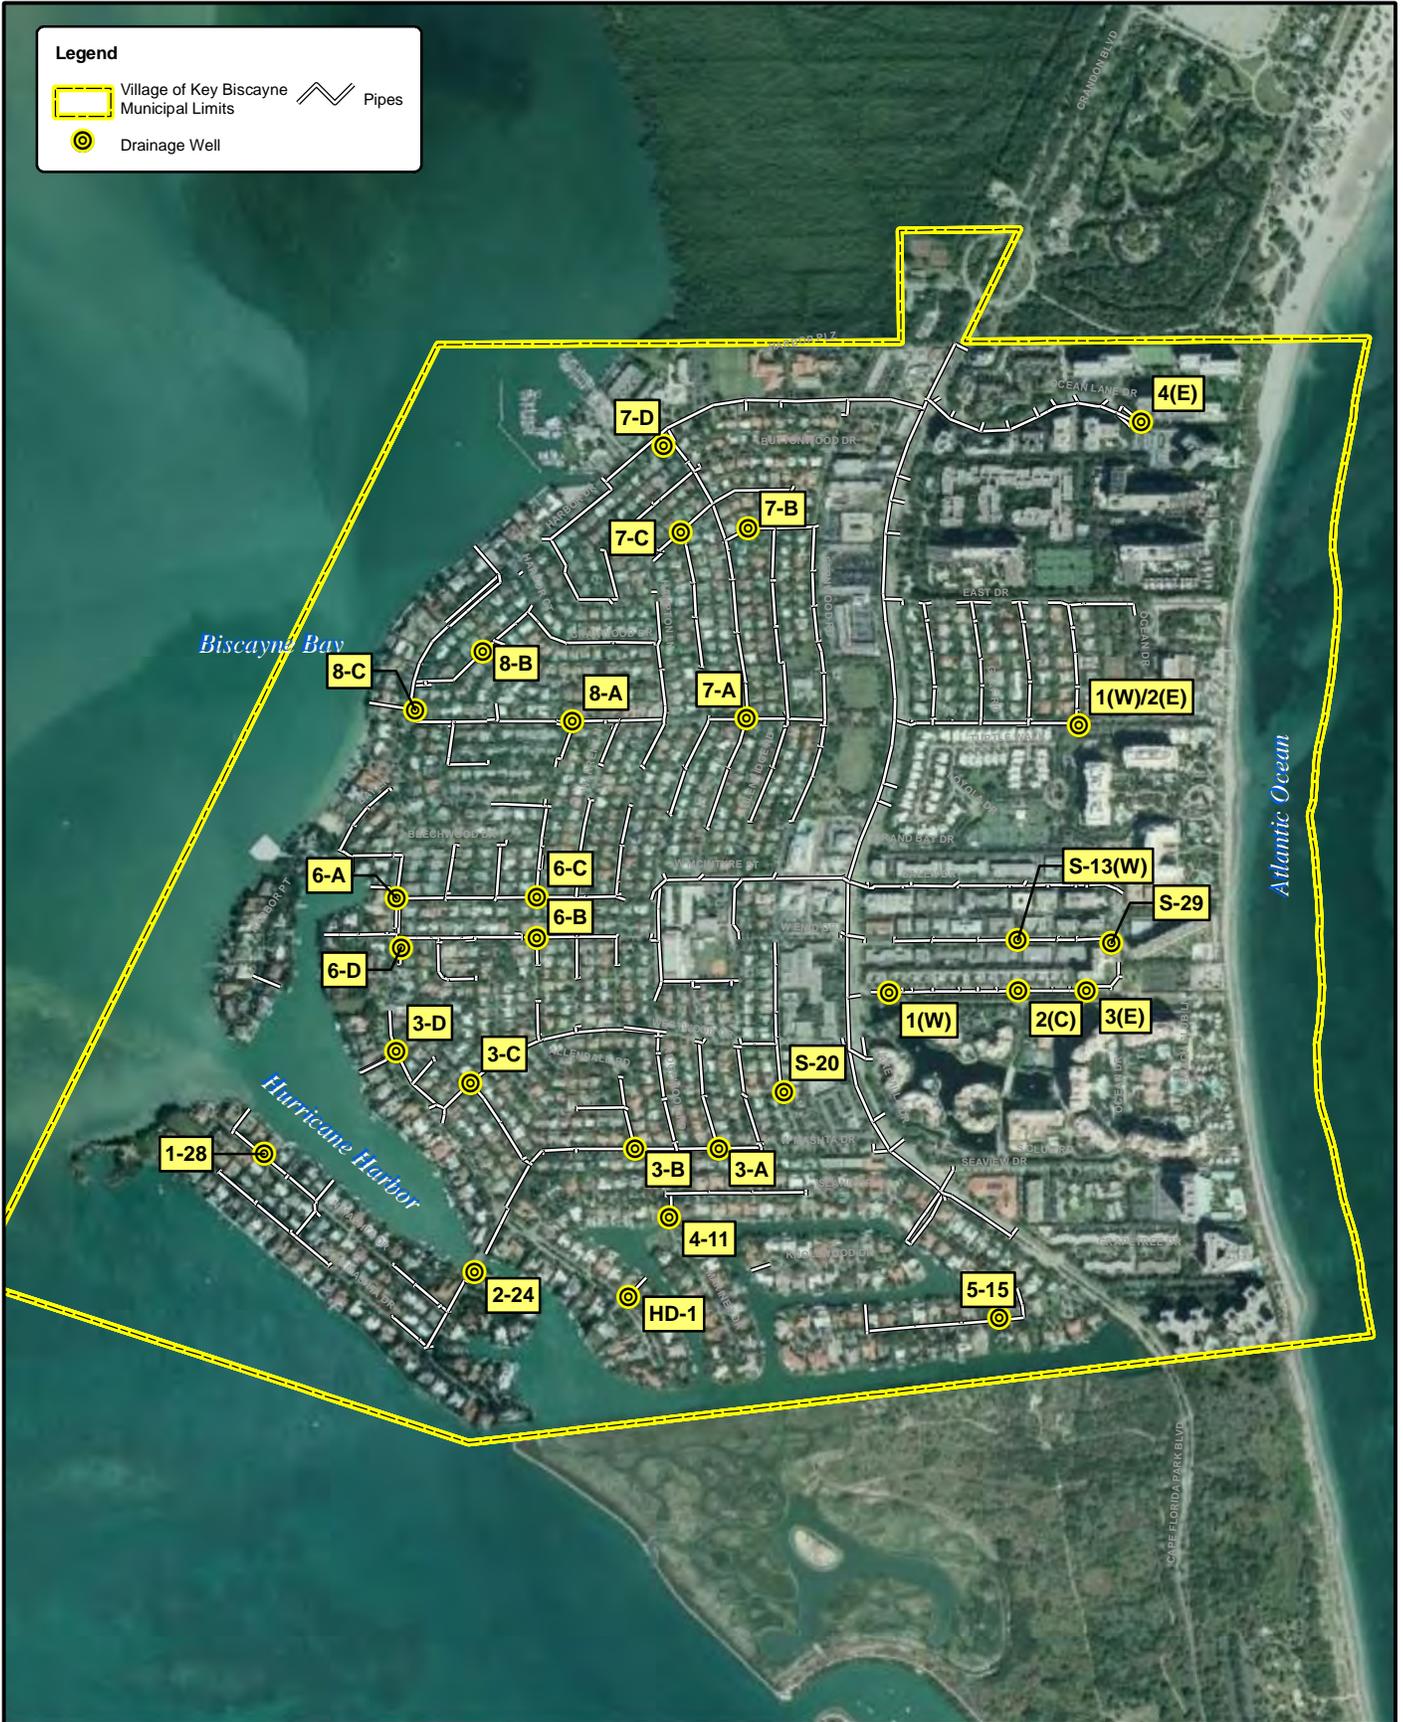
**DRAINAGE WELL LOCATION MAP
STORMWATER MASTER PLAN UPDATE
VILLAGE OF KEY BISCAINE, FLORIDA**
