Stormwater Management Master Plan Update

Village of Key Biscayne

June 28, 2011

TETRA TECH

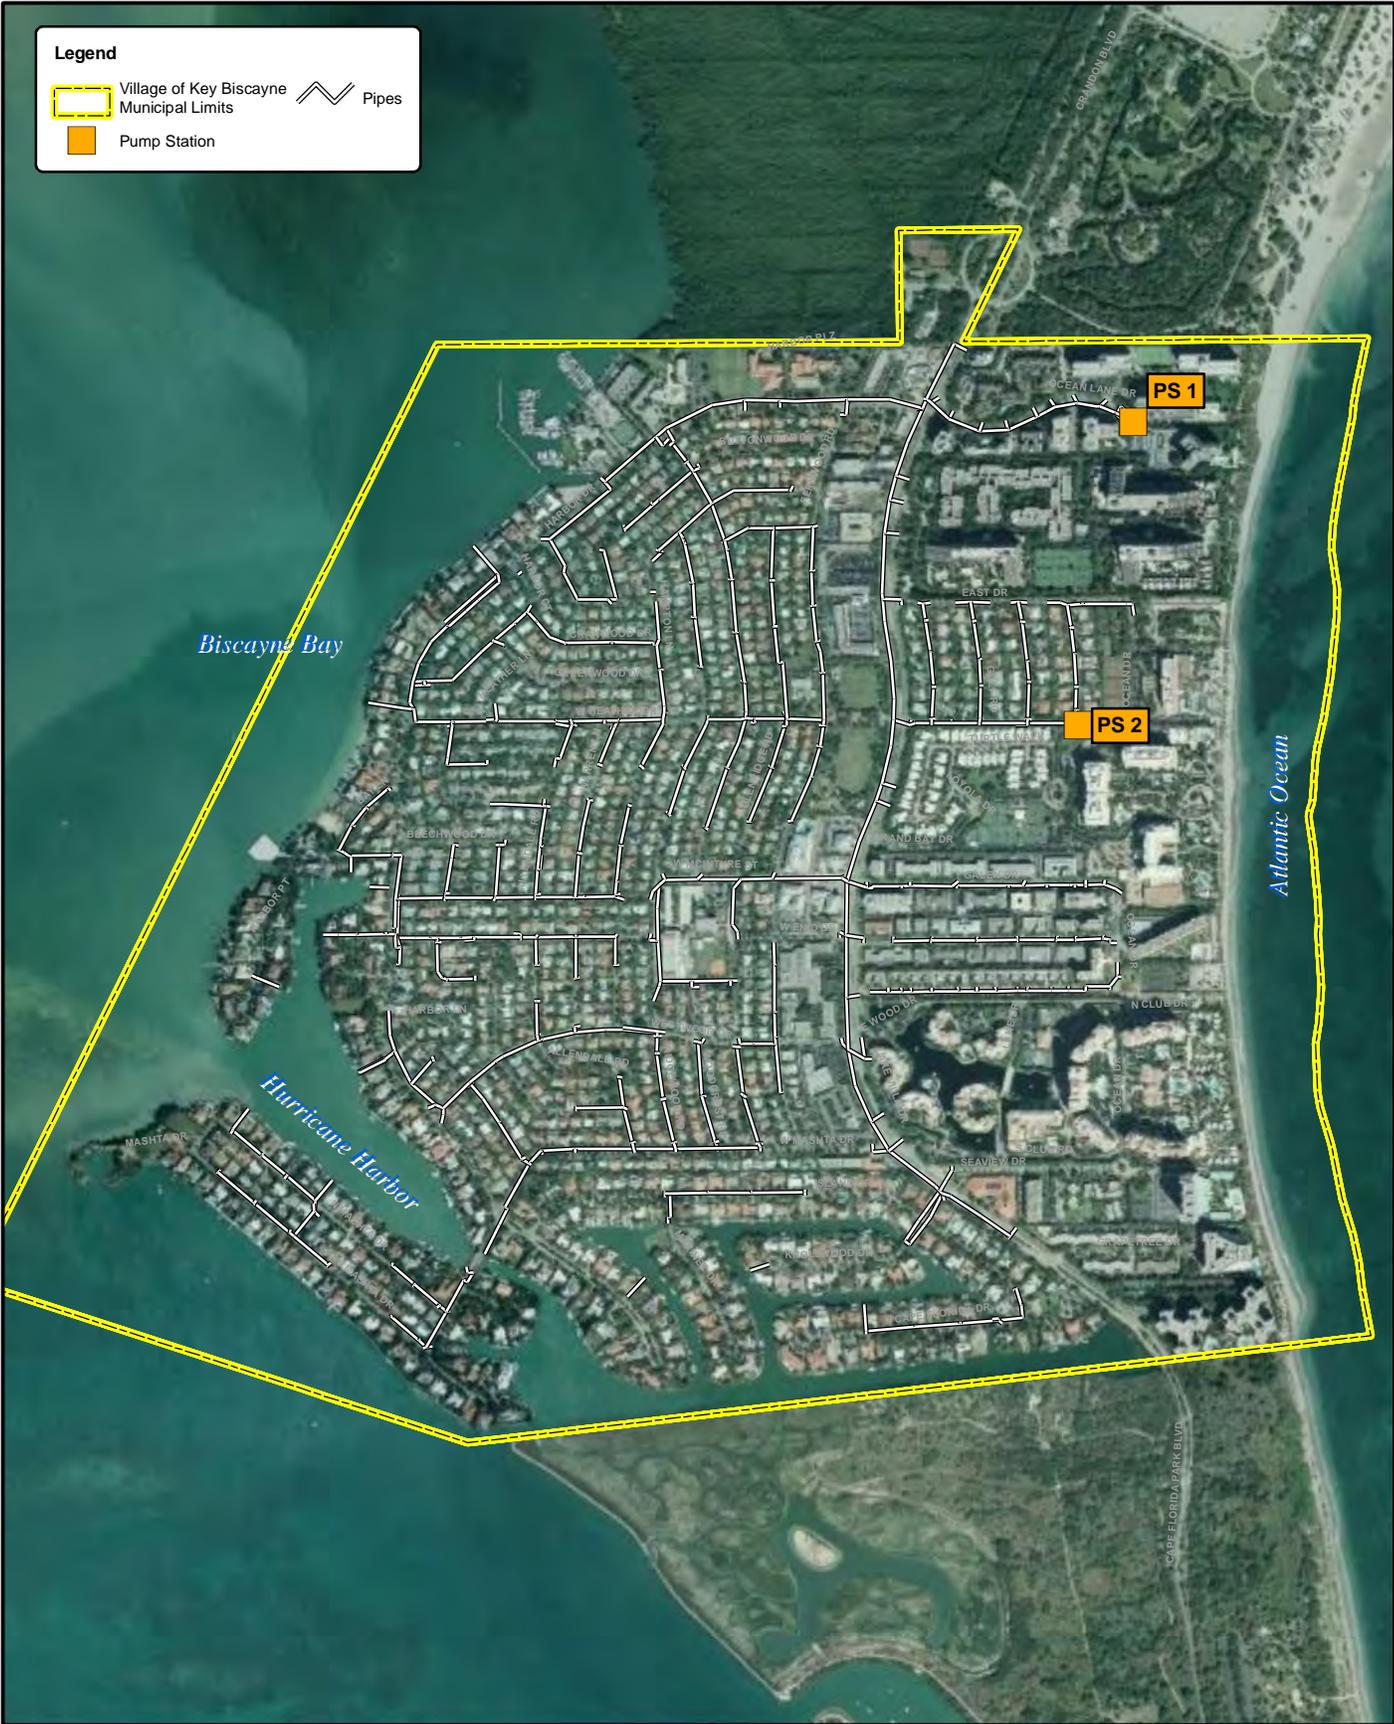
**PUMP STATION LOCATION MAP
STORMWATER MASTER PLAN UPDATE
VILLAGE OF KEY BISCAIYNE, FLORIDA**

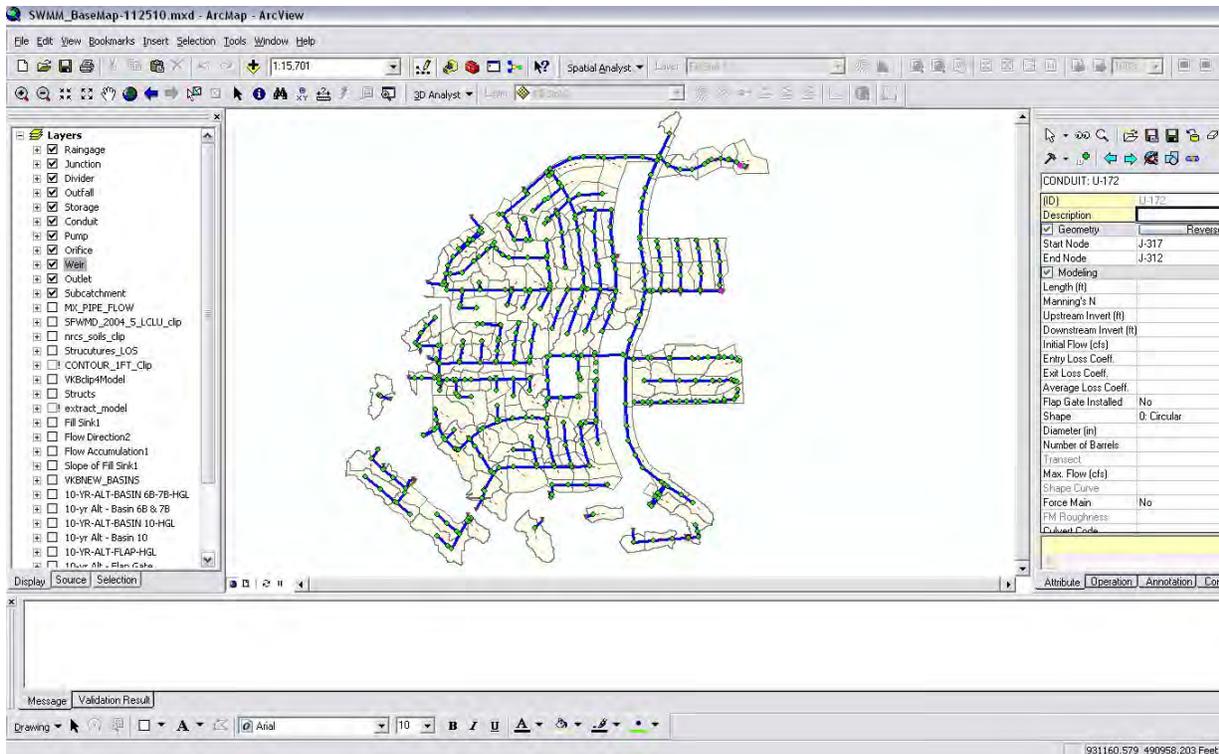
The model conduits range from 12-inches in diameter to 48-inches in diameter. The model increases in complexity with the increasing number of elements included in the model. Therefore, many of the duplicate catch basins were not included in the model. A duplicate catch basin location is where two or four catch basins exist to collect runoff from both sides of the road or an intersection; in these locations only one junction is depicted in the model. The junctions include the actual rim elevation of the catch basin and the bottom elevation of the structure. The conduit include the upstream and downstream pipe invert, if the invert is known. Since most, if not all, storm sewer pipes in the Village are submerged; Tetra Tech estimated invert elevations for some portions of the H&H model. The estimated storm sewer data should not affect the general results of this planning level model given the submerged condition of the existing stormsewer system. **Figure 3.2** shows the model junction-conduit diagram overlain on the basins/subcatchments. Below is a “snap shot” of the node and links in the InfoSWMM software environment.

- a Rain gauge representing the hydrologic scenarios for the SFWMD predicted precipitation and length of storm;
- 184 subcatchments representing the land area that receives rainfall;
- 438 junctions representing the catch basins throughout the Village;
- 54 outfalls representing the outfalls to Biscayne Bay and the drainage wells;
- 441 conduits representing the storm pipes;
- 4 pumps representing the two pump stations;
- 13 weirs representing the weirs within the storm sewer system; and
- 31 outlets representing the flow into the drainage wells.
